Preliminary Field Assessment of Sinkhole Damage in Pokhara, Nepal

ABSTRACT: Since November 2013, numerous sinkholes have been forming in the Armala area of Pokhara Valley, Central Nepal, posing serious threat to local residents. In order to provide measures aimed at reducing sinkhole risk, investigations into the cause and features of the sinkholes are crucial. This paper presents early research results based on two damage surveys conducted in June 2014 and November 2014 in the Armala area. Comparison of photos, taken in the two surveys, clearly indicates not only the formation of new sinkholes, but also the re-activation of filled sinkholes. By means of dynamic cone penetration tests and surface wave method investigations, qualitative characterization of the soil profile was attained, and shallow weak soil layers which are believed to be the location for future sinkholes could be identified. On the basis of the field investigation results, possible sinkhole formation mechanisms are identified for the Armala area. Furthermore, results of a reconnaissance survey conducted in the Armala area in early May 2015 (following the 2015 Gorkha Nepal Earthquake, which occurred on April 25th)

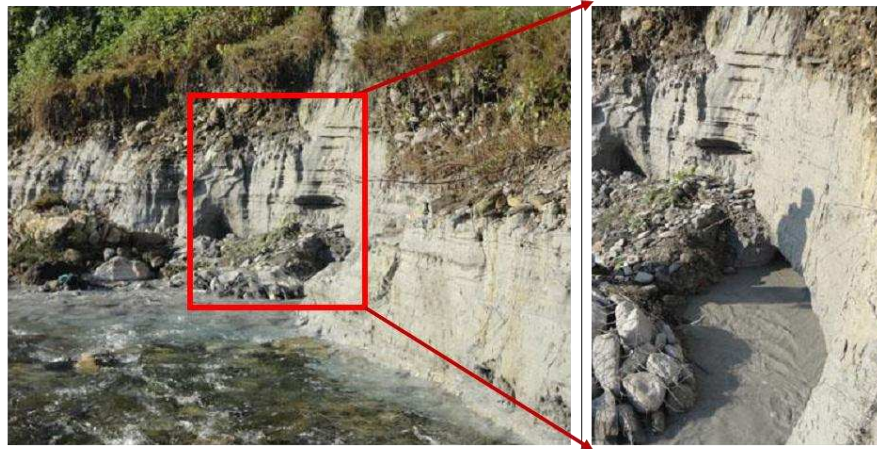
According to local residents, a muddy silty water outlet (shown in Figure 4 corresponding to photo point 1) was observed at the Kali Khola (Small River) riverbank about a week before the first sinkhole appeared in November 2013 (Figure 2). Since then, more than 150 sinkholes developed in this area until June 2014 and more than 200 sinkholes were reported up to November 2014.

Figure 4. Muddy silty water outlet at the riverbank of the Kali Khola (photo point 1) (Photo Courtesy: Technical Research Team, 2014).

Nevertheless, in November 2013, suddenly, a water spring was observed for the first time by local residents (Figure 4). It was rapidly followed by the formation of a number of sinkholes, as already described previously. The authors believe that the formation of the water spring induced a change in the groundwater level i.e. water table decline (Figure 16(b)). The drastic fall in groundwater level and its fluctuation during rainy season, accelerated the erosion process (as evidenced by muddy water observed at the water spring outlet) and cavity enlargement (Figure 16 (c)). The evidence of the erosion process in the ground is shown in Figure 17. The water sample collected from different points in the study area in June 2014 has different turbidity. The water sample collected at the stream or seepage location (water sample (WS) point 3 in

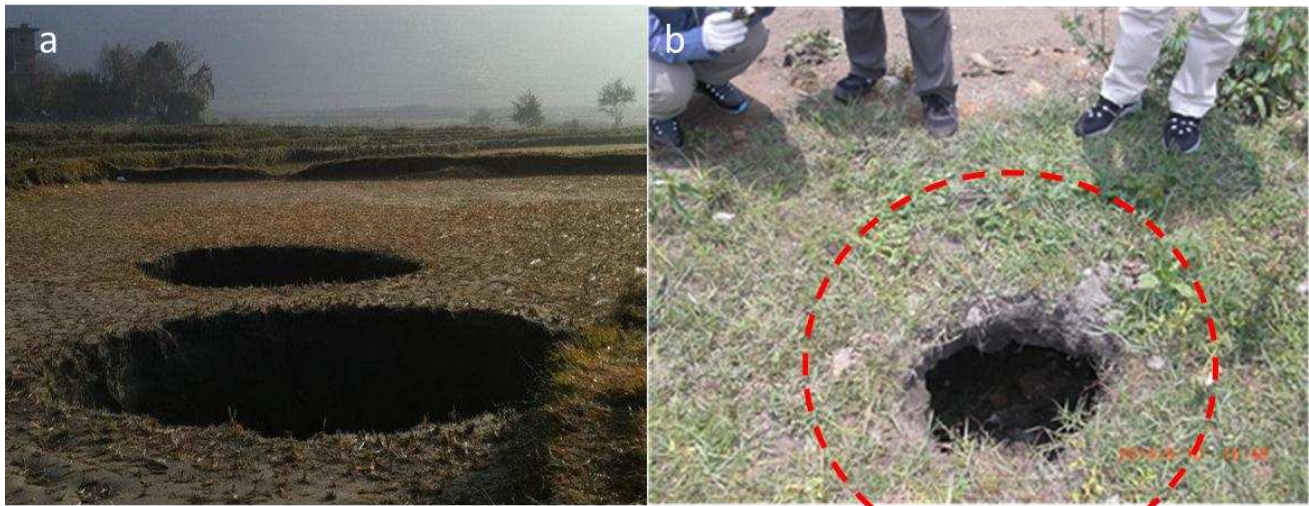
Typical circular-shaped sinkholes that appeared in November 2013 are shown in Figure 5(a). Although the first sinkhole appeared in the northern part of the investigation site, the majority of the sinkholes actually were formed along the Duhuni Khola nearby the main road (as shown by the green dots in Figure 2) between November 25th and December 5th 2013. Later on, the formation of sinkhole extended towards the western side. The depth and size of the sinkholes on level ground along Duhuni Khola were bigger than those developed on sloped ground and increased with time. Eventually, large-size sinkholes ended to connect each other along the Duhuni Khola.

Figure 5. (a) Typical sinkholes formed in November 2013 (Photo Courtesy: Keshab Sharma); and (b) a sinkhole formed in June 2014 (photo point 2).

Figure 5(b) shows a small sinkhole that appeared, at photo point 2, just one day before the survey team visited the damaged area in June 2014. Note that although the sinkhole in Figure 5(b) has a small diameter at the surface, its diameter is in reality much larger in the subsurface (as indicated by the red dashed line). Such spherical shape is due to the fact that the soil in the upper part of the sinkhole was retained by the grass root system supporting the surface soil.

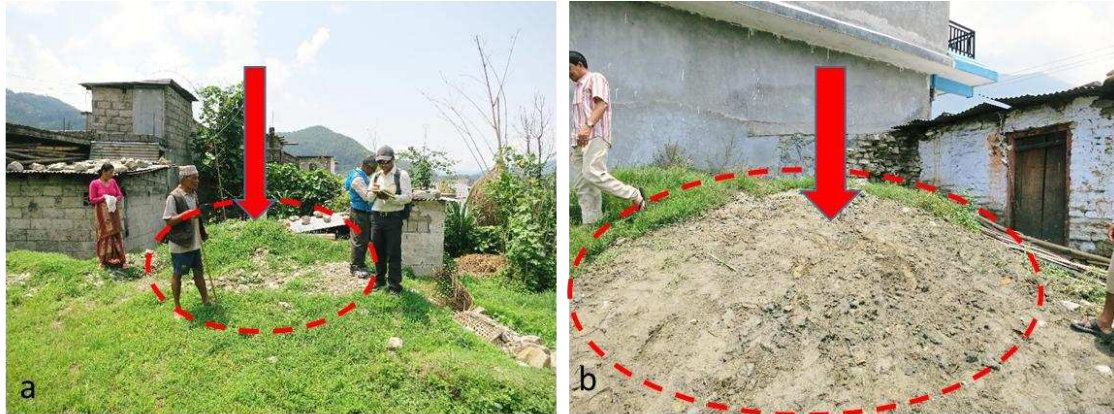
The sinkholes affected not only agricultural farmland. They also caused the collapse of manmade structures like the cowshed shown in Figure 6(a) (corresponding to photo point 3), and the masonry kitchen shown in Figure 6(b) (corresponding to photo point 4). The homeowner reported that about 60 m³ of filling material were used to fill the sinkhole shown in Figure 6(a).

Figure 6. Typical effects of sinkhole formation on residential properties observed on June 2014 included the collapsed of (a) a cowshed and (b) a masonry kitchen.

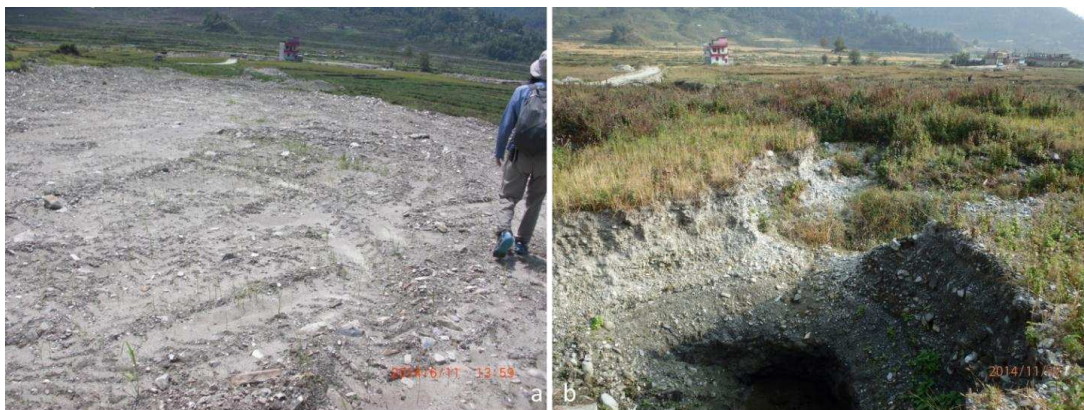
Immediately after the occurrence of the sinkholes, a wide area affected by the cave-in was backfilled by using gravelly soil retrieved from nearby quarries, which is identified by a yellow color filled area in Figure 2. Though, at the time of the first damage survey in June 2014, most of the sinkholes had been fully backfilled (Figure 7a corresponding to photo point 5), the photos taken in November 2014 at the same location clearly show that the backfilling was not an adequate solution as most of the former sinkholes were re-activated (Figure 7b) likely in August 2014 during the peak rainy season in Pokhara Valley.

Figure 7. (a) Sinkholes backfilled area (photo point 5) as seen in June 2014; and (b) Re-activated sinkholes as observed in November 2014.

As mentioned earlier, as an immediate mitigation work, all the old sinkholes were filled by the local government. This practice could disrupt the underground water flow so that ultimately the caving process caused the re-activation of sinkholes. Note that due to loose conditions of backfilled material, it is expected that the development of a re-activated sinkhole is much quicker than that of the original sinkhole where natural compacted soils was gradually eroded by water.

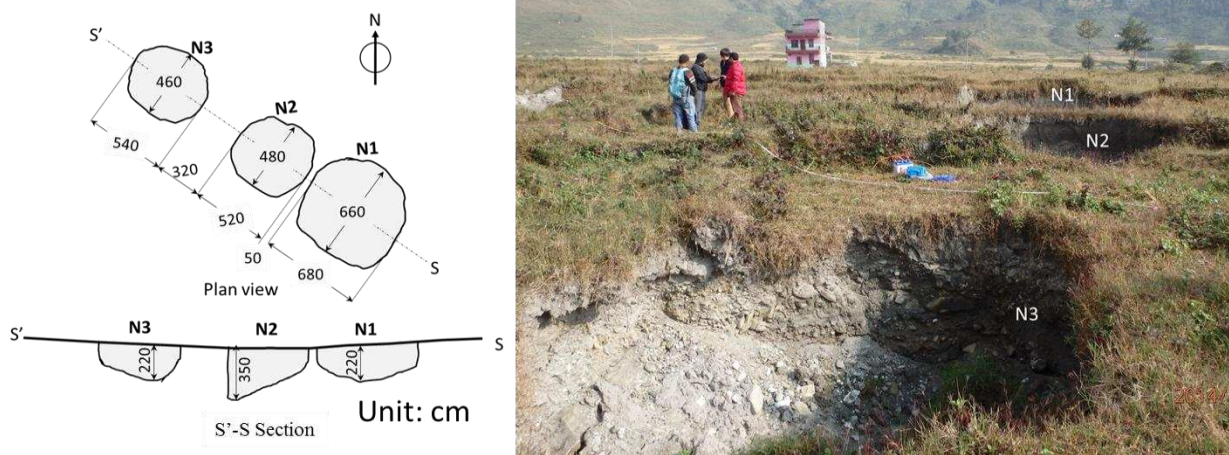
Among many, sinkholes N1, N2 and N3 in the area X shown in Figure 2 were found to be of particular interest. They were developed in a delimited area of approximately 10 m × 20 m, as shown in the schematic map shown in Figure 8. They have a circular pattern and diameters ranging from 4.6 m (N3) to 6.8 m (N1). Their depth measured at the top of the collapsed soil varied from 2.2 m (N1, N3) to a maximum of 3.5 m (N2). According to witnesses, N1 was the first sinkhole to be formed. A few days later, N2 caved-in and finally N3 developed. This progressive formation of several sinkholes along a straight line (moving along the uphill direction from N1 to N3) may suggest that the collapse of N1 caused the complete disruption of underground water flow. Consequently, water started to erode the soil just adjacent to N1 until a new cave-in (N2) was formed. In a similar way, N3 was later developed. The same pattern of sinkhole formation occurred often since November 2013. Most of the newly developed sinkholes are located on the upstream side of the underground water flow.

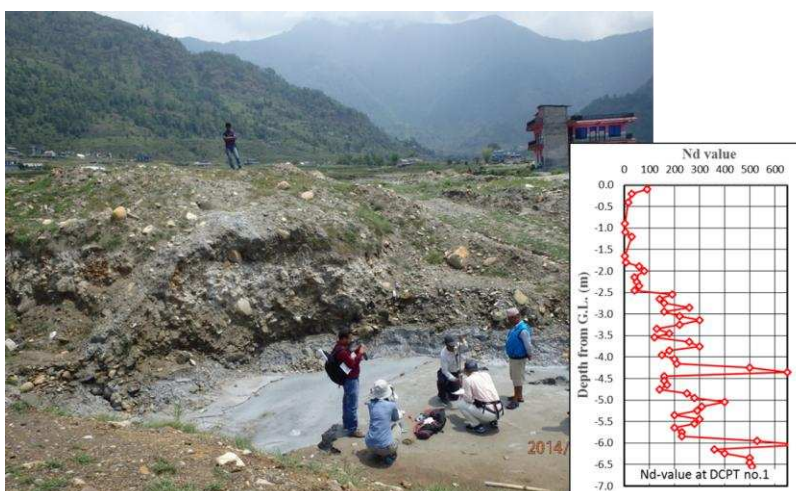
DCPT-1 was carried out at the bottom of a non-filled sinkhole as shown in Figure 10 (corresponding to photo point 7 in Figure 2). As already mentioned, this area is composed of recent flood plain deposits, including a thick gravel layer at shallow depth. Thus, DCPTs could not penetrate more than 6.55m. However, the test results would suggest that the probable depth of the sinkholes should be approximately 4.5-5m, or more precisely 6.5-7 m below the ground level considering that the actual ground level was approximately 2m above the sinkhole bottom.

Figure 10. Result of the Dynamic Cone Penetration Test at DCPT no. 1 at the bottom of a sinkhole.

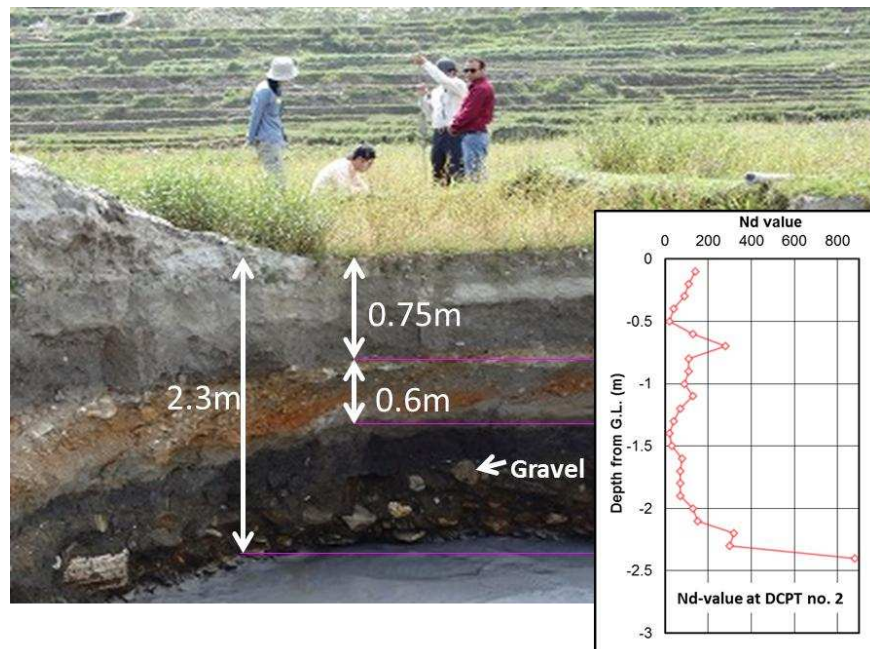
On the other hand, DCPT-2 (Figure 11) was carried out just adjacent to the sinkhole at photo point 8 in Figure 2. The test results were correlated with stratigraphy and structure of the deposits (Figure 11). The converted DCPT N_d -values are plotted in Figure 11. The upper layers of the surface soil could be penetrated until reaching a layer of gravel at a depth of 2.4 m, where even by hitting more than 150 times the penetration process stopped.

By comparing the N_d -values obtained from DCPT-2 and DCPT-3, it is noted that the filled materials are looser than the natural soil. Therefore, the filled material can be easily caved-in and induce the re-activation of filled sinkholes during the rainy season.

Figure 11. Soil profile and DCPT result at DCPT-2 obtained for the sinkhole in photo point 8 (Photo in June 2014).

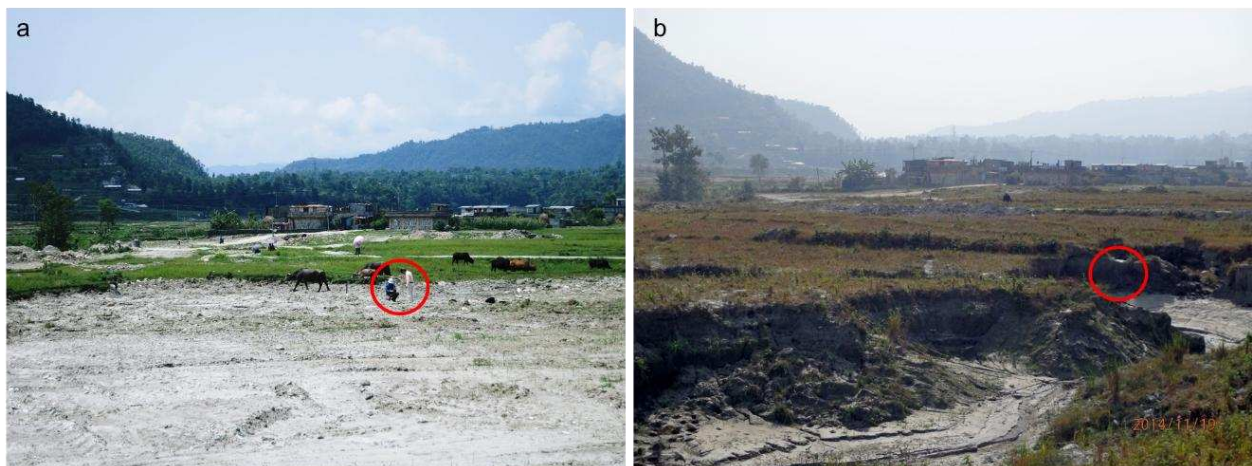
DCPT-3 was carried out at the top of the filled material at photo point 9. As shown in Fig. 12a and 12b, the testing location disappeared due to the collapse of filled material during the rainy season between June and November 2014. From the test results shown in Fig. 13, it is concluded that the used filling materials are sand and gravelly soils. However, the compaction at the surface is not good enough because the N_d -value measurement is low. The DCPT results suggest that the cavity bearing formation is below the gravel layer, and then progressively the cavity size increased and finally the loose upper layer collapsed.

Figure 12. a) Dynamic Cone Penetration Test at DCPT no. 3 (photo point 10) on the filled material (photo taken in June 2014) and b) re-activated sinkhole at the same location (photo taken in November 2014).

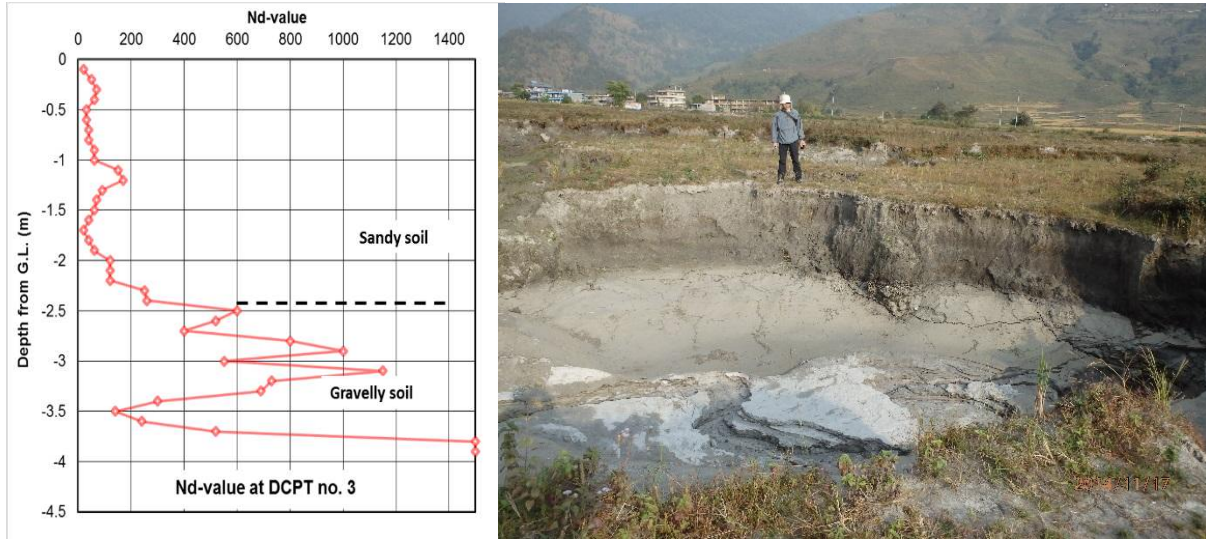
Figure 13 (a) Result of DCPT 3 conducted in June 2014 and (b) its location collapsed after the test.

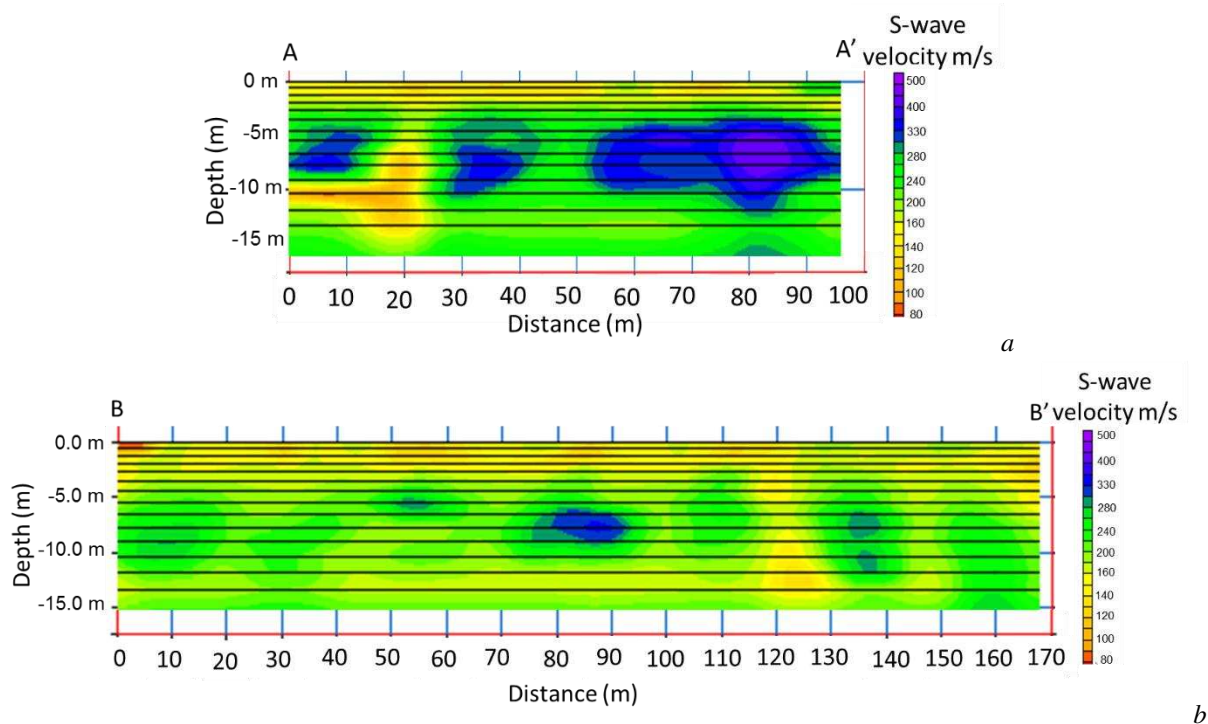
The results of SWM test along sections A-A' and B-B' are shown in Figure 15. It can be seen that the shear wave velocity for the surface layer is in the range of 100-160 m/s, confirming the presence of a loose sand layer of 1.5-m thickness. The underlying gravel has a higher velocity than the surface layer with a shear wave velocity of about 240 m/s. Moreover, the stiff soil below 4 m depth has a shear wave velocity greater than 300 m/s. The velocity of the layer around 10 m depth denotes water flowing path and loose material. A low velocity section observed 20 m far from the starting point in profile A-A' indicates possible cavities in the ground. Similarly, in profile B-B' the loose material at a depth of about 12 m indicates a possible water flowing layer and the weak strata between 120 m to 130 m is a possible future sinkhole.

Figure 15. Profiles of surface wave method: (a) section A-A'; and (b) section B-B'.

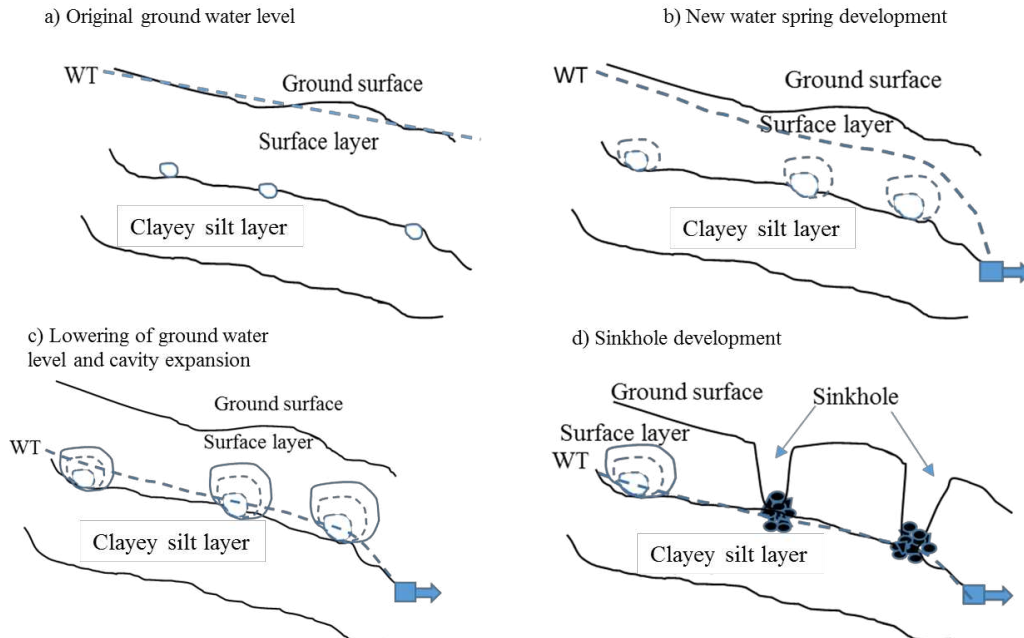
Figure 2) is clear and has no sediments. On the other hand, water samples collected at WS point 1 and 2 shows high turbidity (Figure 17). This indicates that underground water continues to dissolve the silt and there was a continuous caving process till June 2014. As the process continued, the loose, unconsolidated soil and sand above was gradually washed into the cracks and voids. Depending on how thick and strong the top layer was and how close to the surface the void beneath was, the ground was not able to sustain its own weight. Thus, cavities that before were stable, suddenly became unstable and collapsed (Figure 16(d)).

Figure 16. Probable mechanisms of sinkhole observed in the Armala area.

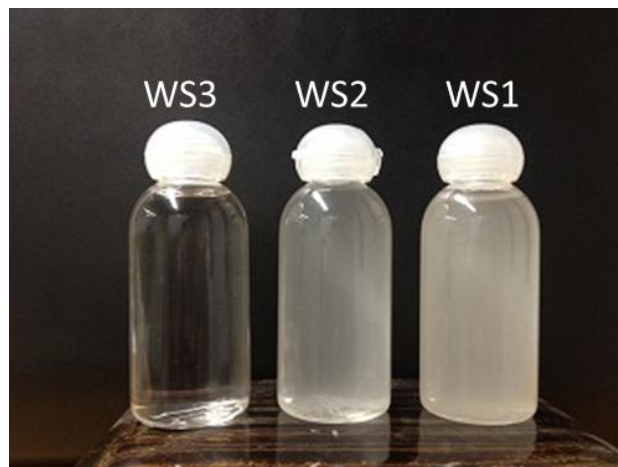
Figure 17. Turbidity of sampled water collected at different point in the Armala area in June 2014 (the water sample locations at ws1, ws2 and ws3 respectively in Figure 2).
