Preliminary Field Assessment of Sinkhole Damage in Pokhara, Nepal

ABSTRACT: Since November 2013, numerous sinkholes have been forming in the Armala area of Pokhara Valley, Central Nepal, posing serious threat to local residents. In order to provide measures aimed at reducing sinkhole risk, investigations into the cause and features of the sinkholes are crucial. This paper presents early research results based on two damage surveys conducted in June 2014 and November 2014 in the Armala area. Comparison of photos, taken in the two surveys, clearly indicates not only the formation of new sinkholes, but also the re-activation of filled sinkholes. By means of dynamic cone penetration tests and surface wave method investigations, qualitative characterization of the soil profile was attained, and shallow weak soil layers which are believed to be the location for future sinkholes could be identified. On the basis of the field investigation results, possible sinkhole formation mechanisms are identified for the Armala area. Furthermore, results of a reconnaissance survey conducted in the Armala area in early May 2015 (following the 2015 Gorkha Nepal Earthquake, which occurred on April 25th)

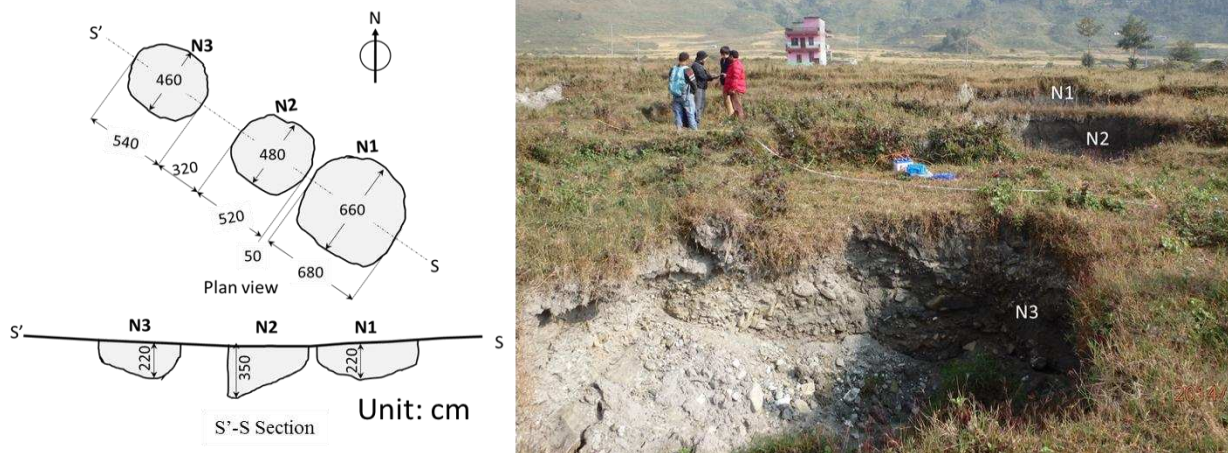
Among many, sinkholes N1, N2 and N3 in the area X shown in Figure 2 were found to be of particular interest. They were developed in a delimited area of approximately 10 m × 20 m, as shown in the schematic map shown in Figure 8. They have a circular pattern and diameters ranging from 4.6 m (N3) to 6.8 m (N1). Their depth measured at the top of the collapsed soil varied from 2.2 m (N1, N3) to a maximum of 3.5 m (N2). According to witnesses, N1 was the first sinkhole to be formed. A few days later, N2 caved-in and finally N3 developed. This progressive formation of several sinkholes along a straight line (moving along the uphill direction from N1 to N3) may suggest that the collapse of N1 caused the complete disruption of underground water flow. Consequently, water started to erode the soil just adjacent to N1 until a new cave-in (N2) was formed. In a similar way, N3 was later developed. The same pattern of sinkhole formation occurred often since November 2013. Most of the newly developed sinkholes are located on the upstream side of the underground water flow.

Figure 8. Series of sinkholes appeared in the area X in Figure 2 (photo point 6).

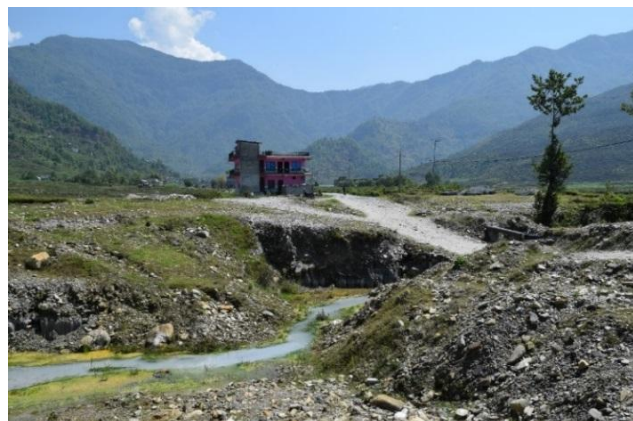
Figure 9. Muddy silty water observed in the sinkhole damaged area (photo point 7) following the 2015 Gorkha Nepal Earthquake.

Following the earthquake, muddy water was observed at the outlet of the local spring (Figure 9) in the Armala area (photo point 7), indicating that the earthquake had altered the subsoil conditions in some ways. Nevertheless, a field survey confirmed that no new sinkholes were formed and the size of existing sinkholes did not change. Yet, as mentioned earlier, muddy water indicates a high content of silt and fines in the water, and thus a process of erosion occurring in the subsoil. The earthquake may have induced a change in groundwater level and/or an increase of pore pressure that re-activated the erosion process. For this reason, the formation of new sinkholes may be anticipated in the near future, especially during the rainy season.

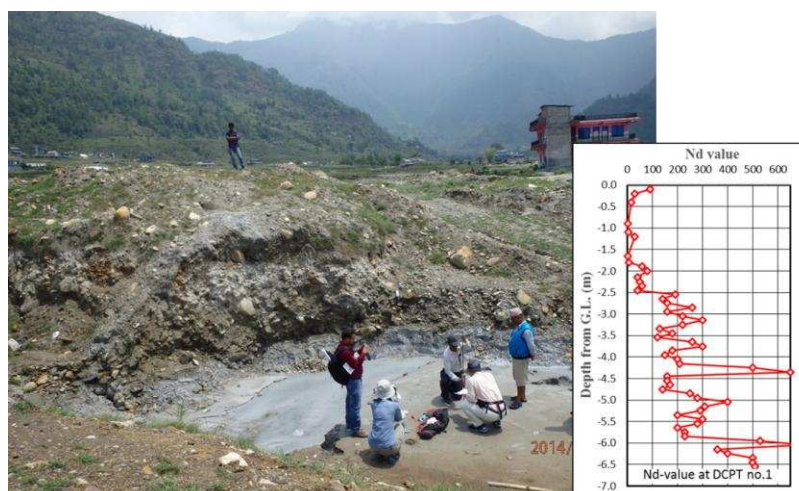
DCPT-1 was carried out at the bottom of a non-filled sinkhole as shown in Figure 10 (corresponding to photo point 7 in Figure 2). As already mentioned, this area is composed of recent flood plain deposits, including a thick gravel layer at shallow depth. Thus, DCPTs could not penetrate more than 6.55m. However, the test results would suggest that the probable depth of the sinkholes should be approximately 4.5-5m, or more precisely 6.5-7 m below the ground level considering that the actual ground level was approximately 2m above the sinkhole bottom.

Figure 10. Result of the Dynamic Cone Penetration Test at DCPT no. 1 at the bottom of a sinkhole.

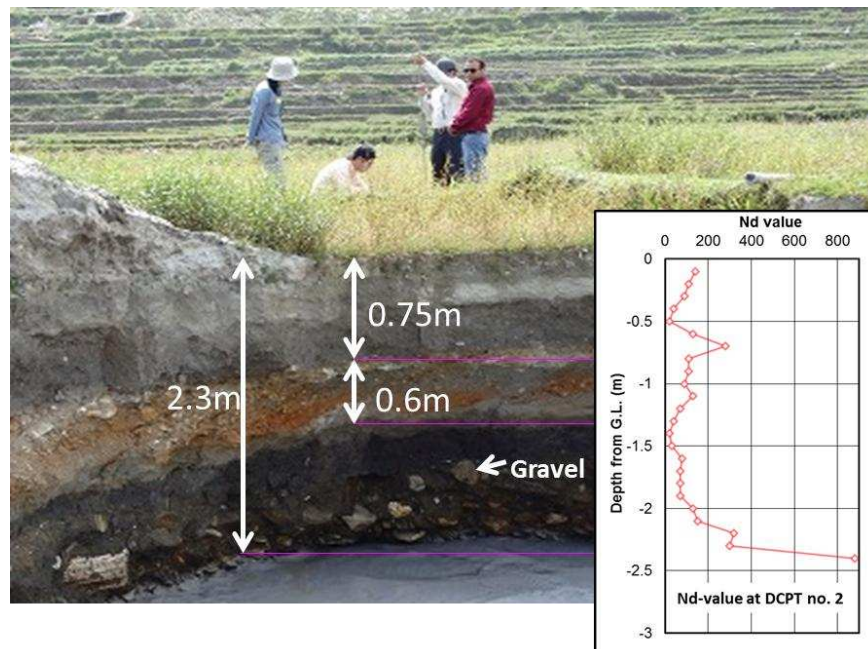
On the other hand, DCPT-2 (Figure 11) was carried out just adjacent to the sinkhole at photo point 8 in Figure 2. The test results were correlated with stratigraphy and structure of the deposits (Figure 11). The converted DCPT N_d -values are plotted in Figure 11. The upper layers of the surface soil could be penetrated until reaching a layer of gravel at a depth of 2.4 m, where even by hitting more than 150 times the penetration process stopped.

By comparing the N_d -values obtained from DCPT-2 and DCPT-3, it is noted that the filled materials are looser than the natural soil. Therefore, the filled material can be easily caved-in and induce the re-activation of filled sinkholes during the rainy season.

Figure 11. Soil profile and DCPT result at DCPT-2 obtained for the sinkhole in photo point 8 (Photo in June 2014).

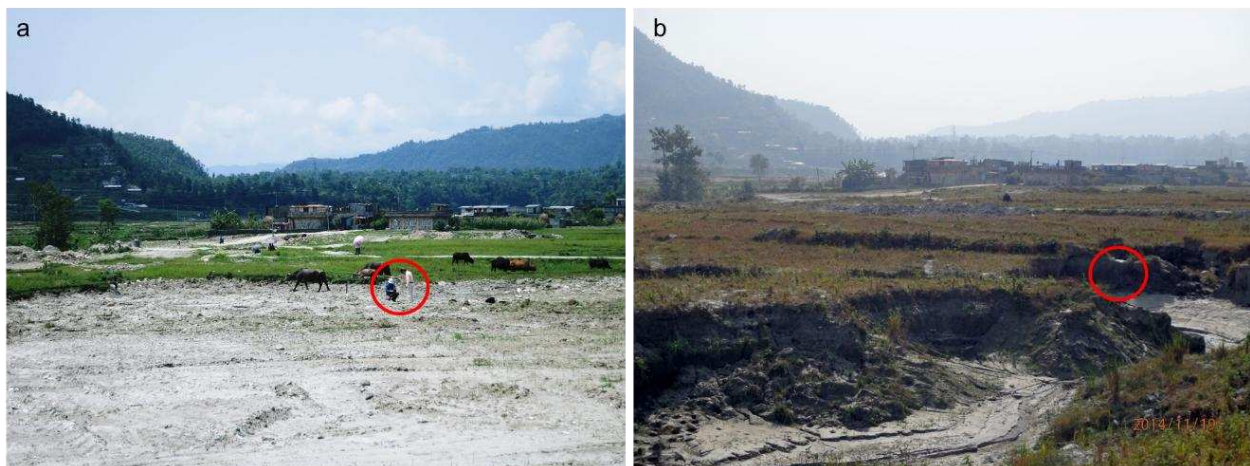
DCPT-3 was carried out at the top of the filled material at photo point 9. As shown in Fig. 12a and 12b, the testing location disappeared due to the collapse of filled material during the rainy season between June and November 2014. From the test results shown in Fig. 13, it is concluded that the used filling materials are sand and gravelly soils. However, the compaction at the surface is not good enough because the N_d -value measurement is low. The DCPT results suggest that the cavity bearing formation is below the gravel layer, and then progressively the cavity size increased and finally the loose upper layer collapsed.

Figure 12. a) Dynamic Cone Penetration Test at DCPT no. 3 (photo point 10) on the filled material (photo taken in June 2014) and b) re-activated sinkhole at the same location (photo taken in November 2014).
