Preliminary Field Assessment of Sinkhole Damage in Pokhara, Nepal

Reference: Pokhrel R.M., Kiyota T., Kuwano R., Chiaro G., Katagiri T. and Arai I. (2015). *Preliminary Field Assessment of sinkhole damage in Pokhara, Nepal*. International Journal of Geoenvironmental Engineering Case histories, <http://casehistories.geoengineer.org>, Vol.3, Issue 2, p.113-125. doi: 10.4417/IJGCH-03-02-04

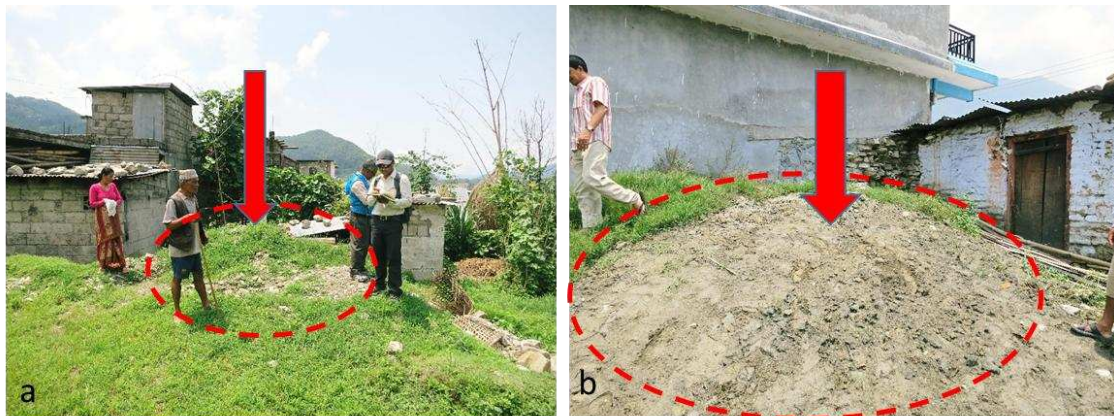
The sinkholes affected not only agricultural farmland. They also caused the collapse of manmade structures like the cowshed shown in Figure 6(a) (corresponding to photo point 3), and the masonry kitchen shown in Figure 6(b) (corresponding to photo point 4). The homeowner reported that about 60 m³ of filling material were used to fill the sinkhole shown in Figure 6(a).

Figure 6. Typical effects of sinkhole formation on residential properties observed on June 2014 included the collapsed of (a) a cowshed and (b) a masonry kitchen.

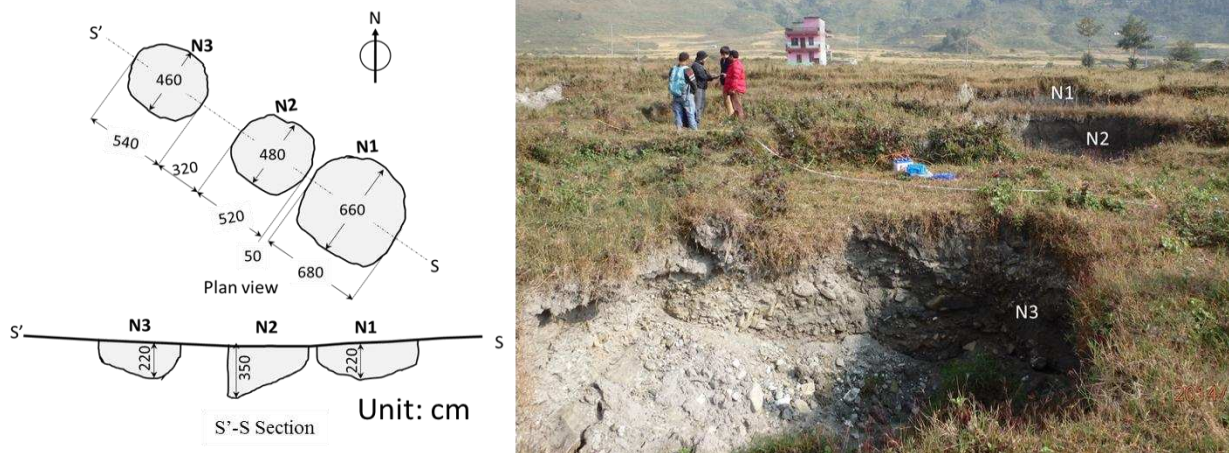
Among many, sinkholes N1, N2 and N3 in the area X shown in Figure 2 were found to be of particular interest. They were developed in a delimited area of approximately 10 m × 20 m, as shown in the schematic map shown in Figure 8. They have a circular pattern and diameters ranging from 4.6 m (N3) to 6.8 m (N1). Their depth measured at the top of the collapsed soil varied from 2.2 m (N1, N3) to a maximum of 3.5 m (N2). According to witnesses, N1 was the first sinkhole to be formed. A few days later, N2 caved-in and finally N3 developed. This progressive formation of several sinkholes along a straight line (moving along the uphill direction from N1 to N3) may suggest that the collapse of N1 caused the complete disruption of underground water flow. Consequently, water started to erode the soil just adjacent to N1 until a new cave-in (N2) was formed. In a similar way, N3 was later developed. The same pattern of sinkhole formation occurred often since November 2013. Most of the newly developed sinkholes are located on the upstream side of the underground water flow.

Figure 8. Series of sinkholes appeared in the area X in Figure 2 (photo point 6).

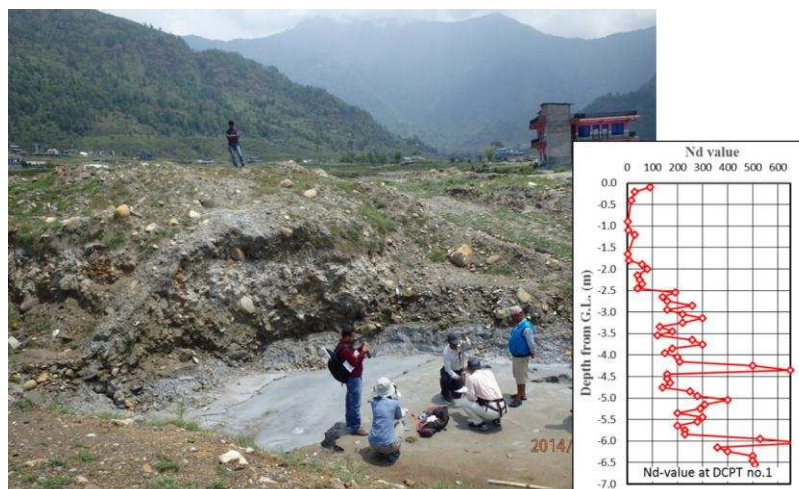
DCPT-1 was carried out at the bottom of a non-filled sinkhole as shown in Figure 10 (corresponding to photo point 7 in Figure 2). As already mentioned, this area is composed of recent flood plain deposits, including a thick gravel layer at shallow depth. Thus, DCPTs could not penetrate more than 6.55m. However, the test results would suggest that the probable depth of the sinkholes should be approximately 4.5-5m, or more precisely 6.5-7 m below the ground level considering that the actual ground level was approximately 2m above the sinkhole bottom.

Figure 10. Result of the Dynamic Cone Penetration Test at DCPT no. 1 at the bottom of a sinkhole.

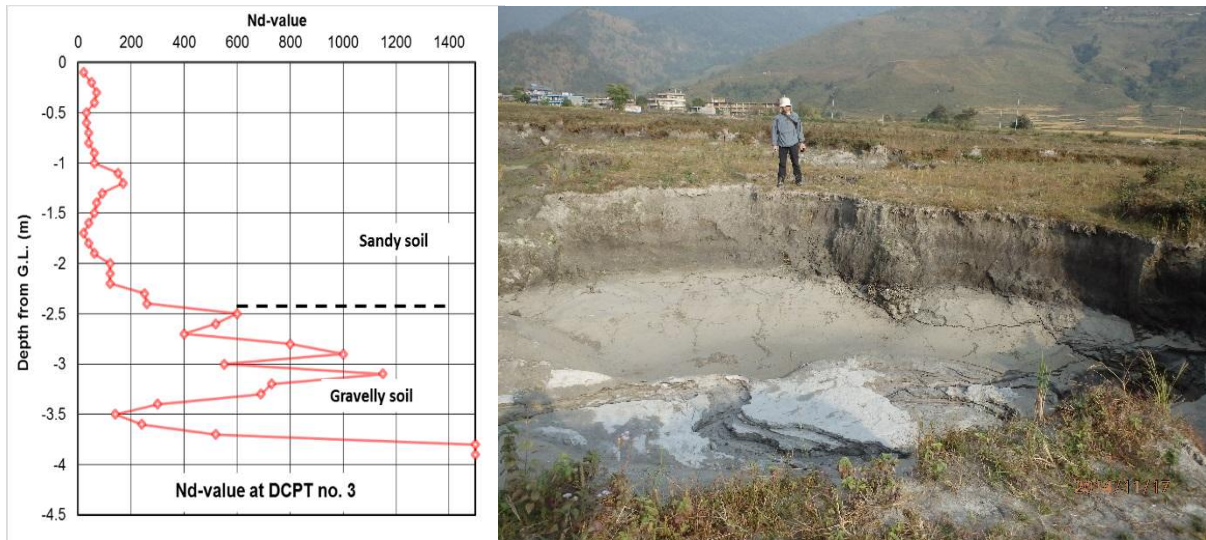
DCPT-3 was carried out at the top of the filled material at photo point 9. As shown in Fig. 12a and 12b, the testing location disappeared due to the collapse of filled material during the rainy season between June and November 2014. From the test results shown in Fig. 13, it is concluded that the used filling materials are sand and gravelly soils. However, the compaction at the surface is not good enough because the N_d -value measurement is low. The DCPT results suggest that the cavity bearing formation is below the gravel layer, and then progressively the cavity size increased and finally the loose upper layer collapsed.

Figure 13 (a) Result of DCPT 3 conducted in June 2014 and (b) its location collapsed after the test.

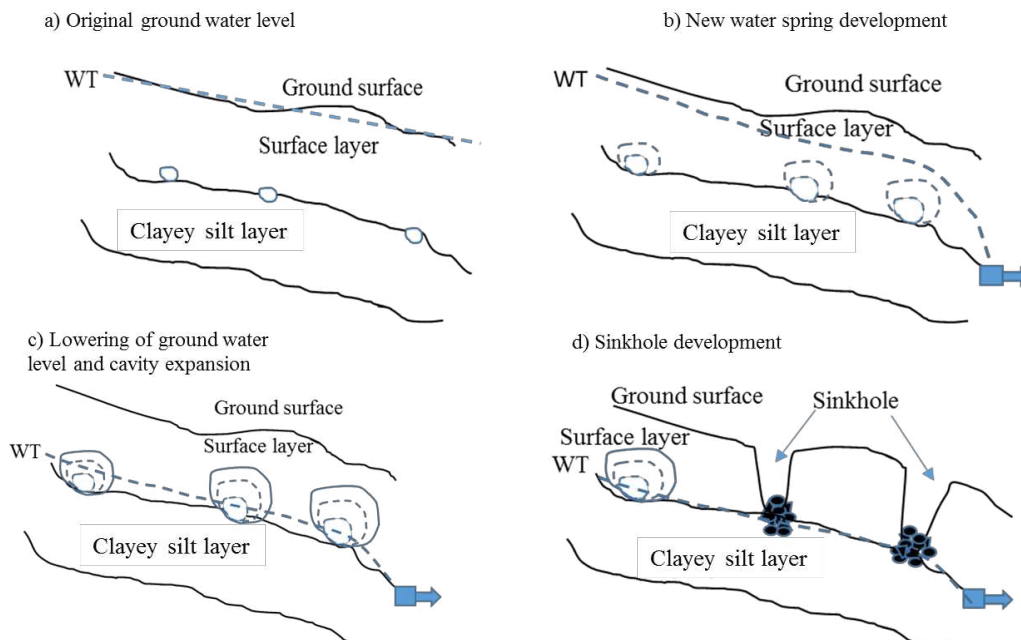
Figure 2) is clear and has no sediments. On the other hand, water samples collected at WS point 1 and 2 shows high turbidity (Figure 17). This indicates that underground water continues to dissolve the silt and there was a continuous caving process till June 2014. As the process continued, the loose, unconsolidated soil and sand above was gradually washed into the cracks and voids. Depending on how thick and strong the top layer was and how close to the surface the void beneath was, the ground was not able to sustain its own weight. Thus, cavities that before were stable, suddenly became unstable and collapsed (Figure 16(d)).

Figure 16. Probable mechanisms of sinkhole observed in the Armala area.

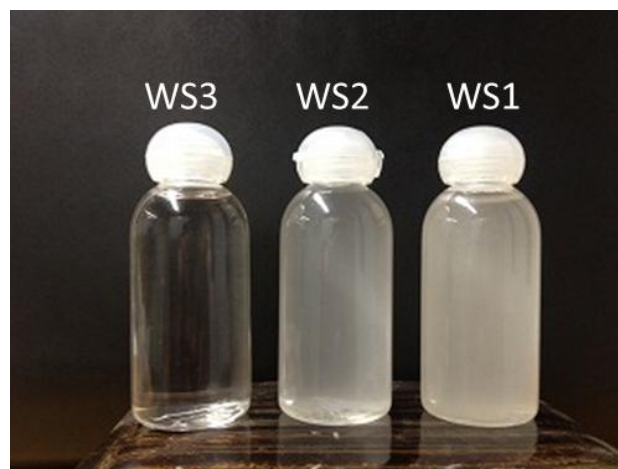
Figure 17. Turbidity of sampled water collected at different point in the Armala area in June 2014 (the water sample locations at ws1, ws2 and ws3 respectively in Figure 2).
