Preliminary Field Assessment of Sinkhole Damage in Pokhara, Nepal

Reference: Pokhrel R.M., Kiyota T., Kuwano R., Chiaro G., Katagiri T. and Arai I. (2015). *Preliminary Field Assessment of sinkhole damage in Pokhara, Nepal*. International Journal of Geoenvironmental Engineering Case histories, <http://casehistories.geoengineer.org>, Vol.3, Issue 2, p.113-125. doi: 10.4417/IJGCH-03-02-04

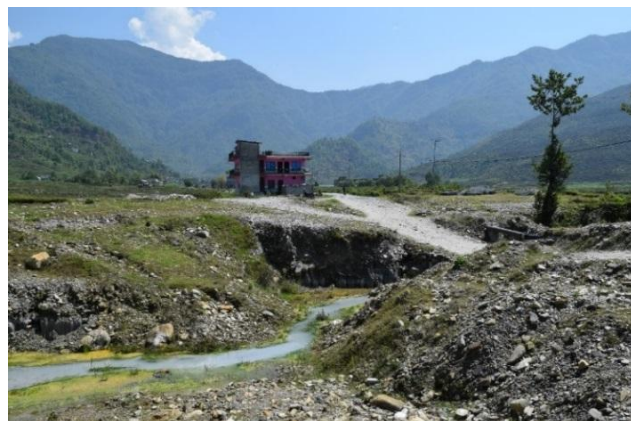
Figure 9. Muddy silty water observed in the sinkhole damaged area (photo point 7) following the 2015 Gorkha Nepal Earthquake.

Following the earthquake, muddy water was observed at the outlet of the local spring (Figure 9) in the Armala area (photo point 7), indicating that the earthquake had altered the subsoil conditions in some ways. Nevertheless, a field survey confirmed that no new sinkholes were formed and the size of existing sinkholes did not change. Yet, as mentioned earlier, muddy water indicates a high content of silt and fines in the water, and thus a process of erosion occurring in the subsoil. The earthquake may have induced a change in groundwater level and/or an increase of pore pressure that re-activated the erosion process. For this reason, the formation of new sinkholes may be anticipated in the near future, especially during the rainy season.
