Preliminary Field Assessment of Sinkhole Damage in Pokhara, Nepal

Reference: Pokhrel R.M., Kiyota T., Kuwano R., Chiaro G., Katagiri T. and Arai I. (2015). *Preliminary Field Assessment of sinkhole damage in Pokhara, Nepal*. International Journal of Geoenvironmental Engineering Case histories, <http://casehistories.geoengineer.org>, Vol.3, Issue 2, p.113-125. doi: 10.4417/IJGCH-03-02-04

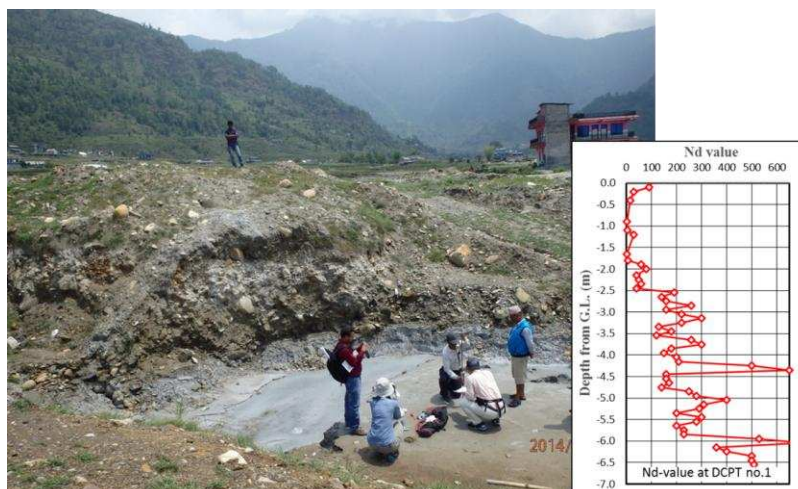
DCPT-1 was carried out at the bottom of a non-filled sinkhole as shown in Figure 10 (corresponding to photo point 7 in Figure 2). As already mentioned, this area is composed of recent flood plain deposits, including a thick gravel layer at shallow depth. Thus, DCPTs could not penetrate more than 6.55m. However, the test results would suggest that the probable depth of the sinkholes should be approximately 4.5-5m, or more precisely 6.5-7 m below the ground level considering that the actual ground level was approximately 2m above the sinkhole bottom.

Figure 10. Result of the Dynamic Cone Penetration Test at DCPT no. 1 at the bottom of a sinkhole.
