The May 25th 2011 Railroad Embankment Failure in Ann Arbor, Michigan, As a Means for Teaching Geotechnical Engineering

ABSTRACT: A 30-m long railroad embankment failure that occurred on May 25 2011 in the city of Ann Arbor, Michigan, is presented. Emphasis is given on the field observations of the failure, the characterization of the site conditions and the seepage and slope stability analyses, all of which represent important components of the training and practice of a geotechnical engineer. The failure occurred following a record wet season that resulted in ponding water against the embankment and high enough water pressures and exit gradients that resulted in instability of the railroad embankment. Detailed background material and the methodology for using the case history in geotechnical engineering education are presented.

International Journal of Geoengineering Case histories, Vol.3, Issue 4, p.234-245. doi: 10.4417/IJGCH-03-04-03

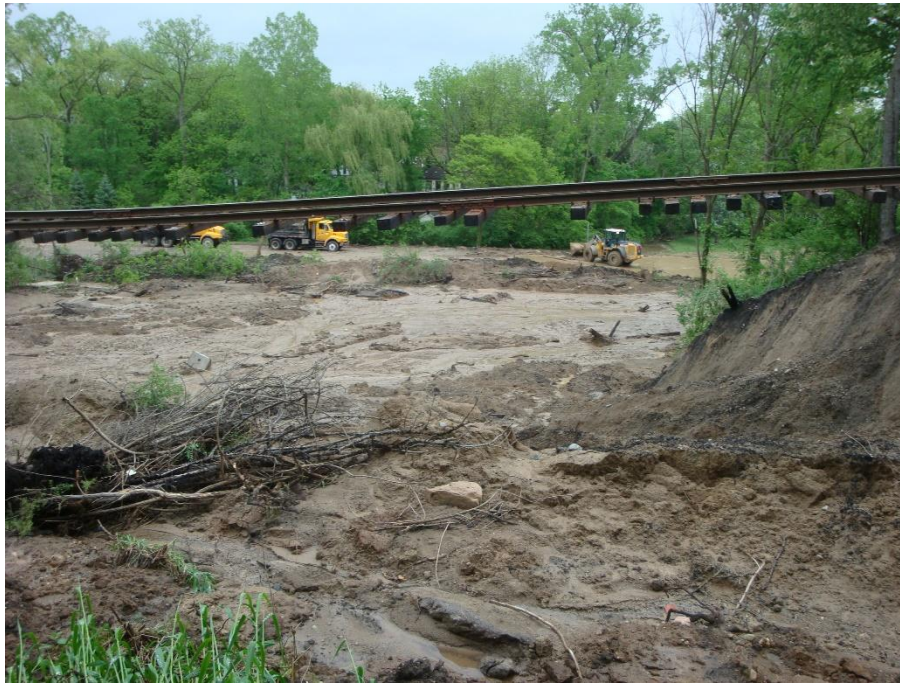
- (a) Shutdown of the railroad for an extended period of time;
- (b) Closure of Plymouth Rd for two days; and
- (c) Flooding and debris deposition on the downslope side of the embankment that damaged a public park southwest of Plymouth Rd and deposited additional sediments in a natural stream, as shown in Fig. 4.

Figure 4. View of the conditions downhill of the failure showing deposition of debris and water. Trucks and dozer are operating on Plymouth Rd. and flooded area further back is a flooded public park.

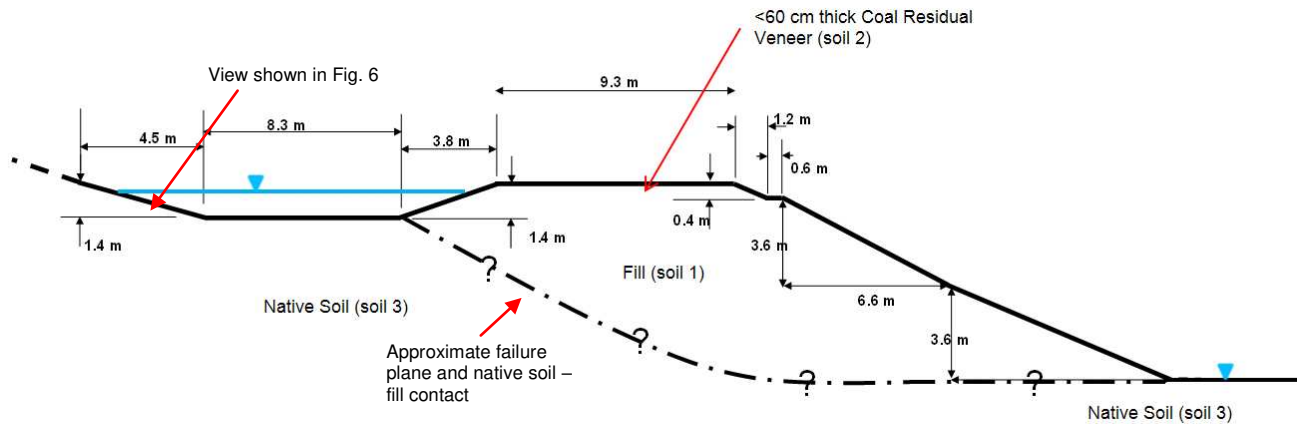
The embankment is constructed partially on a naturally sloping ground and has a total height of 7.6 m as shown in Fig. 5. Its crest, that supports the railroad lines, has a width of 9.3 m. The embankment fill consists of two layers. The main layer (Fill Soil 1) is a silty sand (SM). A surficial layer of very small thickness is also present and consists of coal ash residuals (Soil 2). The natural soil that underlays the embankment is a sandy clay of low plasticity (CL) that geologically is described as very dense glacial deposits (Native Soil-Soil 3).

Figure 5. Cross-section of the railroad embankment at the location of the failure.

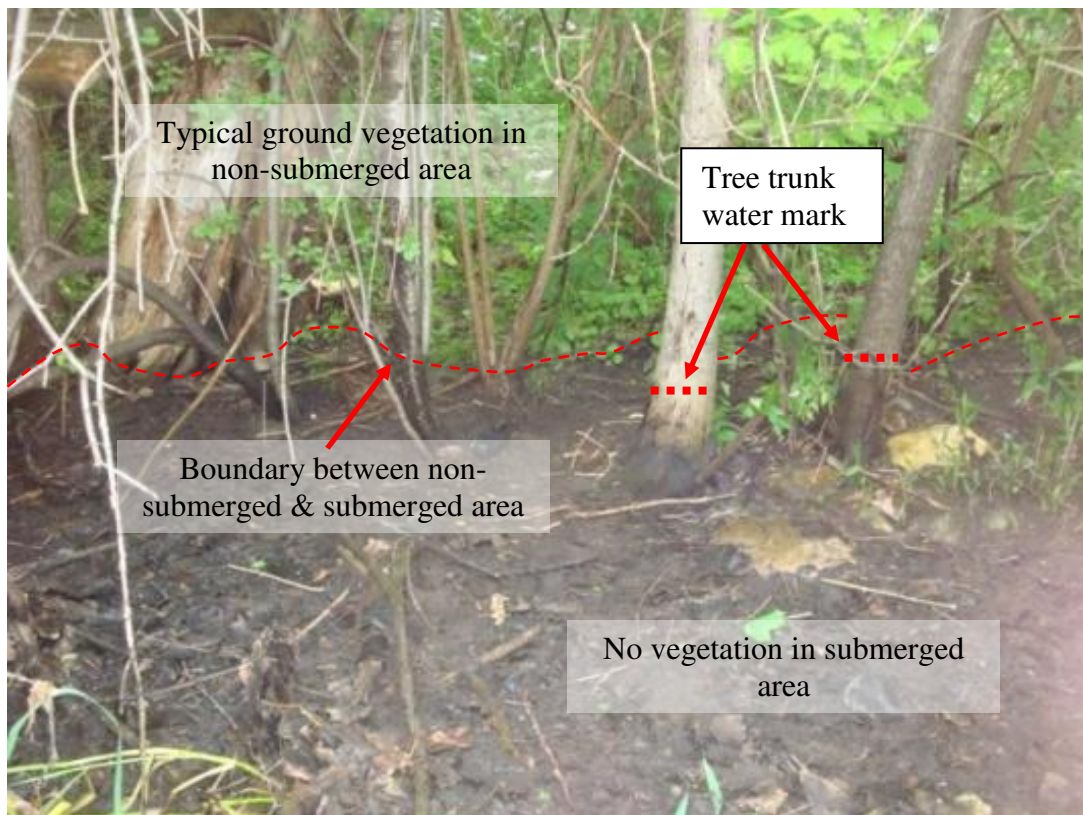
During the site visit, it was observed that the failure location was at a local natural depression that was receiving and accumulating surface water from a wider area. After careful inspection, the authors hypothesized the existence of seasonal ponding water. The surface soil on the uphill side of the embankment was very wet with vegetation that is typical of marshes, such as reeds. Next to the embankment where the water appeared to nearly permanently ponding and below trees there was no vegetation (see web-based supporting information titled “Photos and “Videos”). These conditions were found to be unique compared to other locations along the axis of the embankment. In addition, the level of water could be clearly seen as a watermark on the trunks of trees, as shown in Fig. 6. Based on these observations it was evaluated that the depth of the ponding water could have reached up to 120 cm. Local residents confirmed the existence of ponding water adjacent to the embankment. In fact, it appears that a neighbor used to feed visiting ducks at that location. Retention of ponding water was not part of the original embankment design. It is important to note that ponding water existed for at least some

Figure 6. Area previously covered by ponding water and water mark on tree trunks.

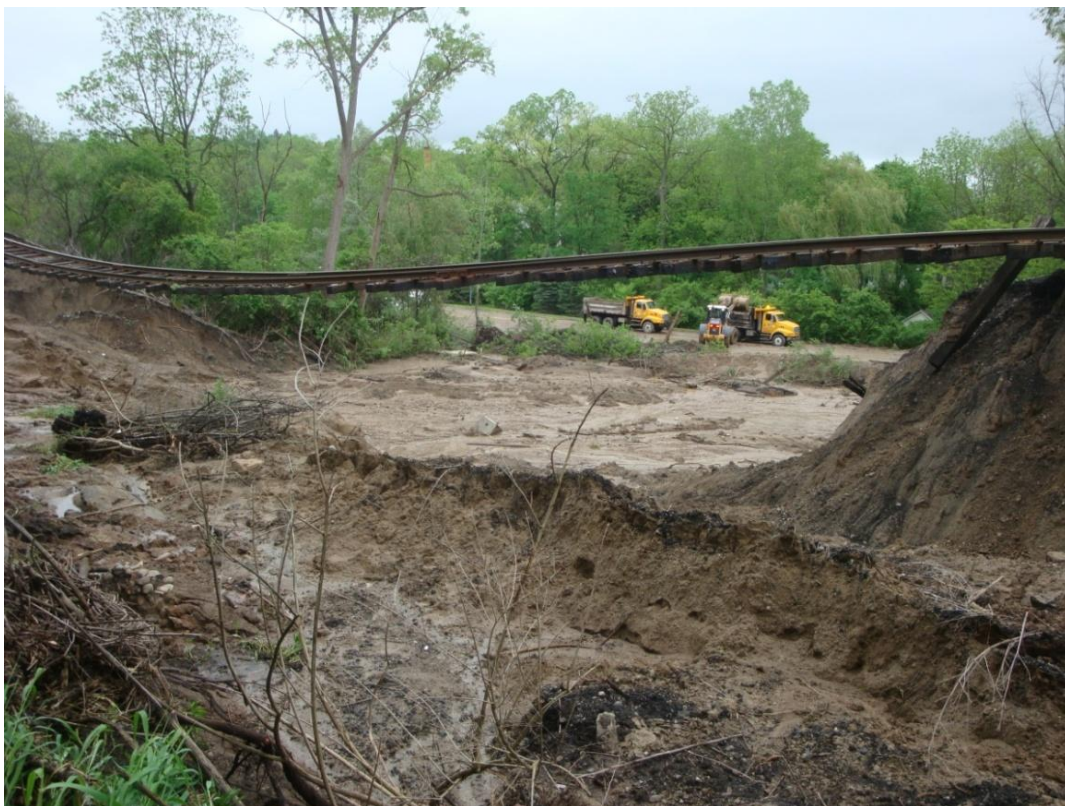
The failure surface appears to engage the entire railroad embankment that is supported on naturally sloping native ground. A 30-m long section of the embankment along the railroad axis slid, and the sliding mass moved a significant distance downslope, removing a number of trees that had grown in the downslope side of the embankment between the railroad embankment and Plymouth Rd. The interpreted failure surface per field observations is shown in Fig. 5 and 7 and is in the vicinity of the contact between the native ground and the embankment fill, but appears to be restricted within the embankment fills and not involve the native soils.

Figure 7. View of the failure along, and perpendicular to, the railroad embankment axis.

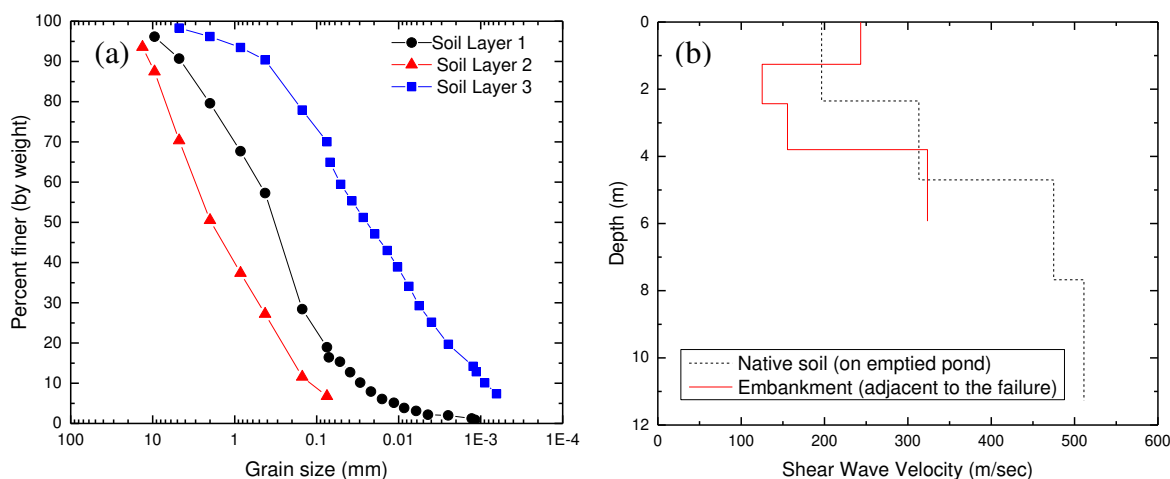
Soil Layer 1: This soil layer represents the main embankment layer, as shown in Fig. 5, and is classified per USCS as silty sand (SM). 18.9% of the material are non-plastic fines as shown in Fig. 8a. Since undisturbed samples were impossible to collect for the sandy fill, tests were conducted on reconstituted specimens at two different density states to evaluate the range of shear strengths expected for these materials. The direct shear tests were conducted in dry conditions. The shear strength of the material at a dense state was evaluated on the basis of direct shear testing, and the peak friction angle was found to be equal to 46° , whereas the post-peak was found to be equal to 38° without any cohesion, as shown in Fig. 9. The large-displacement friction angle at a dense state is approaching the peak friction angle of the soil at the loose state that was found to be equal to 35° . The hydraulic conductivity of the soil at a dry unit weight of 1.71 gr/cm^3 , was equal to $5.1 \cdot 10^{-5} \text{ cm/sec}$ based on a falling head hydraulic conductivity test conducted in the laboratory.

Figure 8. Results of (a) grain size distribution analyses and (b) in-situ shear wave velocity

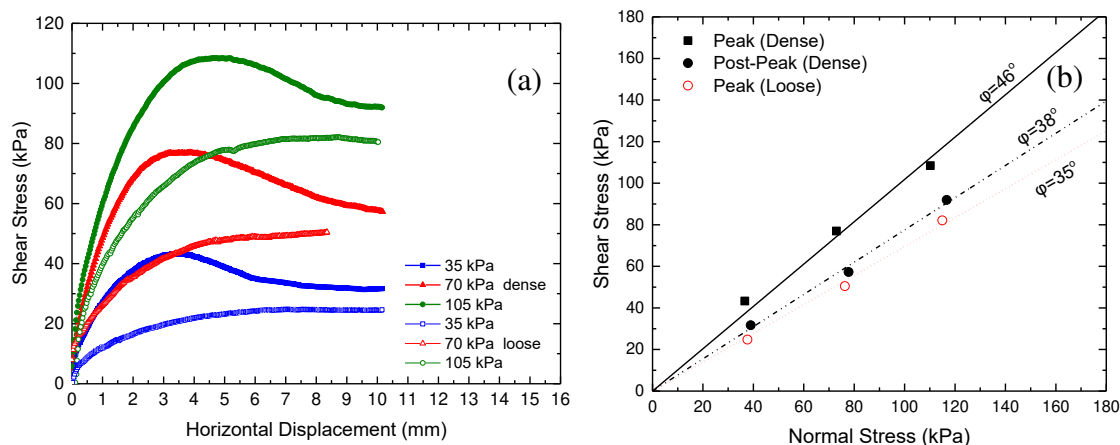
Figure 9. Direct shear results at nominal vertical stresses of 35 kPa, 70 kPa, and 105 kPa on reconstituted specimens of Soil Layer 1.

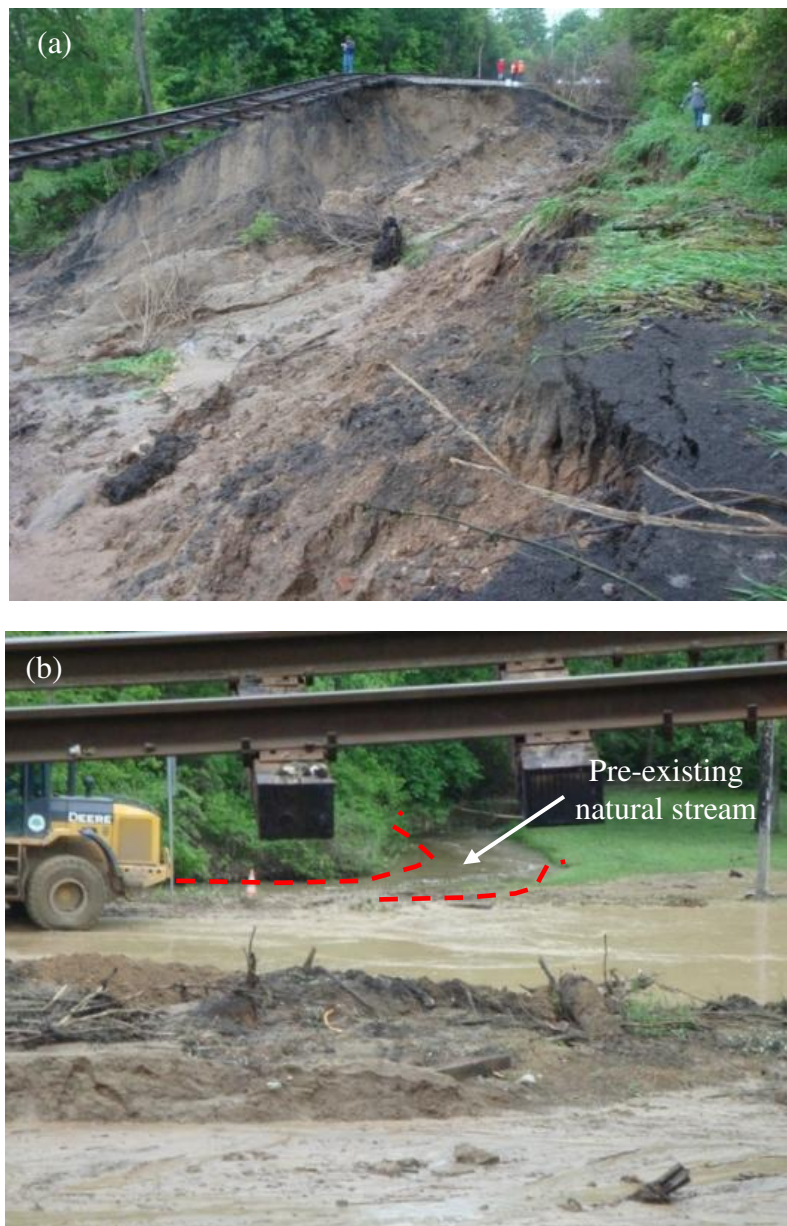
Soil Layer 2: This embankment layer is restricted to the top few cm from the surface and is essentially coal ash residuals that are black in color and can be clearly seen in Fig. 10. The fines are non-plastic and represent only 6.8% of the total mass of the soil, whereas the gravelly size particles are equal to 29.6%. It is classified per USCS as well-graded gravelly sand with silt (SW-SM). This soil layer is not expected to have played a significant role in the failure since it is of very small thickness and restricted at the surface only. Thus, more comprehensive testing to characterize its properties was not conducted.

Figure 10. View of the failure from the crest of the failure surface where (a) the left-in-place embankment is shown; (b) the mass of soil with large amount of water is shown at the toe of the failure reaching the pre-existing natural stream.

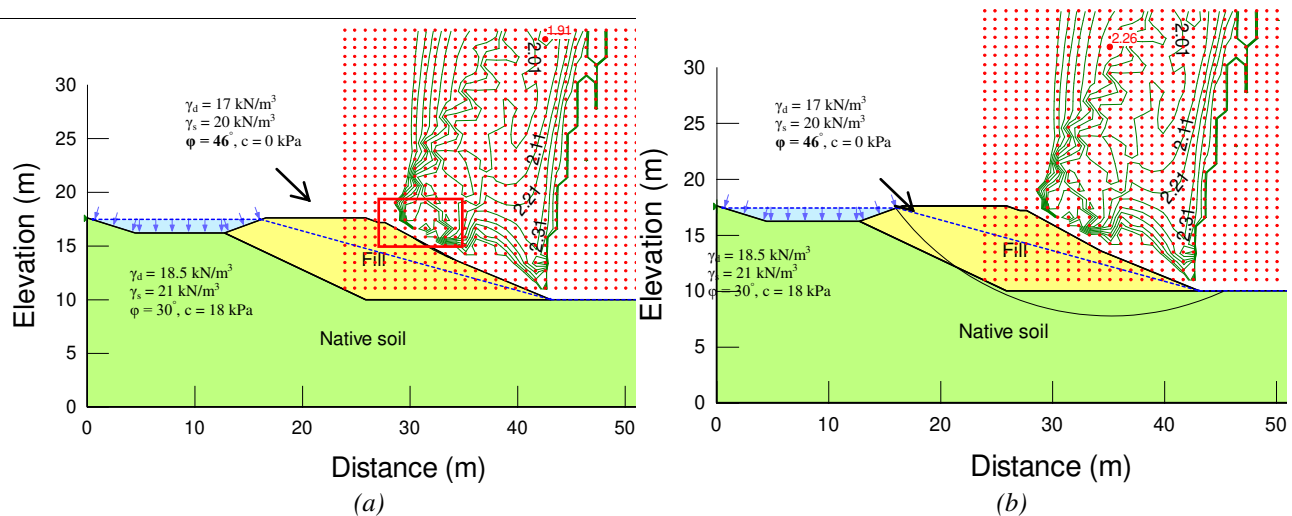
Following site characterization and the assessment of the embankment and failure surface geometry, stability and seepage analyses were conducted using the software programs SEEP/W and SLOPE/W (Geostudio, 2007) and the Spencer method of analysis (Spencer 1967). For stability assessment, parametric analyses were also conducted for reasonable variations of soil properties, as well as variations of the water depth of the ponding water (60 – 120 cm) that is reasonably well documented based on the field observations. These parametric analyses are critical in assessing the impact of uncertainties in the results. The parametric stability analyses indicate that even for the highest ponding water depth, the factor of safety remains significantly higher than one, i.e., it varies between 1.4-1.9 (for friction angles equal to 38° and 46° respectively) for a shallow failure surface that is restricted within the embankment, and is shown in Fig. 11a within the red box. Note that although the failure planes shown are “classic” numerical failure surfaces of purely frictional material with zero cohesion, even for low cohesions of 1-3 kPa, the observation that shallow failure surfaces are most critical remains valid. Higher values of factor of safety that vary between 1.5 and 2.3 were calculated for deeper failure surfaces that intersect the native soil (soil layer 3). Example results of the analyses are presented in Fig. 11.

Figure 11. Indicative results of embankment stability analyses for hydrostatic pore pressures. (a) showing lowest Factor of Safety (FS) of 1.91 for shallow failure planes (in the red box); (b) showing indicative FS of 2.26 for a failure plane that intersects the native soils.

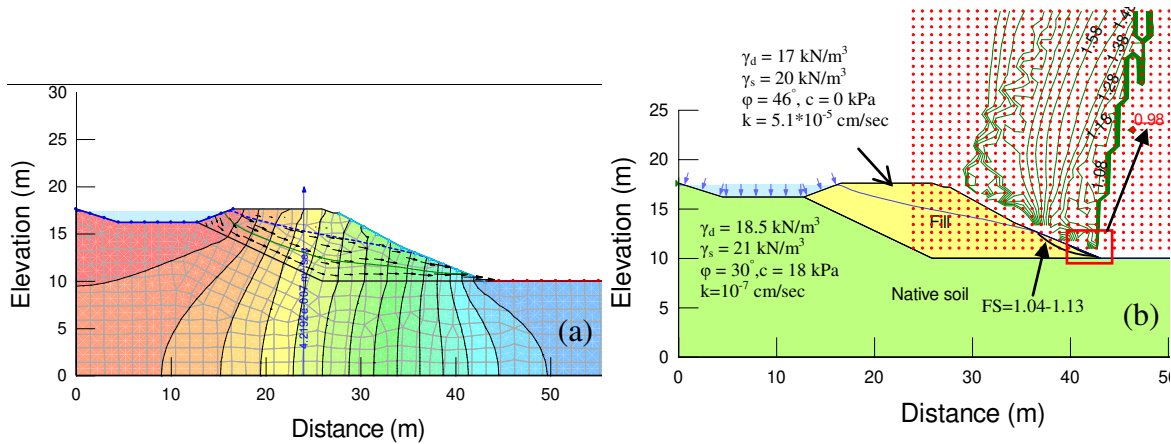
Subsequently, seepage analyses were conducted using the estimated hydraulic conductivities. As described earlier, the natural soil has significantly lower hydraulic conductivity than the embankment soils. Thus, the analyses indicate that when the ponding water depth increases, the exit gradients at the toe of the embankment become high, and vary between 0.48 and 0.78, which are dangerously high and close to critical gradients (~ 0.9). The stability analyses using the calculated hydraulic pressures, indicate failure of the embankment with factors of safety around one, as shown in Fig. 12. Note that this is not surprising as the seepage analysis gives a more realistic pore pressure profile (Fig. 12a) than that of an arbitrarily assumed piezometric surface (e.g., Fig. 11) with the flow concentrating more on the higher hydraulic conductivity soil. The results, indicate that the failure is caused by the high pore pressures that may even cause piping. The numerical results, are supported by the following interesting field observation: The reeds in the ponding water area adjacent to the embankment were found to be bent sideways and positioned horizontally with a direction that was pointing with great accuracy to the exact location where the ponding water initially drained quickly, as shown in Fig. 12.

Figure 12. Indicative results of combined (a) seepage and (b) stability analyses using seepage analyses results
