The May 25th 2011 Railroad Embankment Failure in Ann Arbor, Michigan, As a Means for Teaching Geotechnical Engineering

ABSTRACT: A 30-m long railroad embankment failure that occurred on May 25 2011 in the city of Ann Arbor, Michigan, is presented. Emphasis is given on the field observations of the failure, the characterization of the site conditions and the seepage and slope stability analyses, all of which represent important components of the training and practice of a geotechnical engineer. The failure occurred following a record wet season that resulted in ponding water against the embankment and high enough water pressures and exit gradients that resulted in instability of the railroad embankment. Detailed background material and the methodology for using the case history in geotechnical engineering education are presented.

International Journal of Geoengineering Case histories, Vol.3, Issue 4, p.234-245. doi: 10.4417/IJGCH-03-04-03

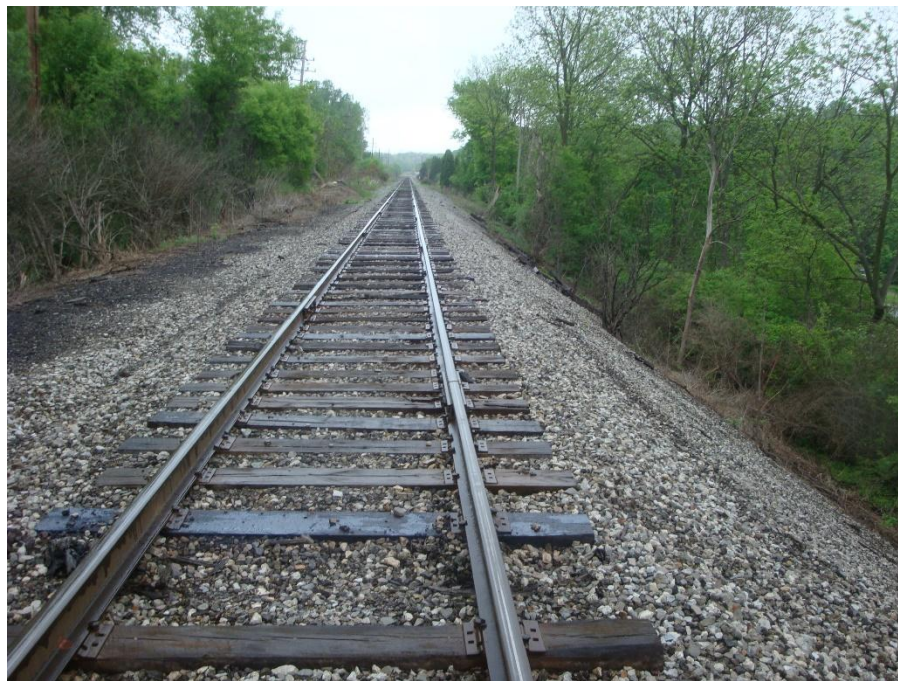
The failure site is located to the north of downtown Ann Arbor in Michigan, USA, as shown in Fig. 2b. The failure took place on the railroad embankment that is heading parallel to Plymouth Rd and adjacent to residential structures. Fig. 3 illustrates an intact portion of the embankment immediately to the East from the failure location. The failure resulted in:

Figure 3. View of intact portion of the embankment immediately to the East of the failure area. One can see that the uphill part of the embankment (left) is supported by natural ground that is at a much higher elevation than the downhill part of the embankment (right).

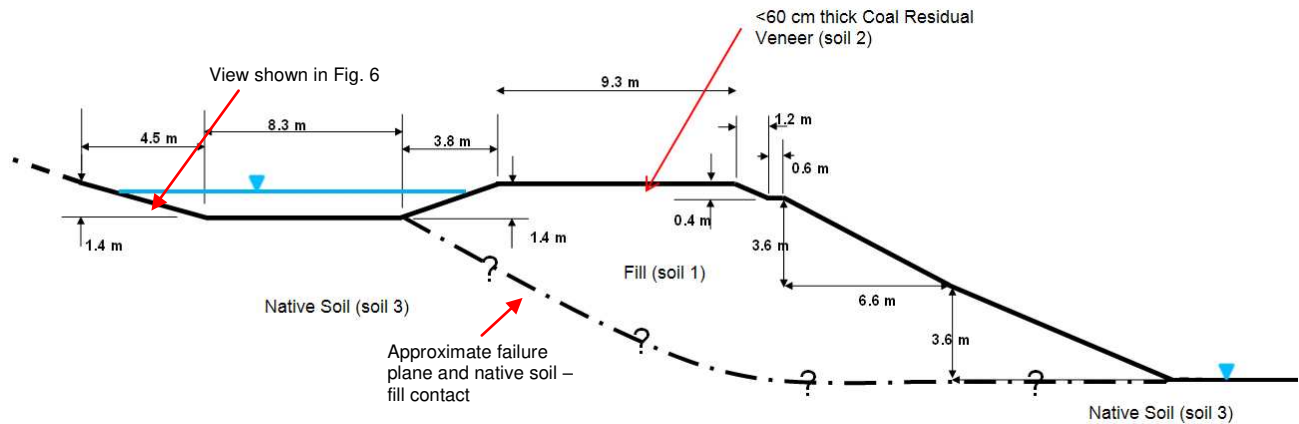
The embankment is constructed partially on a naturally sloping ground and has a total height of 7.6 m as shown in Fig. 5. Its crest, that supports the railroad lines, has a width of 9.3 m. The embankment fill consists of two layers. The main layer (Fill Soil 1) is a silty sand (SM). A surficial layer of very small thickness is also present and consists of coal ash residuals (Soil 2). The natural soil that underlays the embankment is a sandy clay of low plasticity (CL) that geologically is described as very dense glacial deposits (Native Soil-Soil 3).

Figure 5. Cross-section of the railroad embankment at the location of the failure.

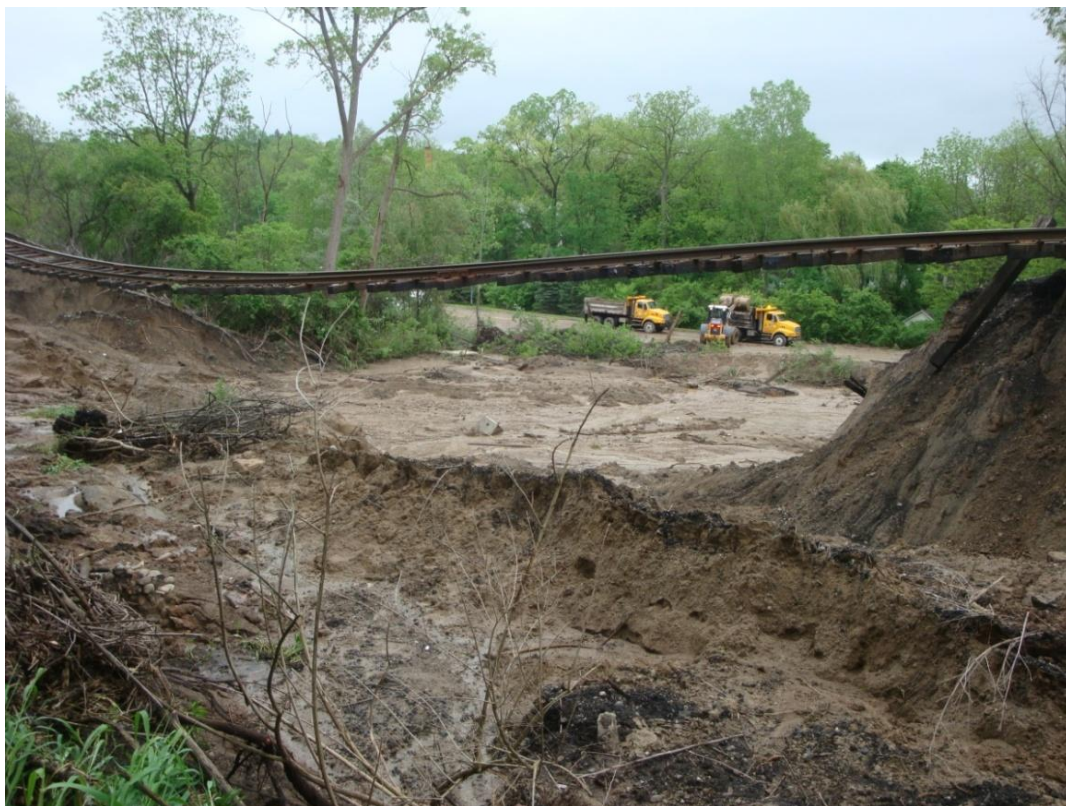
The failure surface appears to engage the entire railroad embankment that is supported on naturally sloping native ground. A 30-m long section of the embankment along the railroad axis slid, and the sliding mass moved a significant distance downslope, removing a number of trees that had grown in the downslope side of the embankment between the railroad embankment and Plymouth Rd. The interpreted failure surface per field observations is shown in Fig. 5 and 7 and is in the vicinity of the contact between the native ground and the embankment fill, but appears to be restricted within the embankment fills and not involve the native soils.

Figure 7. View of the failure along, and perpendicular to, the railroad embankment axis.

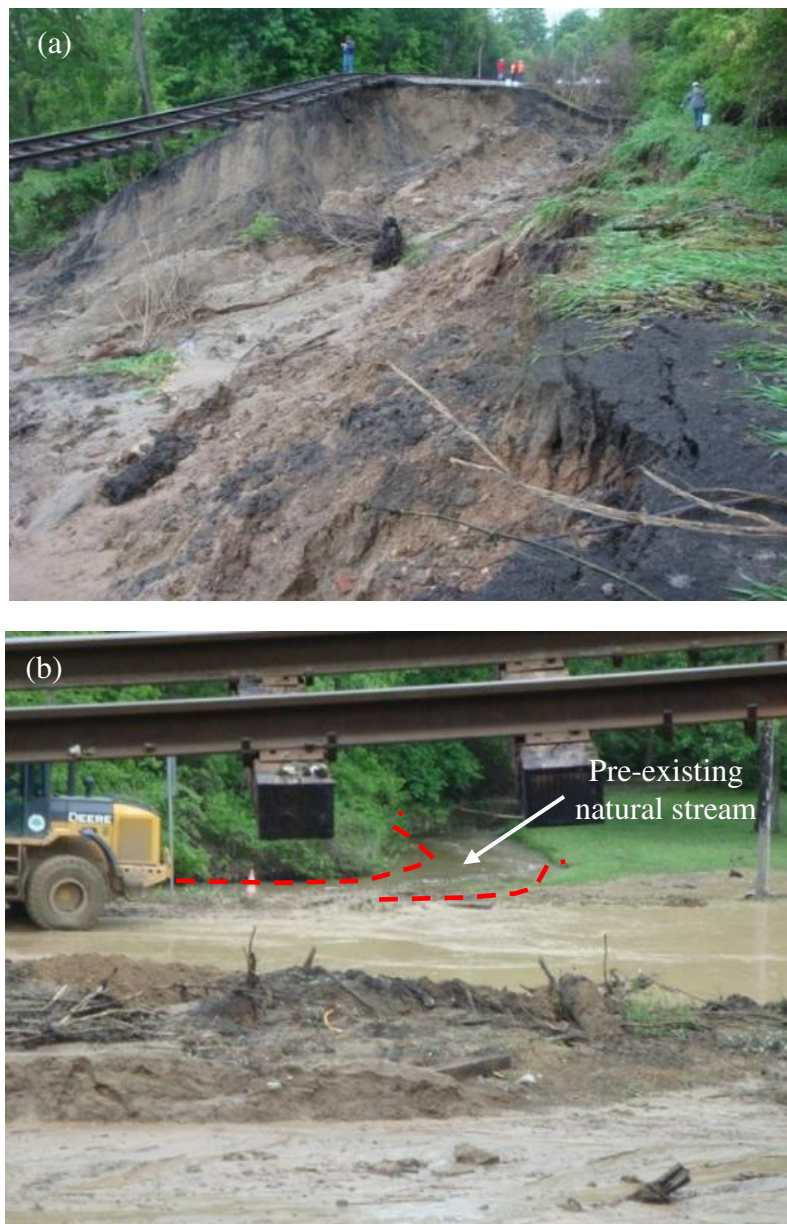
Soil Layer 2: This embankment layer is restricted to the top few cm from the surface and is essentially coal ash residuals that are black in color and can be clearly seen in Fig. 10. The fines are non-plastic and represent only 6.8% of the total mass of the soil, whereas the gravelly size particles are equal to 29.6%. It is classified per USCS as well-graded gravelly sand with silt (SW-SM). This soil layer is not expected to have played a significant role in the failure since it is of very small thickness and restricted at the surface only. Thus, more comprehensive testing to characterize its properties was not conducted.

Figure 10. View of the failure from the crest of the failure surface where (a) the left-in-place embankment is shown; (b) the mass of soil with large amount of water is shown at the toe of the failure reaching the pre-existing natural stream.

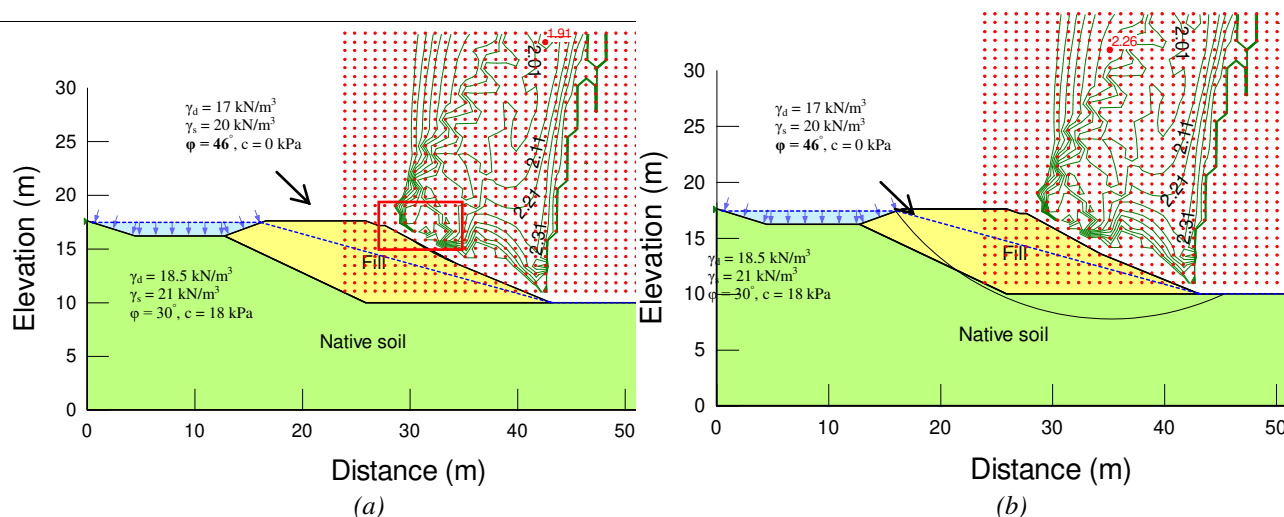
Following site characterization and the assessment of the embankment and failure surface geometry, stability and seepage analyses were conducted using the software programs SEEP/W and SLOPE/W (Geostudio, 2007) and the Spencer method of analysis (Spencer 1967). For stability assessment, parametric analyses were also conducted for reasonable variations of soil properties, as well as variations of the water depth of the ponding water (60 – 120 cm) that is reasonably well documented based on the field observations. These parametric analyses are critical in assessing the impact of uncertainties in the results. The parametric stability analyses indicate that even for the highest ponding water depth, the factor of safety remains significantly higher than one, i.e., it varies between 1.4-1.9 (for friction angles equal to 38° and 46° respectively) for a shallow failure surface that is restricted within the embankment, and is shown in Fig. 11a within the red box. Note that although the failure planes shown are “classic” numerical failure surfaces of purely frictional material with zero cohesion, even for low cohesions of 1-3 kPa, the observation that shallow failure surfaces are most critical remains valid. Higher values of factor of safety that vary between 1.5 and 2.3 were calculated for deeper failure surfaces that intersect the native soil (soil layer 3). Example results of the analyses are presented in Fig. 11.

Figure 11. Indicative results of embankment stability analyses for hydrostatic pore pressures. (a) showing lowest Factor of Safety (FS) of 1.91 for shallow failure planes (in the red box); (b) showing indicative FS of 2.26 for a failure plane that intersects the native soils.
