The May 25th 2011 Railroad Embankment Failure in Ann Arbor, Michigan, As a Means for Teaching Geotechnical Engineering

ABSTRACT: A 30-m long railroad embankment failure that occurred on May 25 2011 in the city of Ann Arbor, Michigan, is presented. Emphasis is given on the field observations of the failure, the characterization of the site conditions and the seepage and slope stability analyses, all of which represent important components of the training and practice of a geotechnical engineer. The failure occurred following a record wet season that resulted in ponding water against the embankment and high enough water pressures and exit gradients that resulted in instability of the railroad embankment. Detailed background material and the methodology for using the case history in geotechnical engineering education are presented.

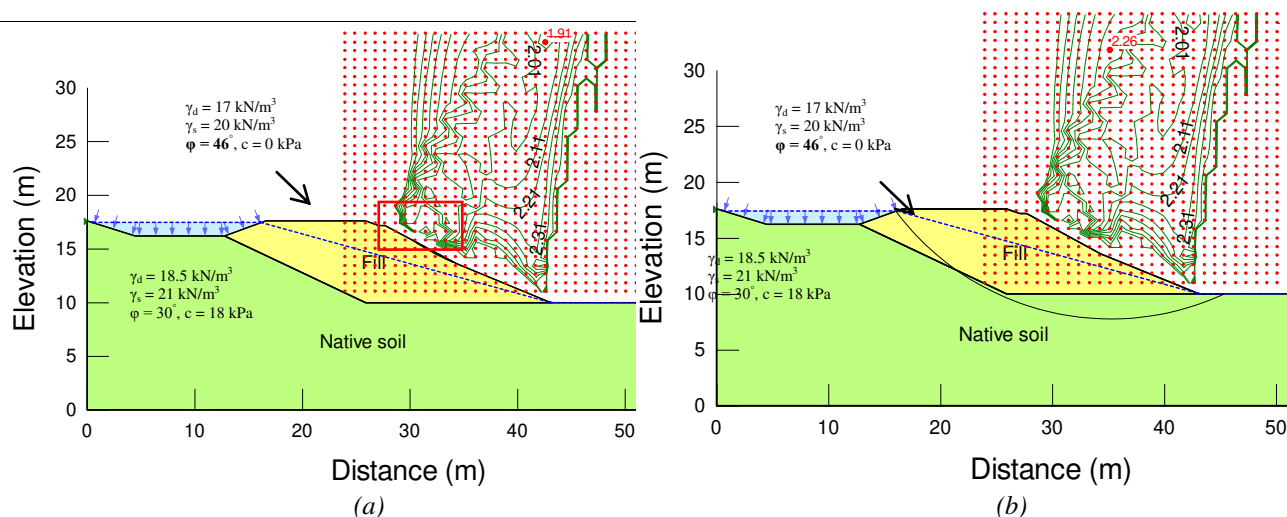
Following site characterization and the assessment of the embankment and failure surface geometry, stability and seepage analyses were conducted using the software programs SEEP/W and SLOPE/W (Geostudio, 2007) and the Spencer method of analysis (Spencer 1967). For stability assessment, parametric analyses were also conducted for reasonable variations of soil properties, as well as variations of the water depth of the ponding water (60 – 120 cm) that is reasonably well documented based on the field observations. These parametric analyses are critical in assessing the impact of uncertainties in the results. The parametric stability analyses indicate that even for the highest ponding water depth, the factor of safety remains significantly higher than one, i.e., it varies between 1.4-1.9 (for friction angles equal to 38° and 46° respectively) for a shallow failure surface that is restricted within the embankment, and is shown in Fig. 11a within the red box. Note that although the failure planes shown are “classic” numerical failure surfaces of purely frictional material with zero cohesion, even for low cohesions of 1-3 kPa, the observation that shallow failure surfaces are most critical remains valid. Higher values of factor of safety that vary between 1.5 and 2.3 were calculated for deeper failure surfaces that intersect the native soil (soil layer 3). Example results of the analyses are presented in Fig. 11.

Figure 11. Indicative results of embankment stability analyses for hydrostatic pore pressures. (a) showing lowest Factor of Safety (FS) of 1.91 for shallow failure planes (in the red box); (b) showing indicative FS of 2.26 for a failure plane that intersects the native soils.

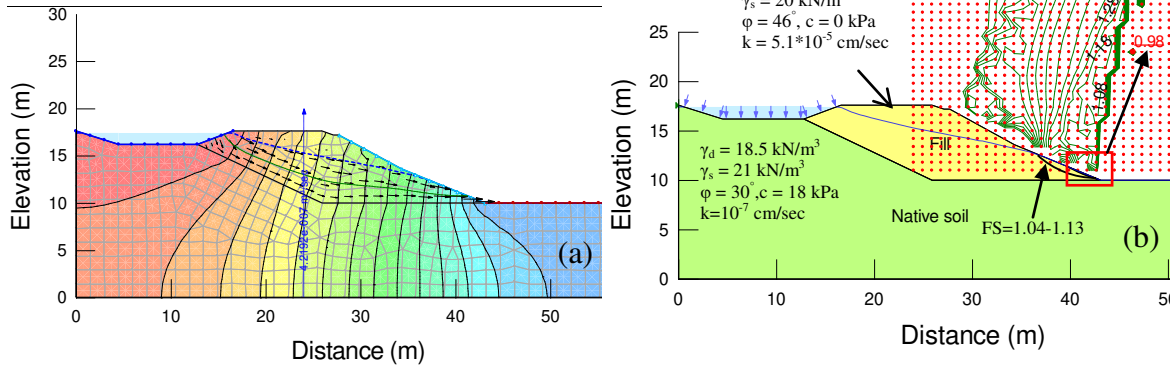
Subsequently, seepage analyses were conducted using the estimated hydraulic conductivities. As described earlier, the natural soil has significantly lower hydraulic conductivity than the embankment soils. Thus, the analyses indicate that when the ponding water depth increases, the exit gradients at the toe of the embankment become high, and vary between 0.48 and 0.78, which are dangerously high and close to critical gradients (~ 0.9). The stability analyses using the calculated hydraulic pressures, indicate failure of the embankment with factors of safety around one, as shown in Fig. 12. Note that this is not surprising as the seepage analysis gives a more realistic pore pressure profile (Fig. 12a) than that of an arbitrarily assumed piezometric surface (e.g., Fig. 11) with the flow concentrating more on the higher hydraulic conductivity soil. The results, indicate that the failure is caused by the high pore pressures that may even cause piping. The numerical results, are supported by the following interesting field observation: The reeds in the ponding water area adjacent to the embankment were found to be bent sideways and positioned horizontally with a direction that was pointing with great accuracy to the exact location where the ponding water initially drained quickly, as shown in Fig. 12.

Figure 12. Indicative results of combined (a) seepage and (b) stability analyses using seepage analyses results
