The May 25th 2011 Railroad Embankment Failure in Ann Arbor, Michigan, As a Means for Teaching Geotechnical Engineering

ABSTRACT: A 30-m long railroad embankment failure that occurred on May 25 2011 in the city of Ann Arbor, Michigan, is presented. Emphasis is given on the field observations of the failure, the characterization of the site conditions and the seepage and slope stability analyses, all of which represent important components of the training and practice of a geotechnical engineer. The failure occurred following a record wet season that resulted in ponding water against the embankment and high enough water pressures and exit gradients that resulted in instability of the railroad embankment. Detailed background material and the methodology for using the case history in geotechnical engineering education are presented.

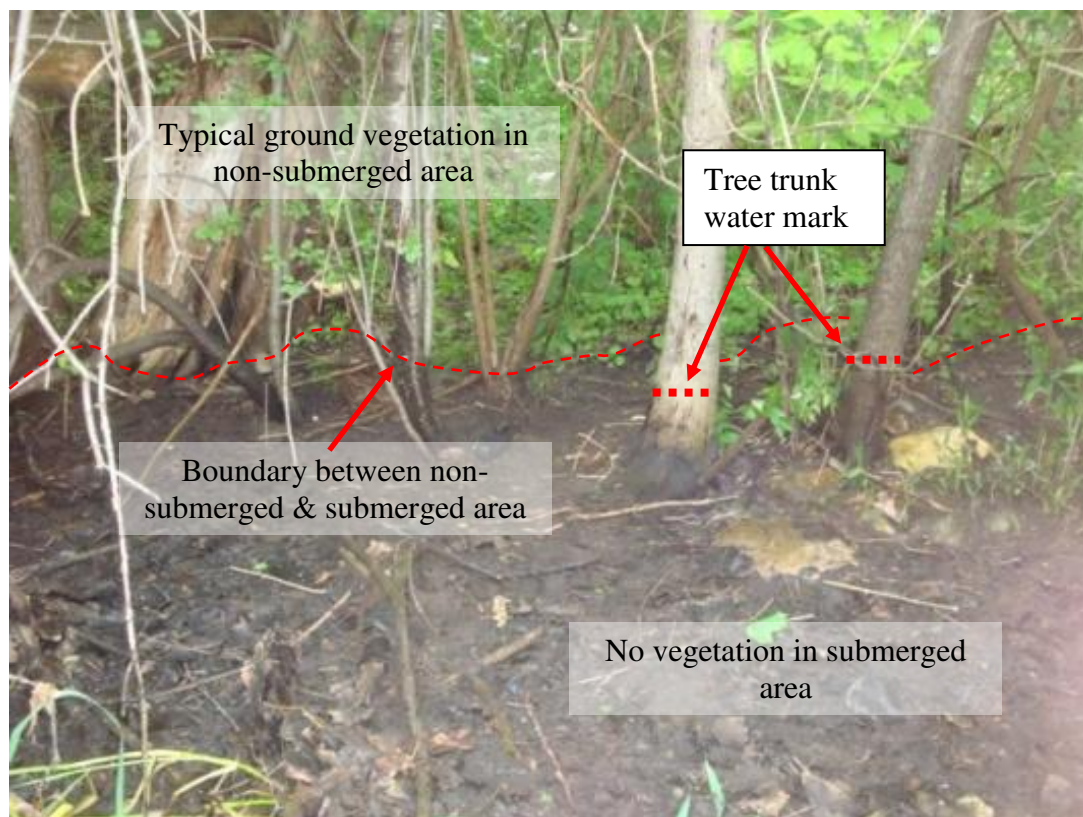
During the site visit, it was observed that the failure location was at a local natural depression that was receiving and accumulating surface water from a wider area. After careful inspection, the authors hypothesized the existence of seasonal ponding water. The surface soil on the uphill side of the embankment was very wet with vegetation that is typical of marshes, such as reeds. Next to the embankment where the water appeared to nearly permanently ponding and below trees there was no vegetation (see web-based supporting information titled “Photos and “Videos”). These conditions were found to be unique compared to other locations along the axis of the embankment. In addition, the level of water could be clearly seen as a watermark on the trunks of trees, as shown in Fig. 6. Based on these observations it was evaluated that the depth of the ponding water could have reached up to 120 cm. Local residents confirmed the existence of ponding water adjacent to the embankment. In fact, it appears that a neighbor used to feed visiting ducks at that location. Retention of ponding water was not part of the original embankment design. It is important to note that ponding water existed for at least some

period of time prior to failure. However, the spring of 2011 was particularly wet and probably more water accumulated compared to previous years. It is also not entirely clear whether a clogged storm drain existed in that location.

Figure 6. Area previously covered by ponding water and water mark on tree trunks.

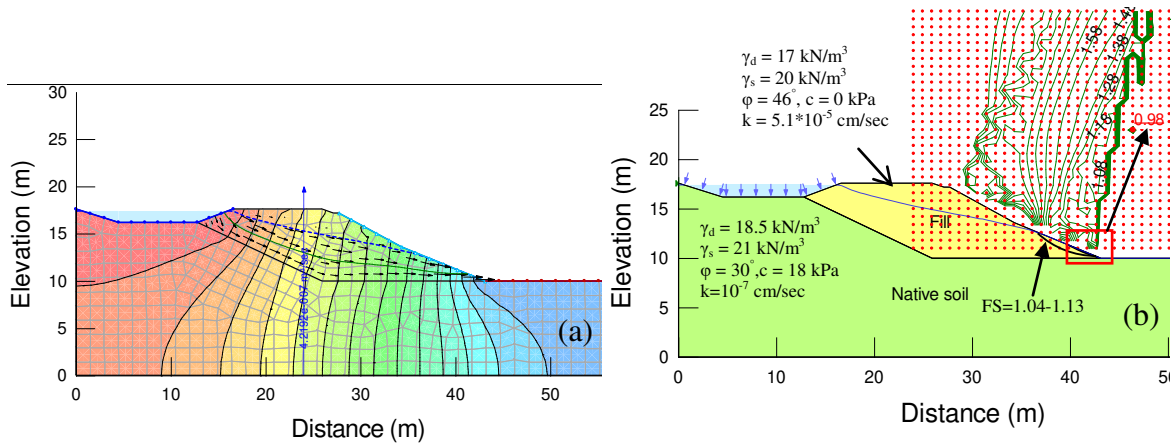
Subsequently, seepage analyses were conducted using the estimated hydraulic conductivities. As described earlier, the natural soil has significantly lower hydraulic conductivity than the embankment soils. Thus, the analyses indicate that when the ponding water depth increases, the exit gradients at the toe of the embankment become high, and vary between 0.48 and 0.78, which are dangerously high and close to critical gradients (~ 0.9). The stability analyses using the calculated hydraulic pressures, indicate failure of the embankment with factors of safety around one, as shown in Fig. 12. Note that this is not surprising as the seepage analysis gives a more realistic pore pressure profile (Fig. 12a) than that of an arbitrarily assumed piezometric surface (e.g., Fig. 11) with the flow concentrating more on the higher hydraulic conductivity soil. The results, indicate that the failure is caused by the high pore pressures that may even cause piping. The numerical results, are supported by the following interesting field observation: The reeds in the ponding water area adjacent to the embankment were found to be bent sideways and positioned horizontally with a direction that was pointing with great accuracy to the exact location where the ponding water initially drained quickly, as shown in Fig. 12.

Figure 12. Indicative results of combined (a) seepage and (b) stability analyses using seepage analyses results
