A Large Scale Landslide in a Coal Mine in Marly Formations: Evaluation, Analysis and Rehabilitation

ABSTRACT: *This paper describes a large scale landslide in a coal mine in Servia area in Kozani, Greece, which occurred in February 2011. The landslide, of ~250m width and ~350m length, took place in marly lacustrine sediments. The main factors for the manifestation of the landslide were a temporary interruption of works, the existence of a specific weak surface, the clayey nature and the sensitivity of marl to environmental agents, the action of water and the large slope height. Due to the magnitude and the position of the failure, a geotechnical solution was proposed that involved rearrangement of ground masses. The proposed solution led to successful rehabilitation and unimpeded continuation of the exploitation process.*

Reference: Prountzopoulos, G., Fortsakis, P., Marinos, V. and Marinos, P. (2016). *A Large Scale Landslide in a Coal Mine in Marly Formations: Evaluation, Analysis and Rehabilitation*. International Journal of Geoengineering Case histories, Vol.4, Issue 1, p.29-45. doi: 10.4417/IJGCH-04-01-03

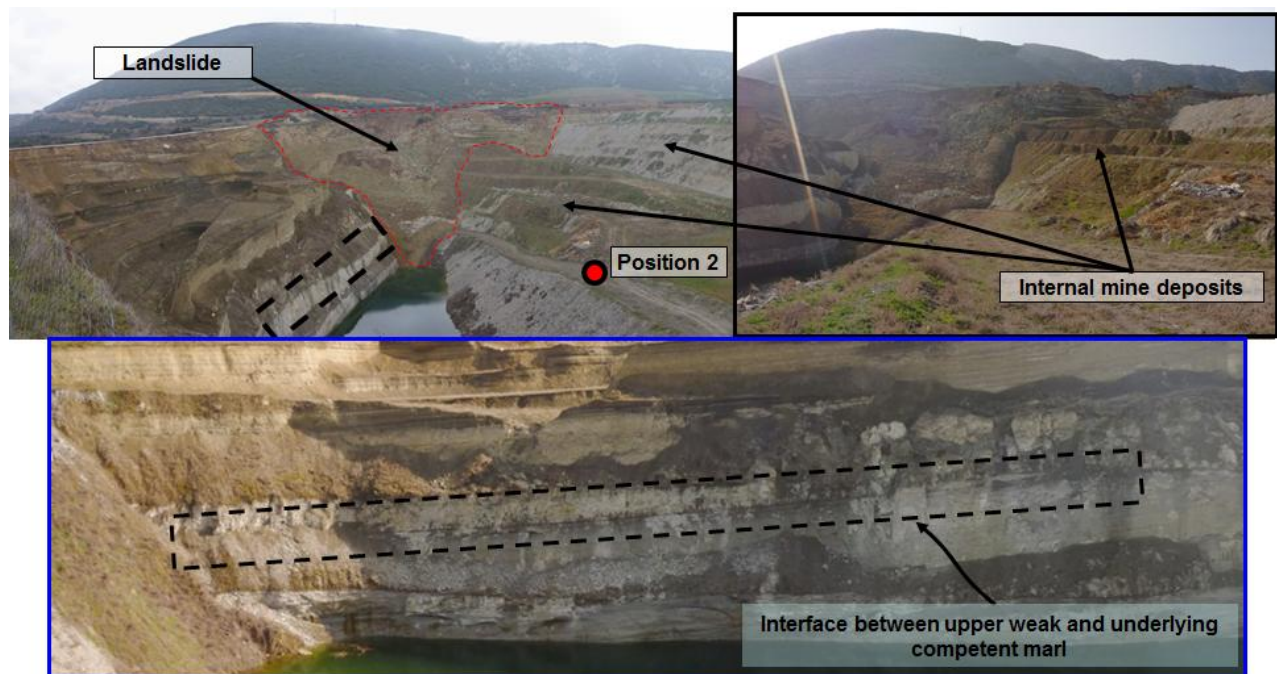
Figure 3 illustrates a general aspect of the landslide from its E and NE side (Positions 1 and 2 in Figure 2) and a view of the contact surface between the weak and the competent marl, which played a major role in the landslide manifestation. Figure 4 illustrates various aspects of the landslide and its main features.

The landslide had a clearly three dimensional character, due to the lateral "constraints" posed by the non-commercial deposits of the mine at its north part and the exploitation limit at its south part. The failure surface at the landslide crest at its NW boundary had a considerable (subvertical) inclination and was steeply dipping towards the weak contact surface between the weathered and the underlying compact marl (Figure 4a left and 4c). On the contrary, at the west boundary of the landslide crest, the failure surface had a milder inclination (Figure 4a and 4b right) and seemed to have travelled a considerable length within the shallower weak marl formation. Within the landslide, large blocks of the marly formation were almost monolithically displaced (see Figure 4a and 4d) with limited cracking and detachments within their mass, giving the impression of a combination of rock slide and typical rotational landslide to the incident.

Figure 3. Aspect of the coalmine and the landslide from Position 1 (upper left), the landslide from Position 2 (upper right) and the contact surface between the weak and the competent marl (bottom)

Actions for the enhancement of the stability of the area and the rehabilitation of the landslide had to be taken immediately. Clear signs of instability migration outside the boundaries of the landslide were observed, in the form of new cracks uphill of the landslide crest. A possible extension of the instability to the W-SW would seriously jeopardize the alternative route (already under construction) of the drifted local road and affect areas outside the expropriation boundary of the coal mine. In that sense, evaluation of the landslide and commencement of stabilization works had to be performed within the shortest possible time period.

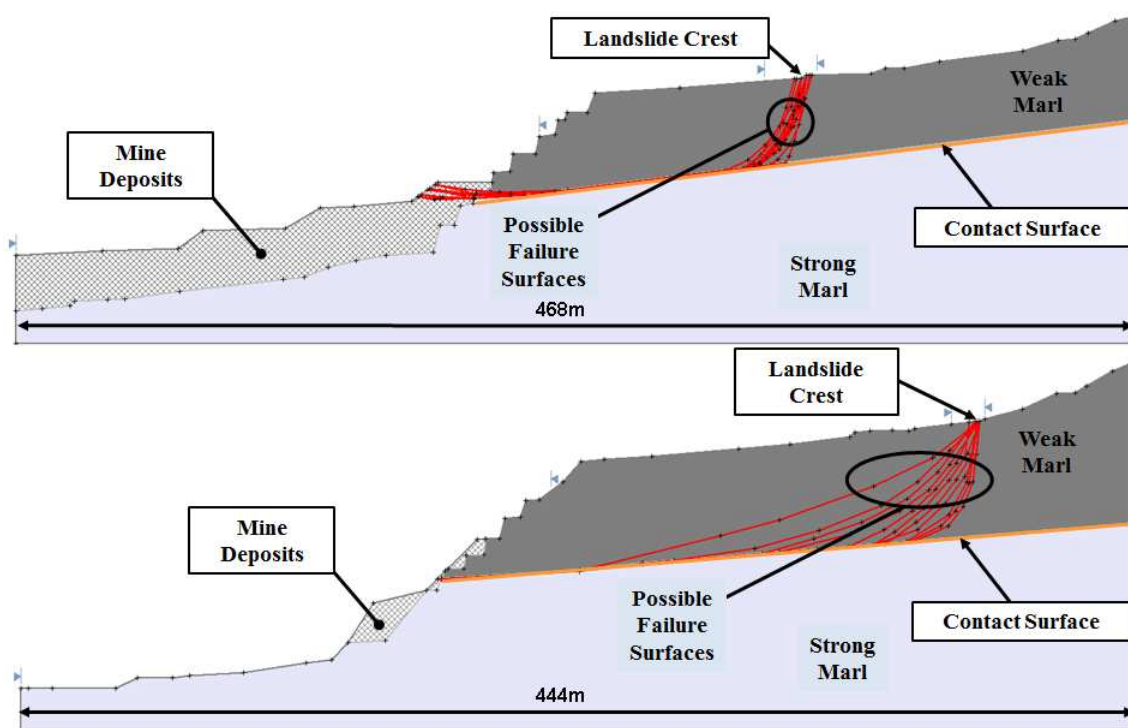
Given the three dimensional character of the landslide, as mentioned earlier, two analysis sections were systematically checked (Sections 2 and 3) so as to estimate some rational parameters for the assessment of rehabilitation proposals. Figure 5 illustrates the analysis sections along with their main features. The process that was adopted is summarized in the following steps:

1. After in-situ inspection and study of available surveying mapping, conclusions were reached concerning the general shape of the failure surface along Section 2 (subvertical near the crest) and Section 3 (with more gentle slope near the crest). Based on these conclusions, a set of possible failure surfaces was considered for each Section, with varying inclination and part of the surface passing through the weak marl formation and along the contact surface between the weak and the competent marl.

Figure 5. Analysis Section 2 (up) and 3 (down). Slide software model.

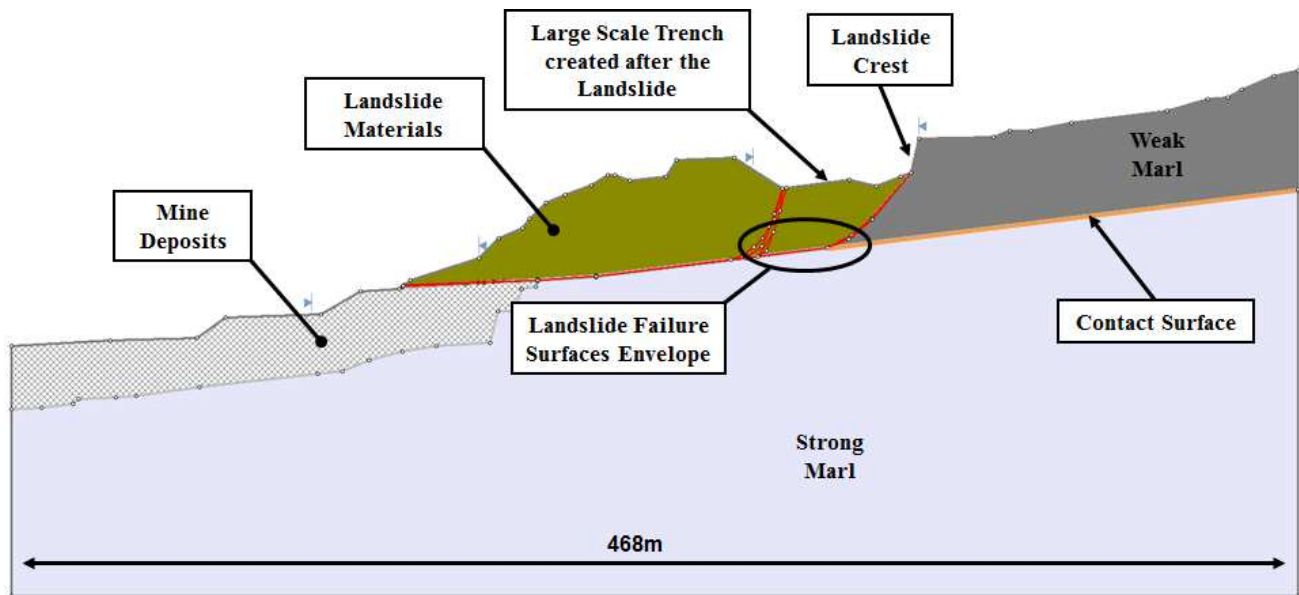
Figure 9. Analysis Section 2 after the landslide

The relevant analyses yielded results of the safety factor between 1.06 and 1.11, which were considered marginal, given the possible further deterioration of the shear strength of the materials involved in the slides, due to ongoing movements, especially during the rainy season in the area. Specifically, analyses of Section 2 resulted in a minimum value of the safety factor equal to 1.11, whereas the corresponding minimum value from Section 3 was 1.06. Analyses with free selection of surfaces by the software were not performed, as these would yield unrealistically low values of the safety factor (considerably <1), under the assumption that the total mass included in the landslide envelope had been downgraded to its residual strength (zero cohesion and low friction), which was not the case due to monolithic, undisturbed blocks existing within the slid mass. The fact that the resulting safety factor values were rational, i.e. marginally larger than unity, indicating a temporarily stable situation after a main landslide event, enhanced our confidence in the assumptions that were made.

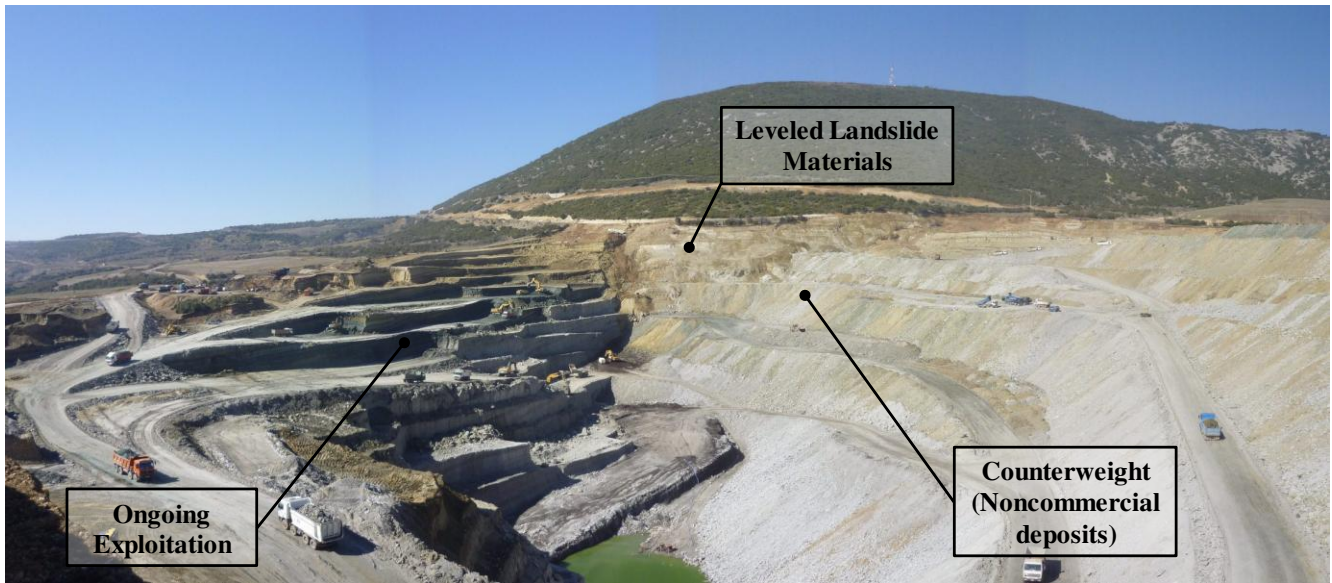
Figure 13. Aspect of the coal mine area after completion of counterweight construction and leveling works (March 2012).

The proposed rehabilitation scheme was successfully applied in order to stabilize the landslide before any intervention to its mass. The operation of the coal mine has continued without significant instability incidents ever since. The following figures show an aerial photo of the coal mine area and an aspect of the same from within the mine area, after completion of landslide counterweight construction and leveling of the landslide materials.

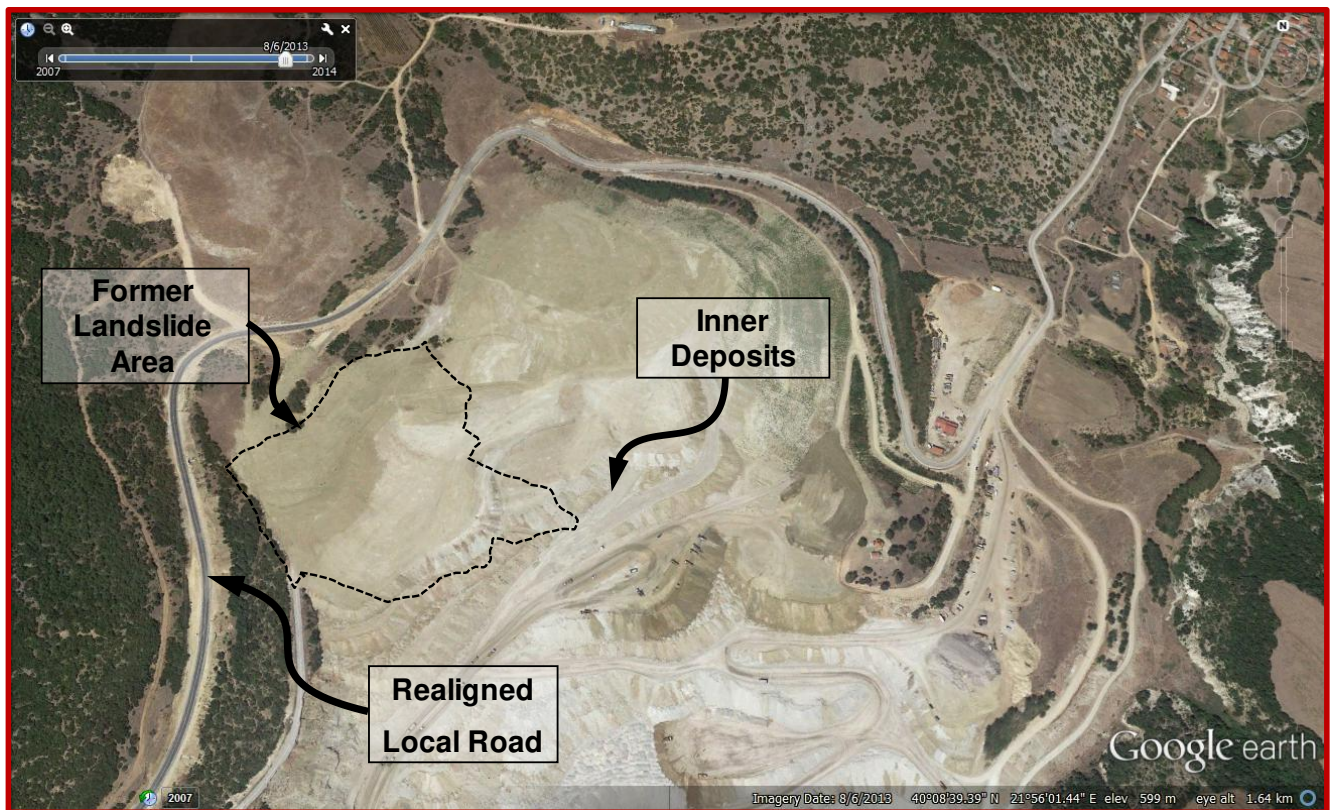
Figure 14. Aerial photo of the coal mine area after completion of counterweight construction and leveling works.
