A Large Scale Landslide in a Coal Mine in Marly Formations: Evaluation, Analysis and Rehabilitation

ABSTRACT: *This paper describes a large scale landslide in a coal mine in Servia area in Kozani, Greece, which occurred in February 2011. The landslide, of ~250m width and ~350m length, took place in marly lacustrine sediments. The main factors for the manifestation of the landslide were a temporary interruption of works, the existence of a specific weak surface, the clayey nature and the sensitivity of marl to environmental agents, the action of water and the large slope height. Due to the magnitude and the position of the failure, a geotechnical solution was proposed that involved rearrangement of ground masses. The proposed solution led to successful rehabilitation and unimpeded continuation of the exploitation process.*

Reference: Prountzopoulos, G., Fortsakis, P., Marinos, V. and Marinos, P. (2016). *A Large Scale Landslide in a Coal Mine in Marly Formations: Evaluation, Analysis and Rehabilitation*. International Journal of Geoengineering Case histories, Vol.4, Issue 1, p.29-45. doi: 10.4417/IJGCH-04-01-03

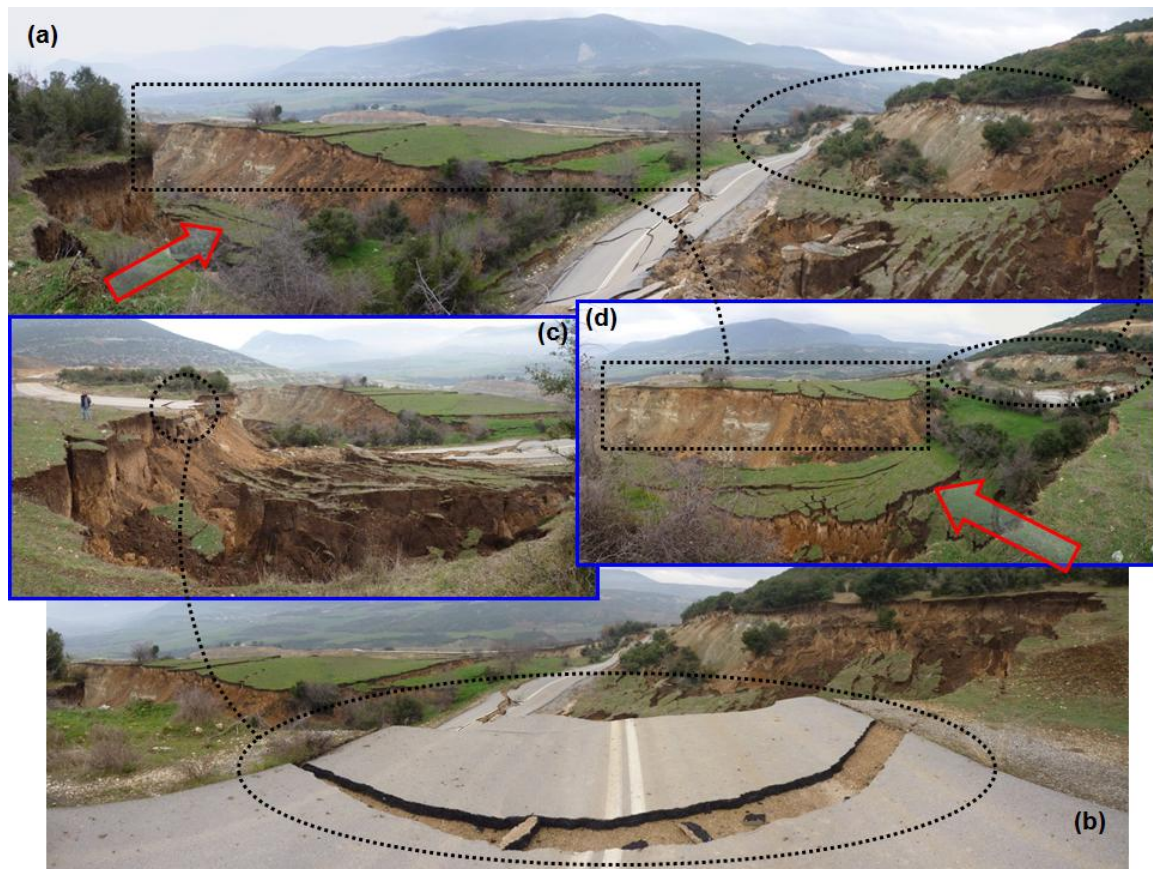
Figure 4. Aspect of the landslide from Position 3 (a & b), Position 4 (c) and Position 5 (d), the landslide crest (oval shape in a & d), the block that moved almost monolithically downstream (rectangle in a & d) and the mass that sank behind the block (arrow in a & d).

To evaluate the stability conditions of the landslide before any intervention, it was assumed that the critical failure surfaces either pass through the total failure envelope of the event, or through zones where significant shearing and relative movements were observed between “intact” parts of the marl formation, such as the zone downslope of the large scale trench that is shown in Figure 4.
