A Large Scale Landslide in a Coal Mine in Marly Formations: Evaluation, Analysis and Rehabilitation

ABSTRACT: *This paper describes a large scale landslide in a coal mine in Servia area in Kozani, Greece, which occurred in February 2011. The landslide, of ~250m width and ~350m length, took place in marly lacustrine sediments. The main factors for the manifestation of the landslide were a temporary interruption of works, the existence of a specific weak surface, the clayey nature and the sensitivity of marl to environmental agents, the action of water and the large slope height. Due to the magnitude and the position of the failure, a geotechnical solution was proposed that involved rearrangement of ground masses. The proposed solution led to successful rehabilitation and unimpeded continuation of the exploitation process.*

Reference: Prountzopoulos, G., Fortsakis, P., Marinou, V. and Marinou, P. (2016). *A Large Scale Landslide in a Coal Mine in Marly Formations: Evaluation, Analysis and Rehabilitation*. International Journal of Geoengineering Case histories, Vol.4, Issue 1, p.29-45. doi: 10.4417/IJGCH-04-01-03

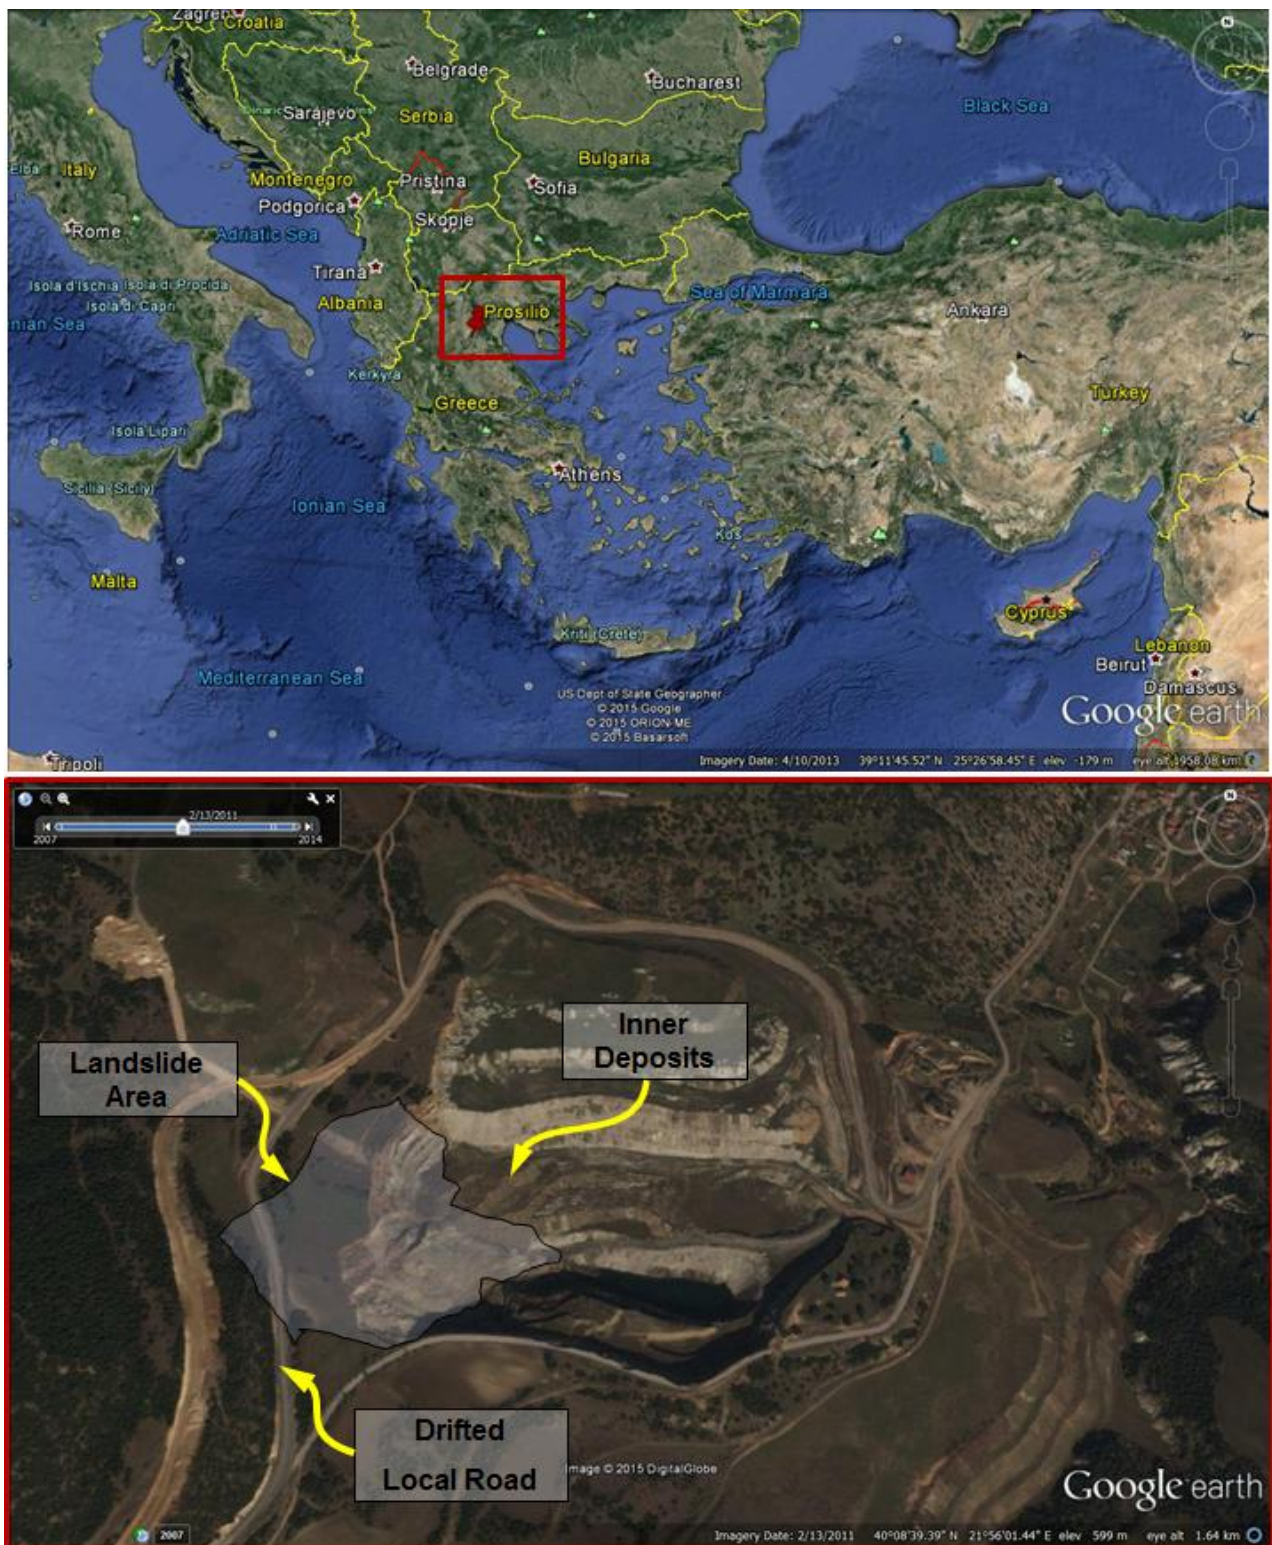
Figure 1 includes a demarcation of the position of the landslide, together with an aerial photo of the coal mine, only few days before the landslide. The landslide area, the local road affected by the landslide and the initially placed deposits for lateral retaining action to the mine slope are indicated on the satellite photo.

Figure 1. Position of landslide (up – red pin inside the red rectangle) and aerial photograph of the coal mine 2 weeks before the landslide (down). The area that was later occupied by the landslide is indicated with the transparent shape.

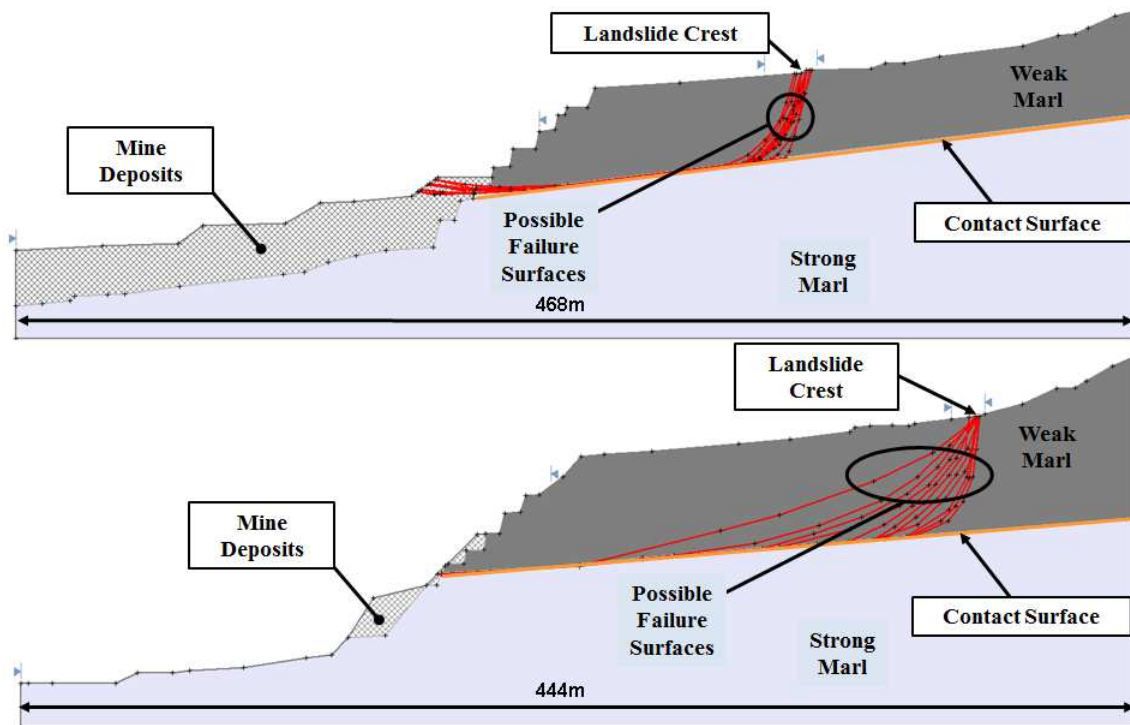
1. After in-situ inspection and study of available surveying mapping, conclusions were reached concerning the general shape of the failure surface along Section 2 (subvertical near the crest) and Section 3 (with more gentle slope near the crest). Based on these conclusions, a set of possible failure surfaces was considered for each Section, with varying inclination and part of the surface passing through the weak marl formation and along the contact surface between the weak and the competent marl.

Figure 5. Analysis Section 2 (up) and 3 (down). Slide software model.

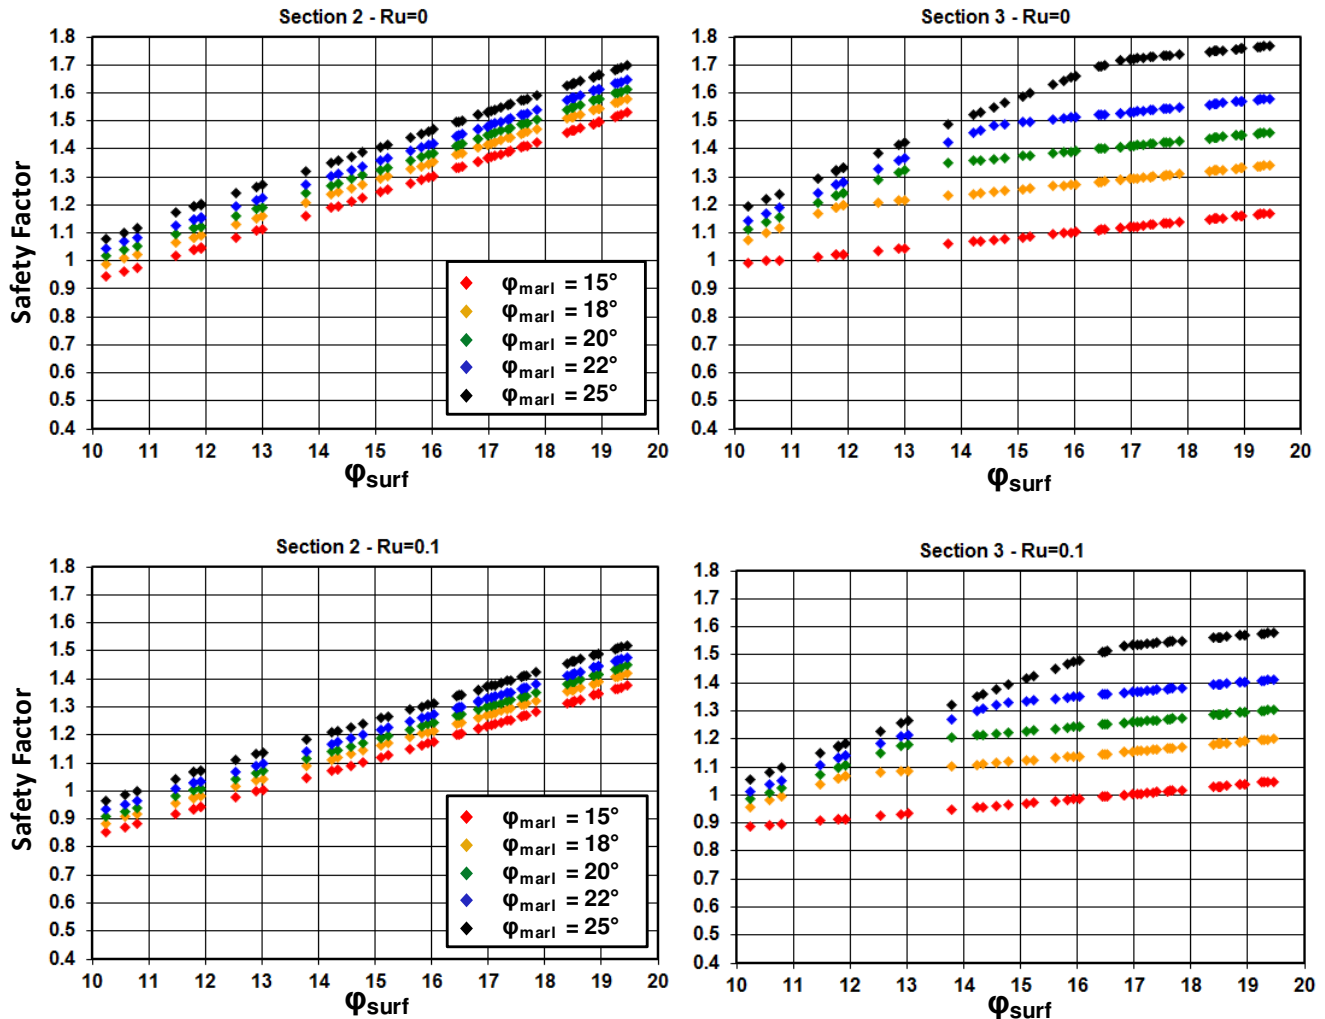
2. Values of the safety factor for values of pore pressure ratio $R_u=0-0.1$ generally lie above unity for both Sections analyzed (see Figure 6), especially for $\phi_{surf} > 13^\circ$ and were therefore excluded. This result was actually anticipated, since water seemed to have had a major role in the landslide triggering.

Figure 6. Variation of safety factor for different values of ϕ_{marl} and ϕ_{surf} for $R_u=0.0$ (up) and $R_u=0.1$ (down), as computed for Section 2 (left) and Section 3 (right)

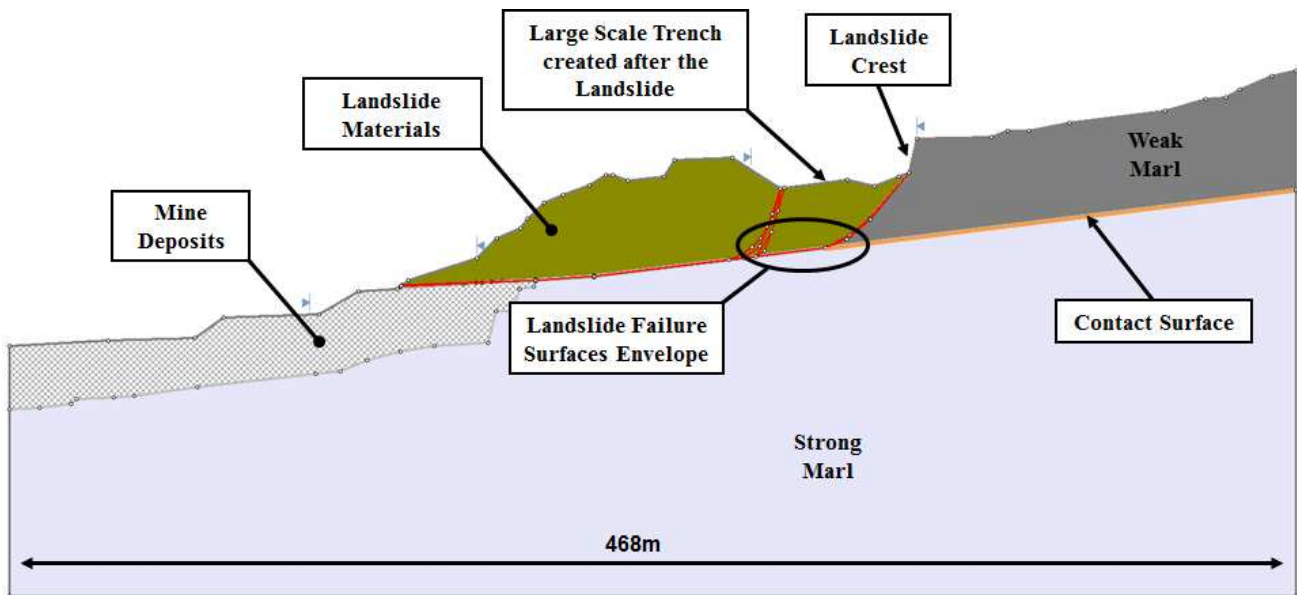
Figure 9. Analysis Section 2 after the landslide

The relevant analyses yielded results of the safety factor between 1.06 and 1.11, which were considered marginal, given the possible further deterioration of the shear strength of the materials involved in the slides, due to ongoing movements, especially during the rainy season in the area. Specifically, analyses of Section 2 resulted in a minimum value of the safety factor equal to 1.11, whereas the corresponding minimum value from Section 3 was 1.06. Analyses with free selection of surfaces by the software were not performed, as these would yield unrealistically low values of the safety factor (considerably <1), under the assumption that the total mass included in the landslide envelope had been downgraded to its residual strength (zero cohesion and low friction), which was not the case due to monolithic, undisturbed blocks existing within the slid mass. The fact that the resulting safety factor values were rational, i.e. marginally larger than unity, indicating a temporarily stable situation after a main landslide event, enhanced our confidence in the assumptions that were made.

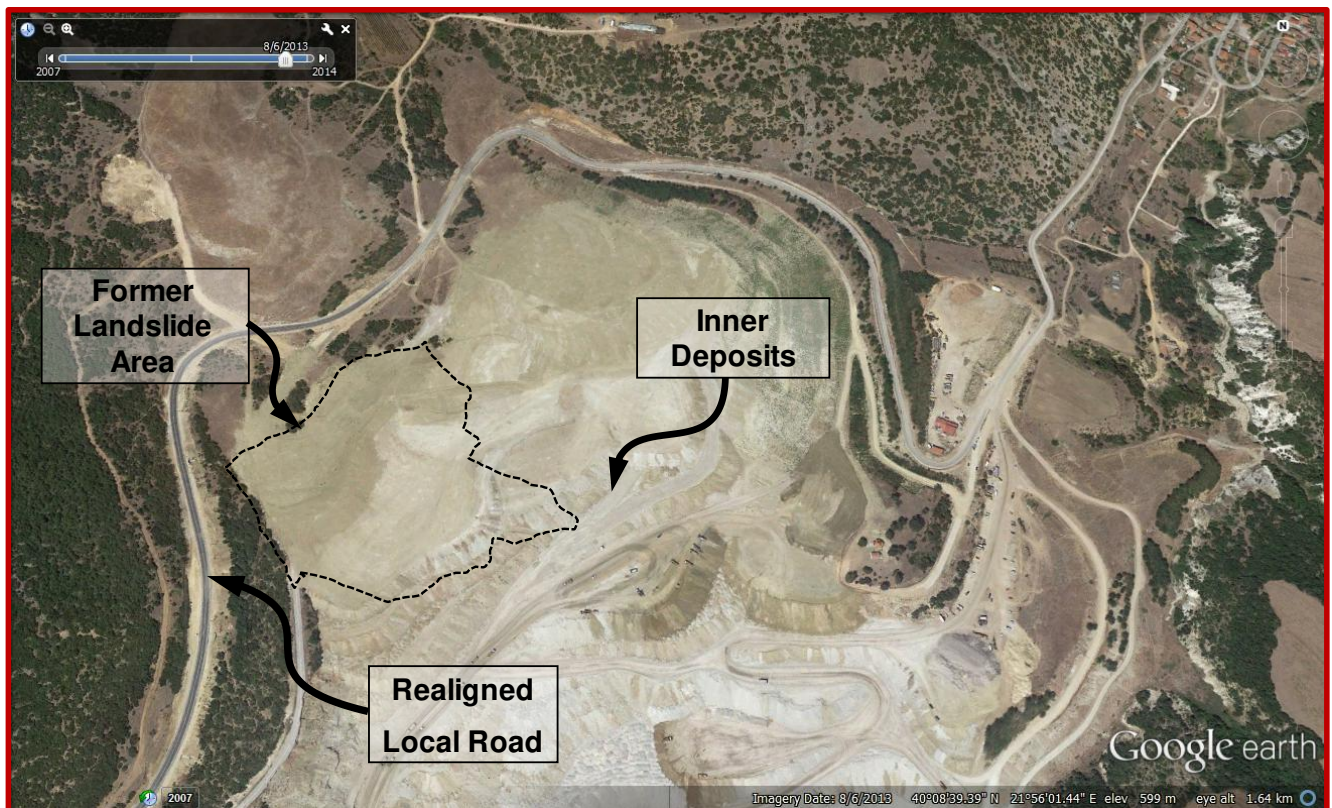
Figure 14. Aerial photo of the coal mine area after completion of counterweight construction and leveling works.

The proposed rehabilitation scheme was successfully applied in order to stabilize the landslide before any intervention to its mass. The operation of the coal mine has continued without significant instability incidents ever since. The following figures show an aerial photo of the coal mine area and an aspect of the same from within the mine area, after completion of landslide counterweight construction and leveling of the landslide materials.
