A Large Scale Landslide in a Coal Mine in Marly Formations: Evaluation, Analysis and Rehabilitation

ABSTRACT: *This paper describes a large scale landslide in a coal mine in Servia area in Kozani, Greece, which occurred in February 2011. The landslide, of ~250m width and ~350m length, took place in marly lacustrine sediments. The main factors for the manifestation of the landslide were a temporary interruption of works, the existence of a specific weak surface, the clayey nature and the sensitivity of marl to environmental agents, the action of water and the large slope height. Due to the magnitude and the position of the failure, a geotechnical solution was proposed that involved rearrangement of ground masses. The proposed solution led to successful rehabilitation and unimpeded continuation of the exploitation process.*

Reference: Prountzopoulos, G., Fortsakis, P., Marinos, V. and Marinos, P. (2016). *A Large Scale Landslide in a Coal Mine in Marly Formations: Evaluation, Analysis and Rehabilitation*. International Journal of Geoengineering Case histories, Vol.4, Issue 1, p.29-45. doi: 10.4417/IJGCH-04-01-03

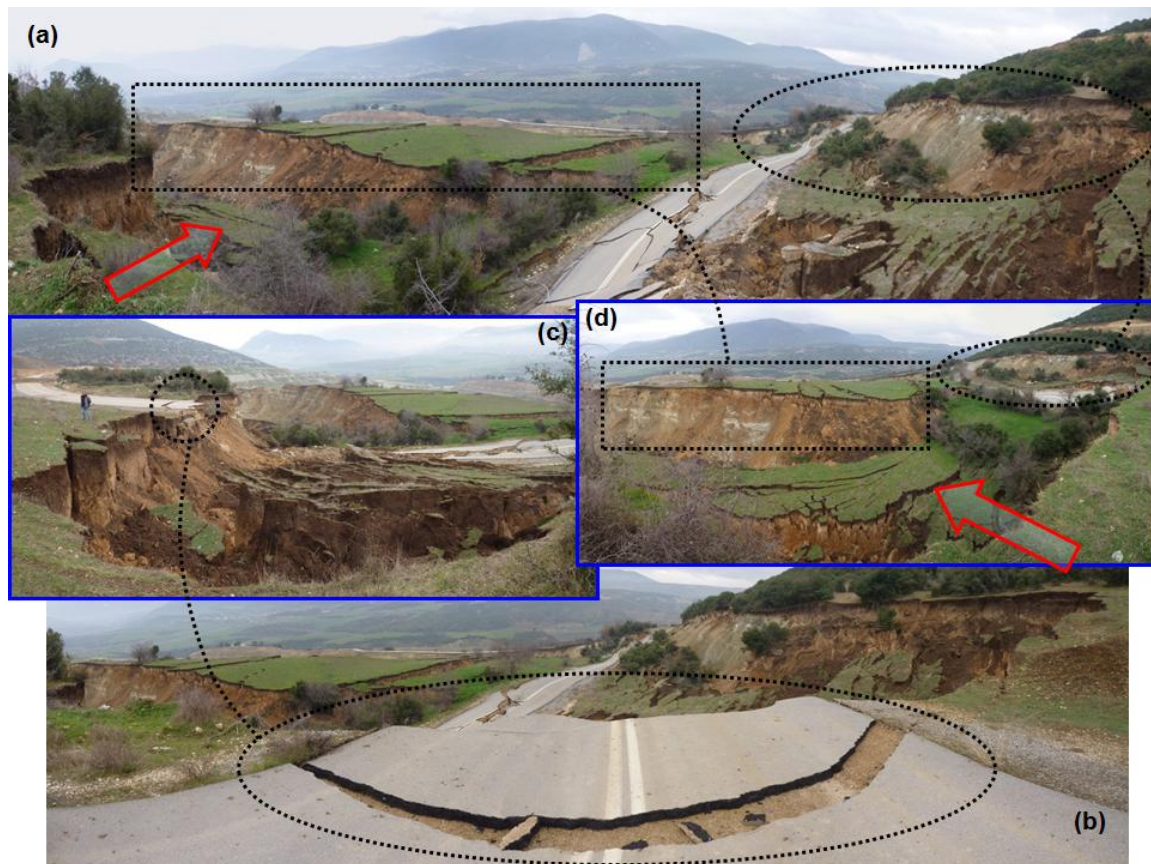
Figure 4. Aspect of the landslide from Position 3 (a & b), Position 4 (c) and Position 5 (d), the landslide crest (oval shape in a & d), the block that moved almost monolithically downstream (rectangle in a & d) and the mass that sank behind the block (arrow in a & d).

To evaluate the stability conditions of the landslide before any intervention, it was assumed that the critical failure surfaces either pass through the total failure envelope of the event, or through zones where significant shearing and relative movements were observed between “intact” parts of the marl formation, such as the zone downslope of the large scale trench that is shown in Figure 4.

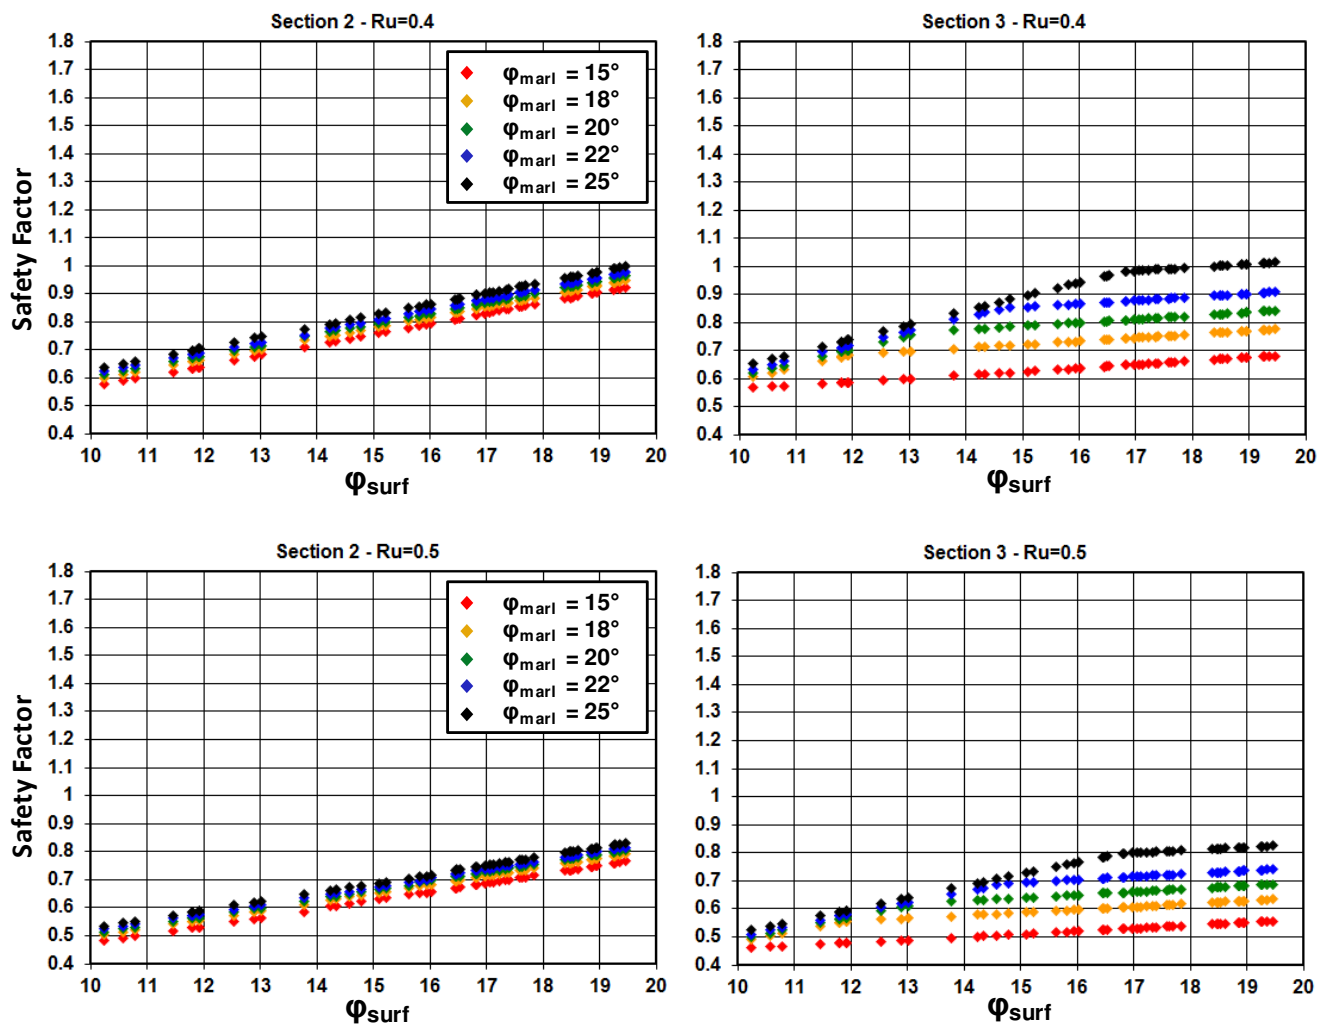
3. Values of the safety factor for values of the pore pressure ratio $R_u=0.4-0.5$ were generally well below unity for both analysis Sections (see Figure 8), especially for $\phi_{surf} < 17^\circ-18^\circ$ and were not considered likely. Values of the safety factor for $\phi_{surf} > 18^\circ$, given the nature of the specific surface and the fact that are assumed to refer to residual strength, were not considered reasonable.

Figure 8. Variation of safety factor for different values of ϕ_{marl} and ϕ_{surf} for $R_u=0.4$ (up) and $R_u=0.5$ (down), as computed for Section 2 (left) and Section 3 (right)
