A Large Scale Landslide in a Coal Mine in Marly Formations: Evaluation, Analysis and Rehabilitation

ABSTRACT: *This paper describes a large scale landslide in a coal mine in Servia area in Kozani, Greece, which occurred in February 2011. The landslide, of ~250m width and ~350m length, took place in marly lacustrine sediments. The main factors for the manifestation of the landslide were a temporary interruption of works, the existence of a specific weak surface, the clayey nature and the sensitivity of marl to environmental agents, the action of water and the large slope height. Due to the magnitude and the position of the failure, a geotechnical solution was proposed that involved rearrangement of ground masses. The proposed solution led to successful rehabilitation and unimpeded continuation of the exploitation process.*

Reference: Prountzopoulos, G., Fortsakis, P., Marinis, V. and Marinis, P. (2016). *A Large Scale Landslide in a Coal Mine in Marly Formations: Evaluation, Analysis and Rehabilitation*. International Journal of Geoengineering Case histories, Vol.4, Issue 1, p.29-45. doi: 10.4417/IJGCH-04-01-03

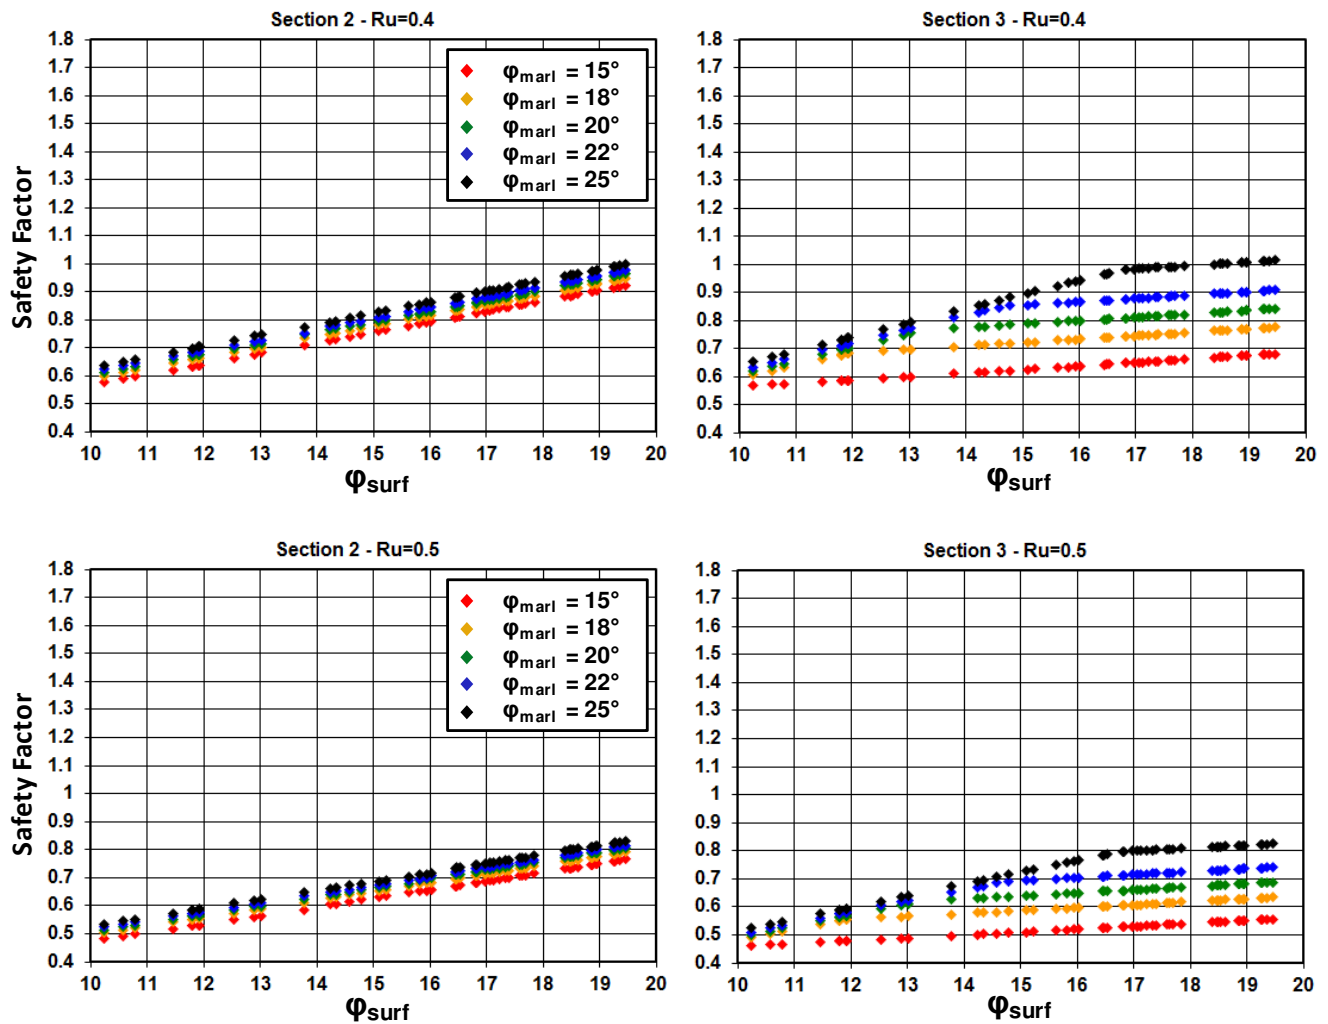
3. Values of the safety factor for values of the pore pressure ratio $R_u=0.4-0.5$ were generally well below unity for both analysis Sections (see Figure 8), especially for $\phi_{surf} < 17^\circ-18^\circ$ and were not considered likely. Values of the safety factor for $\phi_{surf} > 18^\circ$, given the nature of the specific surface and the fact that are assumed to refer to residual strength, were not considered reasonable.

Figure 8. Variation of safety factor for different values of ϕ_{marl} and ϕ_{surf} for $R_u=0.4$ (up) and $R_u=0.5$ (down), as computed for Section 2 (left) and Section 3 (right)

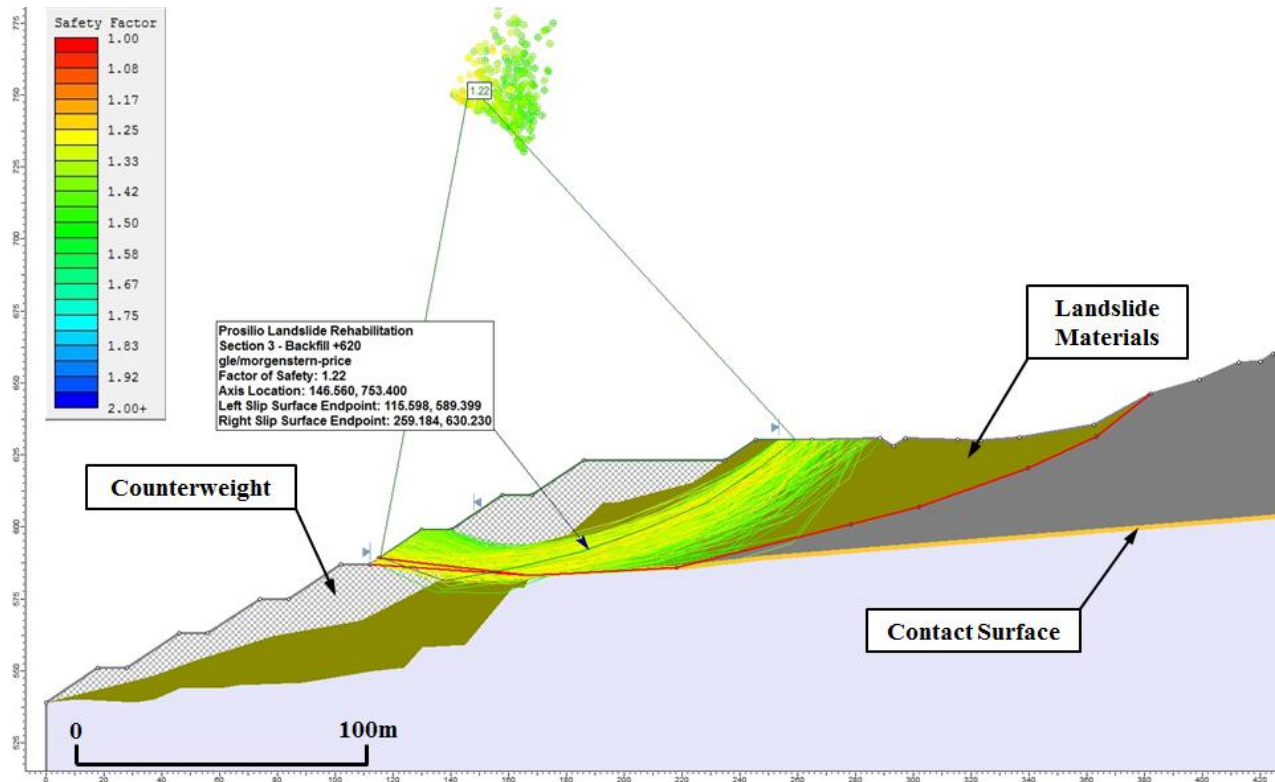
Figure 12. Analysis Results for Section 3 with backfill at the toe up to elevation +620 (F.S. = 1.22)

2. Placement of non commercial deposits at the toe of the landslide up to an elevation approximately 35 m above the contact surface between the upper weak and the undelying competent marl (~+620 m absolute evelation), did not significantly differentiate the safety factor. Specifically, considering the envelope of the landslide or surfaces along obvious large scale movements within the total landslide mass as potential failure surfaces, the computed values of the safety factor ranged between 1.56 and 1.70. Assuming that any failure surface within the total landslide envelope was possible, the safety factor ranged between 1.22 and 1.57. Therefore, it was shown that the additional placement up to the specific level was only to facilitate the landslide removal and exploitation procedureds and was not necessary for the stabilization of the landslide. In fact, locally, due to the existing geometry and morphology of the landslide, this additional placement could somehow reduce the available safety factor, as part of the deposits would actually increase the sliding moment for certain potential failure surfaces (pose additional loading to the landslide - see Figure 12 above).
