Remediation of The Pissouri Landslide in Cyprus

Argyris Alexandris, Archirodon NV, Athens, Greece, (form. OTM SA); email: a.alexandris@archirodon.net,
Irini Katsipi Griva, OTM SA, Athens, Greece; email: otmate@otenet.gr
Maria Abarioti, OTM SA, Athens, Greece; email: otmate@otenet.gr

Pissouri Landslide in Cyprus. International Journal of Geotechnical Engineering Case histories, Vol.4, Issue 1, p.14-28. doi: 10.4417/IJGCH-04-01-02

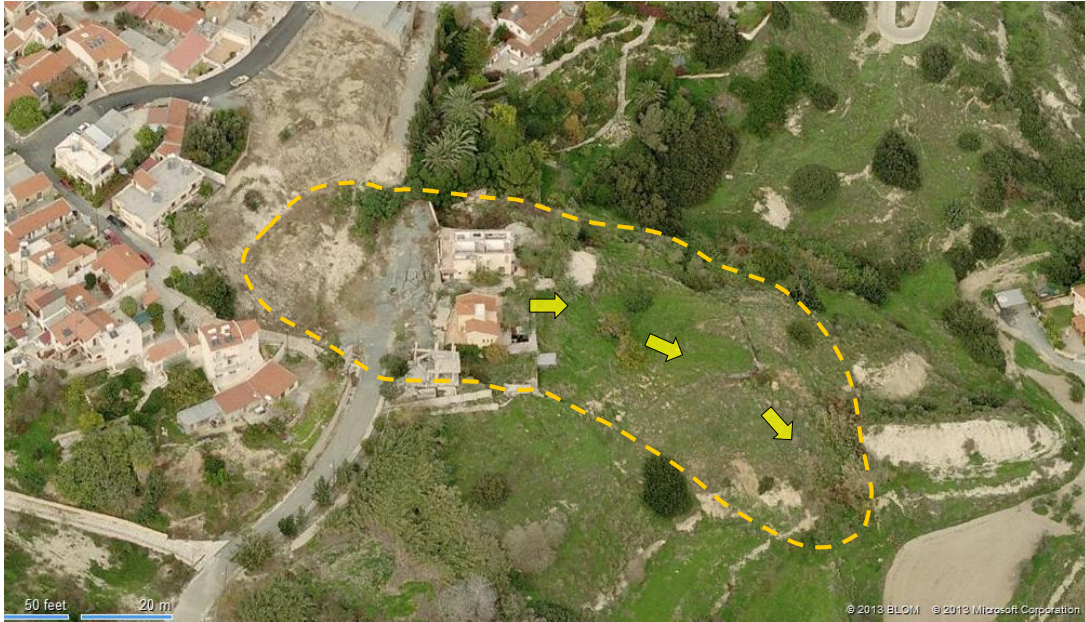
of the build-up area, approximately 80,000 m³ of ground mobilized and moved 0.5 m to 1.0 m downslope. The landslide distorted a section of a country road which was crossing the upper part of the slide and three residential buildings built adjacent to it. It continued to move the following years, at low rates during the dry seasons and at an accelerating rate during the wet seasons. With an average movement rate of 3 cm per month the landslide displacement accumulated up to 3.00 m – 3.50 m during the next 10 years. The landslide was immediately followed by water springing at the toe of the sliding mass, and continued the following years to seasonally gush out water and mud, pinpointing the significance of groundwater seepage through the sliding mass to its mobilization. An aerial view of the landslide, the distorted road and the damaged buildings is presented in figure 1, which can also be seen on the photographs of figure 2.

Figure 1. Aerial view of the Pissouri landslide. Dashed line indicates the border of the sliding mass. Notice the distorted road and the damaged residential buildings resting on the sliding mass.

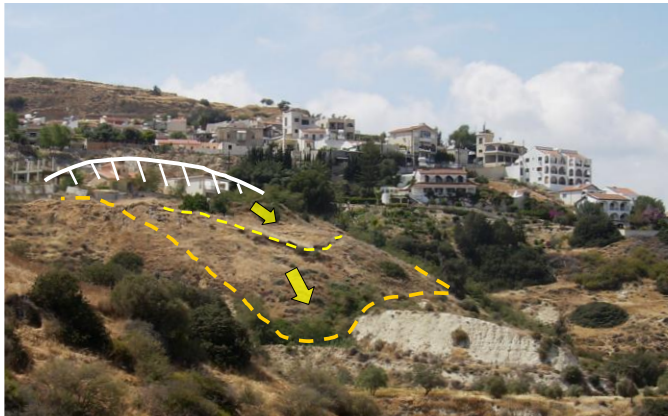
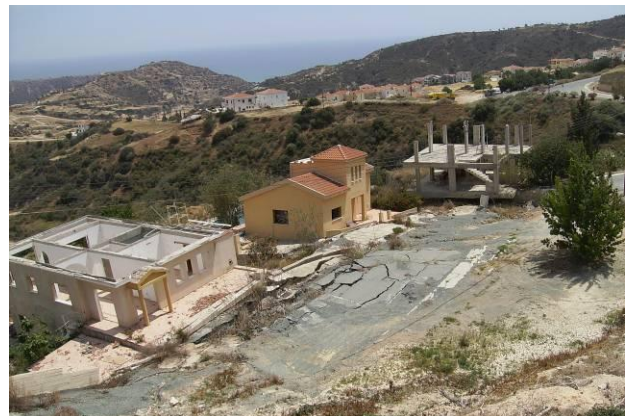
Figure 2. Left: Northward view of the Pissouri landslide. Dashed line marks the border of the sliding mass. Back scarp is also marked. Right: The distorted road and damaged buildings resting at the upper part of the sliding mass.

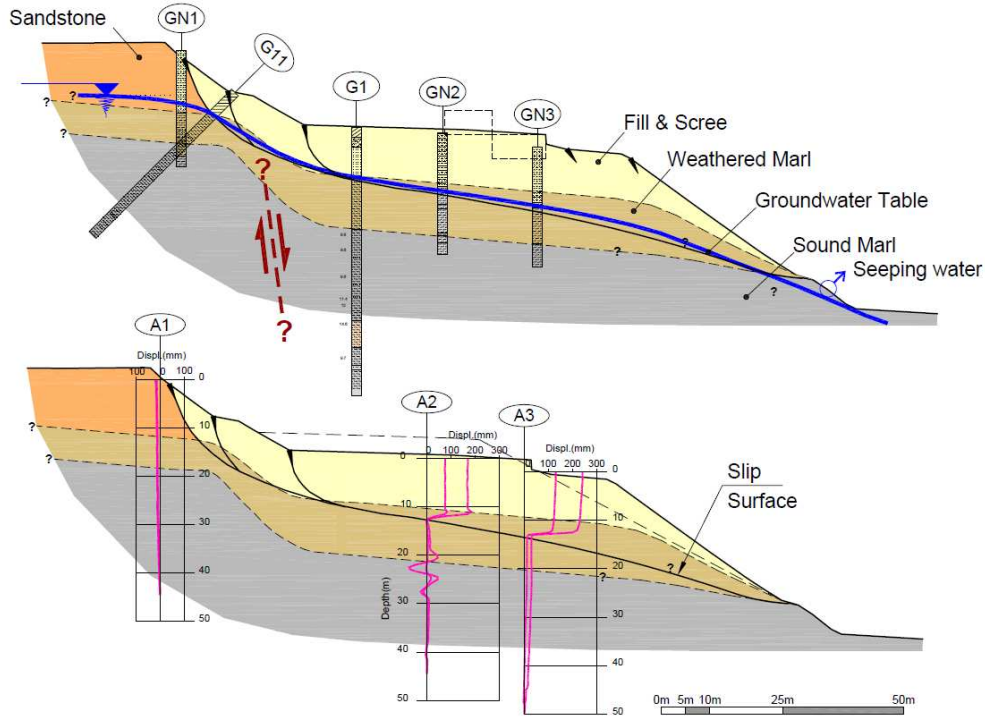
Figure 5. Geotechnical section along the sliding mass. Top: Exploratory boreholes Stratigraphy and ground water table
Bottom: Inclinometer readings and location of slip surface.

The slip surface was located by combining the monitoring data from the two inclinometer tubes (A2 & A3) installed within the sliding mass and the careful mapping of slope breaks and cracks, visible on the ground (in some cases), on the cracked pavement of the distorted road, the houses and the paved ground around them. The third inclinometer tube which had been installed further upslope did not show signs of movement (as shown in figure 5) and allowed the identification of the back scarp of the slide with confidence.

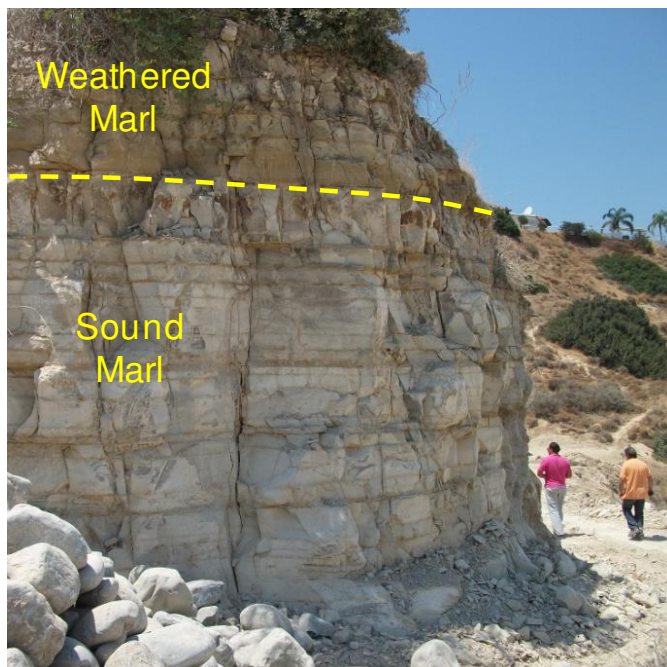
The bedrock is a low strength yellowish calcareous marlstone ($UCS \approx 10$ MPa), fairly undisturbed, but marked by a medium to thick bedding (10 - 100 cm) dipping with a low angle to south-southeast. Stress relief lead to the development of sub-verical joints and fissures and water circulation gradually resulted to the development of a capping weathered crust. Weathering is associated with oxidization and decalcification of the marlstone, the gradual increase in pore volume (further promoting seepage) and subsequent intact strength degradation to that of a stiff soil. In the landslide site the thickness of the weathered marl crust is 5 to 10 meters and the material was encountered in places disturbed and sheared by the landslide movement. The succession of sound and weathered marl is depicted on the photograph of Figure 6, where the weathered material is noted by the distinct brownish color and its intense fissility. Soil samples obtained from the weathered zone are classified as CH-MH with a plasticity index (PI) ranging from 20% to 35% and clay fraction (CF) between 30% and 60%. Natural water content of the weathered marl does not exceed 30% and the material is generally stiff with SPT values ranging from 25 blows/ft to refusal. Typical classification test results from this zone are also presented in Figure 6.

Figure 6. Left: Typical appearance of the bedded calcareous marl and the overlying weathered crust.
Right: Typical soil classification test results performed on samples retrieved from the weathered marl zone.

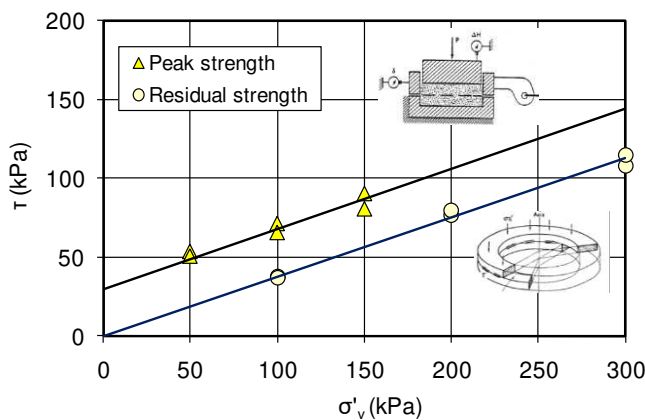
The shear strength parameters of the weathered marl, where the slip surface eventually developed, was investigated in the laboratory by means of a few slow (drained) shear box tests, which averaged to $c'=30$ kPa and $\phi'=21^\circ$ as shown in figure 7. Residual shear strength parameters, were obtained from ring shear tests (Broamhead ring shear apparatus) which yielded values of $c_r'=0$ and $\phi_r'=21^\circ$. The values of the residual angle of shearing resistance determined directly by the ring shear tests are compared with the dataset presented by Skempton (1985) (Figure 8) and are found to be in the upper bound of the scatter. This is probably due to the fact that the particular ring shear tests were carried out on fairly silty samples (classified as MH) and not on clayey ones.

Figure 7. Shear box and ring shear test results on soil samples from the weathered marl horizon. Peak strength $c'=30$ kPa, $\phi'=21^\circ$. Residual strength $c_r'=0$ kPa $\phi_r'=21^\circ$.

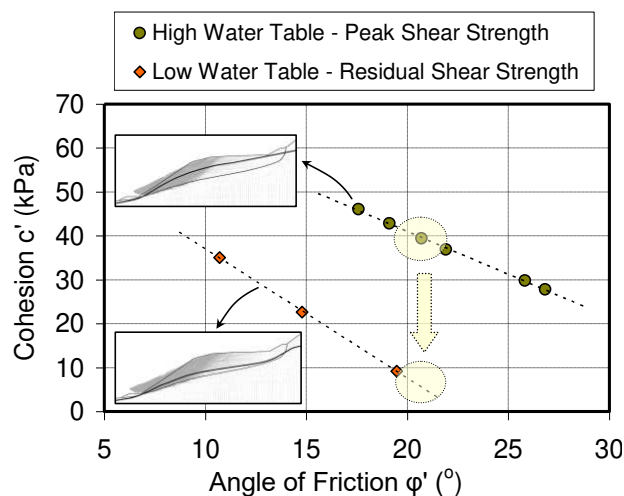
These analyses manifested the fact that an elevated water table can mobilize the weathered marl crust with operational shear strength parameters close to the peak values, as they were determined by the shear box tests performed on the soil samples. They also show that the slide remained mobile after water table lowering, (dry season) if the operational strength values of the weathered marl crust at the failure surface were close to the residual strength values, determined by the ring shear tests. It is concluded that most likely we deal with a new slide, which was brought in the verge of failure due to gradual loading of the upslope area with scree and manmade fill and the gradual progression of the weathering process. The development of high water pressures triggered an already mature slide, which continued to be active even during the dry seasons due to the drop of the shear strength values from peak to residual.

Figure 14. Back analyses results. Estimated mobilized shear strength parameters for a higher and lower water table coincide with the transition of shear strength values from peak to residual.

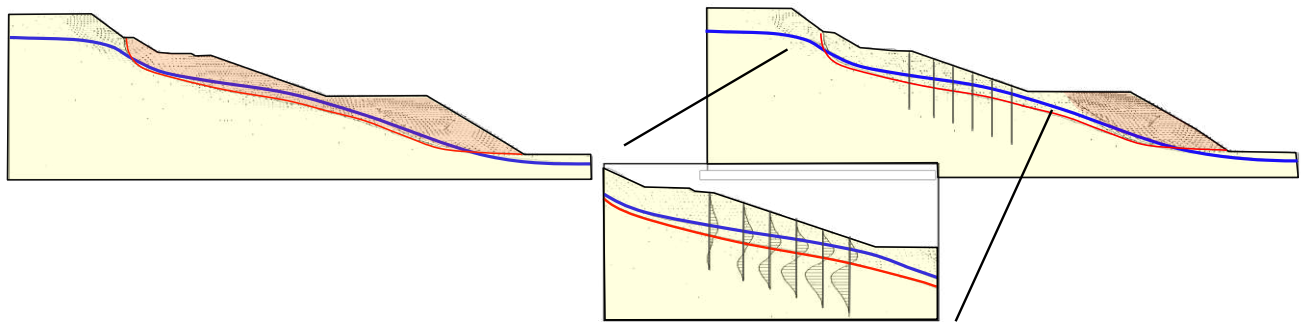
The construction of the toe buttress and the trimming of the upslope area of the landslide, lead to sufficient factors of safety (FOS=1.6) under normal conditions (low water table, static conditions), which though drop to low values with an elevated water table and very low values under seismic conditions. It was also observed that these low factors of safety are associated with mobilization of the entire sliding mass. The dowelling effect of the bored piles isolates and stabilizes the upper part of the sliding mass, while the lower part may remain more critical but still with sufficient FoS. Figure 17 depicts the critical sliding mode with and without the dowelling piles. In this case the raised water table yield a FOS = 1.6 and the seismic analysis a FOS=1.15.

Figure 17. Stability analysis of the remediated slope. Left: Without the stabilization piles the entire sliding mass mobilizes as a single body. Right: With the addition of the piles the toe buttress is more critical.

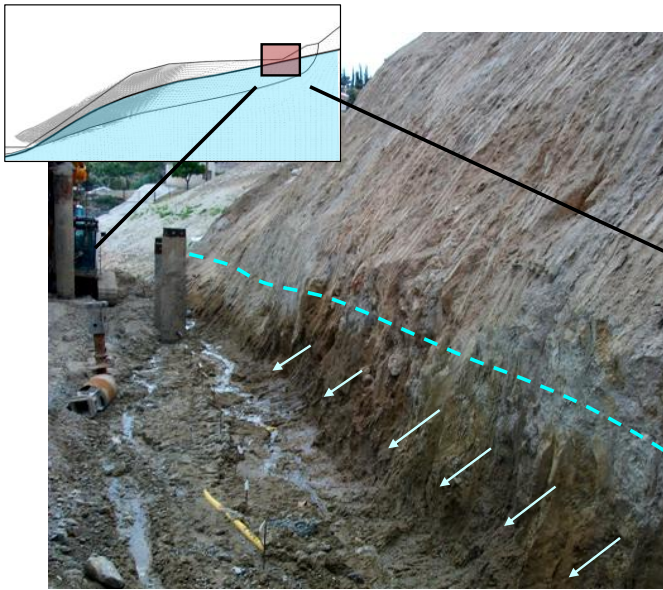
Figure 20. Water seeping out of the marl at the landslide back scarp

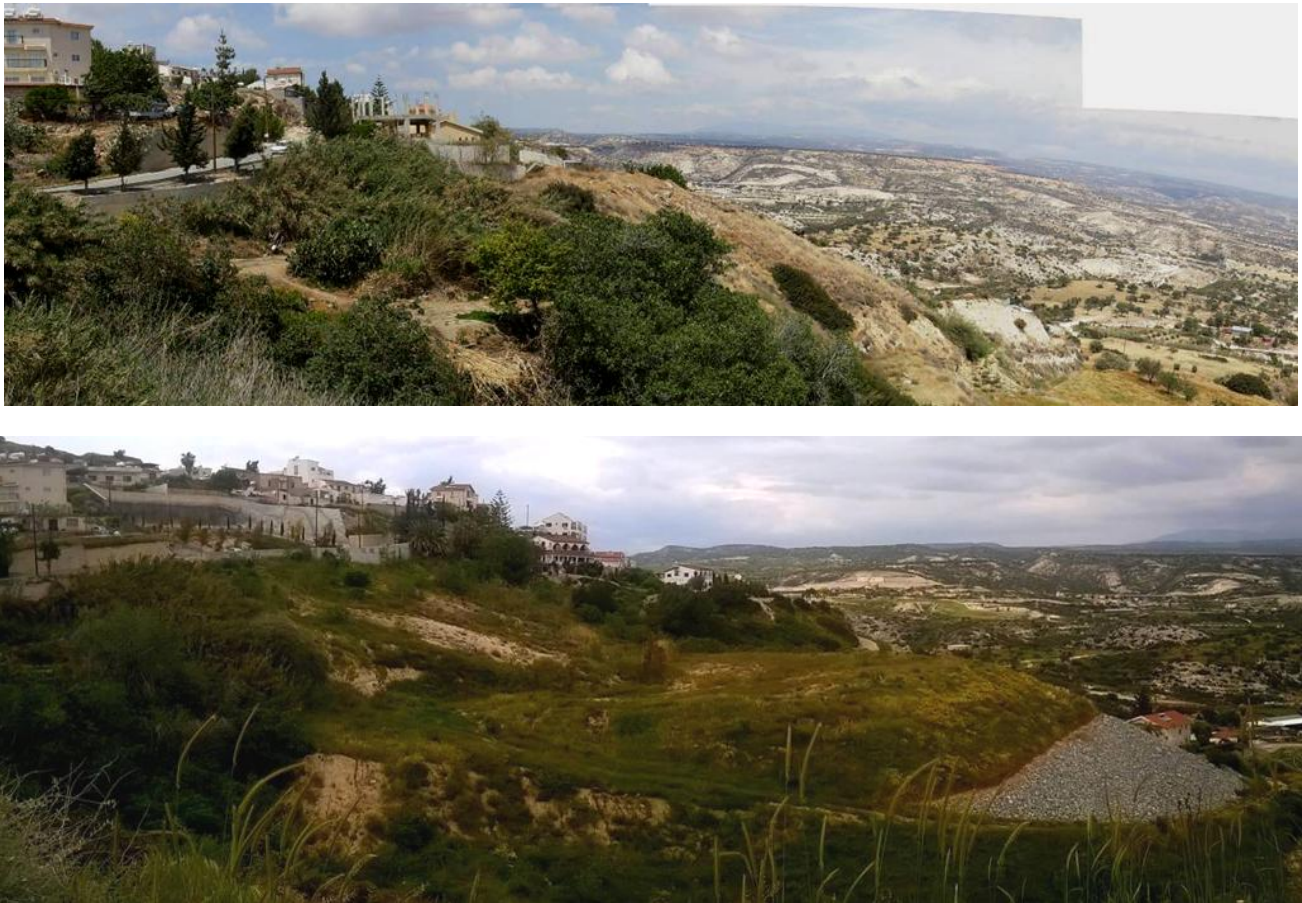
Figure 23. The landslide area before (top) and after (bottom) the stabilization works.
