Remediation of The Pissouri Landslide in Cyprus

ABSTRACT: During the winter of 2001-2002, a landslide of 80.000 m³ was activated and moved downslope at the Northeast outskirts of the Pissouri village in Cyprus (Limassol prefecture), displacing a section of a country road that was crossing the upper part of the sliding mass and destroying three newly built residences. This paper presents the geologic and hydrogeologic regime of the landslide and its implication on the landslide's mobilization. Geotechnical site investigation and post failure monitoring, in conjunction with slope stability back analysis formed the basis for the study of the slide and subsequently guided the remediation strategy. Various possible interventions to stabilize the slope and allow the safe reconstruction of the displaced road have been investigated and compared considering both economic and environmental criteria. The performance of the remediation measures has been studied in terms of stability safety, using numerical models previously calibrated via back analyses. Observations made during the execution of the stabilization works provided additional data verifying and supplementing the original design.

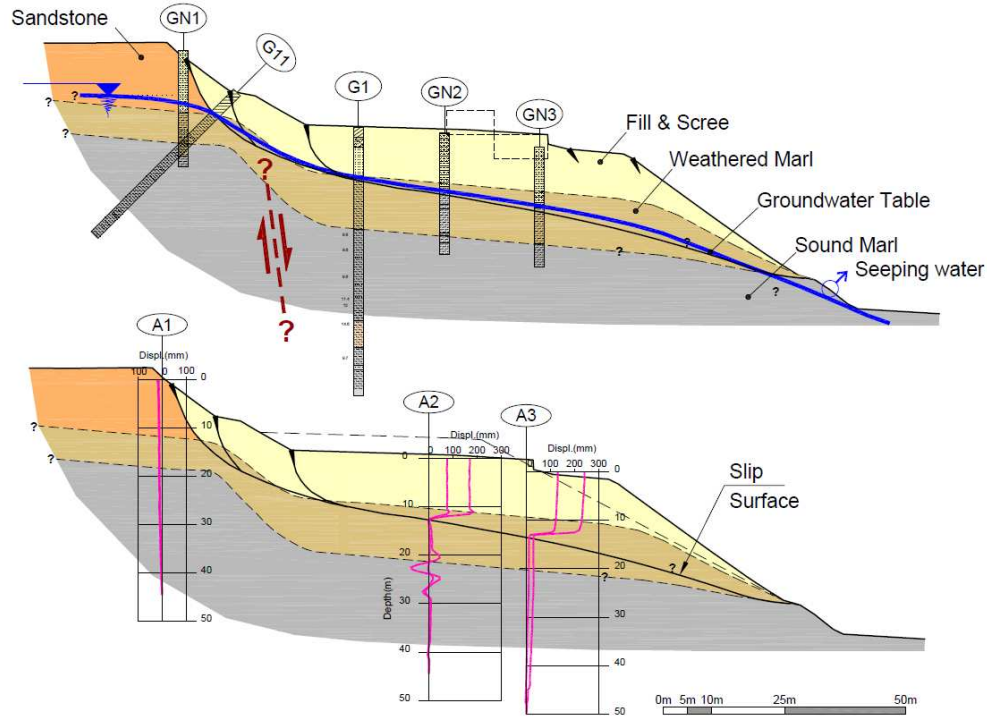
Figure 5. Geotechnical section along the sliding mass. Top: Exploratory boreholes Stratigraphy and ground water table
Bottom: Inclinometer readings and location of slip surface.

The slip surface was located by combining the monitoring data from the two inclinometer tubes (A2 & A3) installed within the sliding mass and the careful mapping of slope breaks and cracks, visible on the ground (in some cases), on the cracked pavement of the distorted road, the houses and the paved ground around them. The third inclinometer tube which had been installed further upslope did not show signs of movement (as shown in figure 5) and allowed the identification of the back scarp of the slide with confidence.

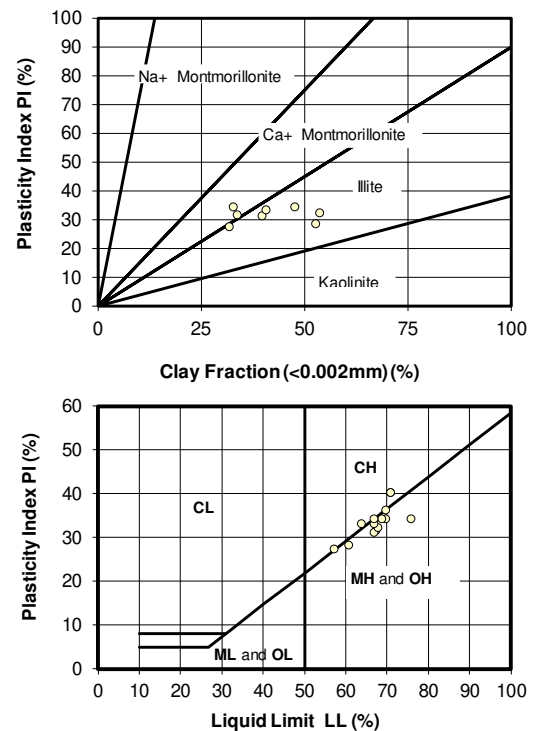
Figure 6. Left: Typical appearance of the bedded calcareous marl and the overlying weathered crust.
Right: Typical soil classification test results performed on samples retrieved from the weathered marl zone.

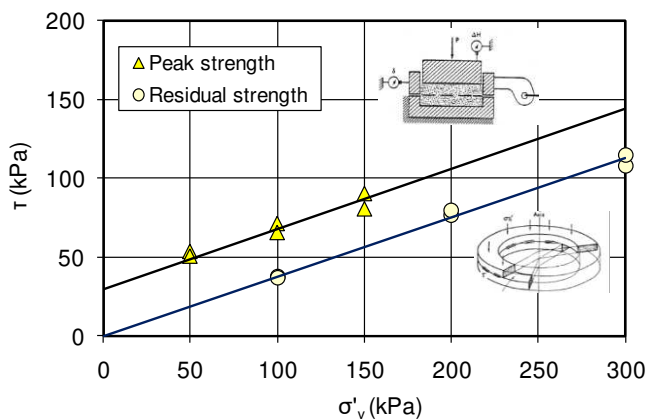
The shear strength parameters of the weathered marl, where the slip surface eventually developed, was investigated in the laboratory by means of a few slow (drained) shear box tests, which averaged to $c'=30$ kPa and $\phi'=21^\circ$ as shown in figure 7. Residual shear strength parameters, were obtained from ring shear tests (Broamhead ring shear apparatus) which yielded values of $c_r'=0$ and $\phi_r'=21^\circ$. The values of the residual angle of shearing resistance determined directly by the ring shear tests are compared with the dataset presented by Skempton (1985) (Figure 8) and are found to be in the upper bound of the scatter. This is probably due to the fact that the particular ring shear tests were carried out on fairly silty samples (classified as MH) and not on clayey ones.

Figure 7. Shear box and ring shear test results on soil samples from the weathered marl horizon. Peak strength $c'=30$ kPa, $\phi'=21^\circ$. Residual strength $c_r'=0$ kPa $\phi_r'=21^\circ$.

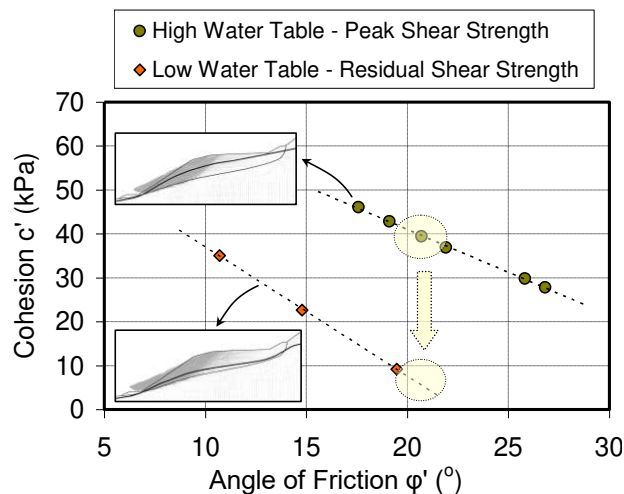
These analyses manifested the fact that an elevated water table can mobilize the weathered marl crust with operational shear strength parameters close to the peak values, as they were determined by the shear box tests performed on the soil samples. They also show that the slide remained mobile after water table lowering, (dry season) if the operational strength values of the weathered marl crust at the failure surface were close to the residual strength values, determined by the ring shear tests. It is concluded that most likely we deal with a new slide, which was brought in the verge of failure due to gradual loading of the upslope area with scree and manmade fill and the gradual progression of the weathering process. The development of high water pressures triggered an already mature slide, which continued to be active even during the dry seasons due to the drop of the shear strength values from peak to residual.

Figure 14. Back analyses results. Estimated mobilized shear strength parameters for a higher and lower water table coincide with the transition of shear strength values from peak to residual.

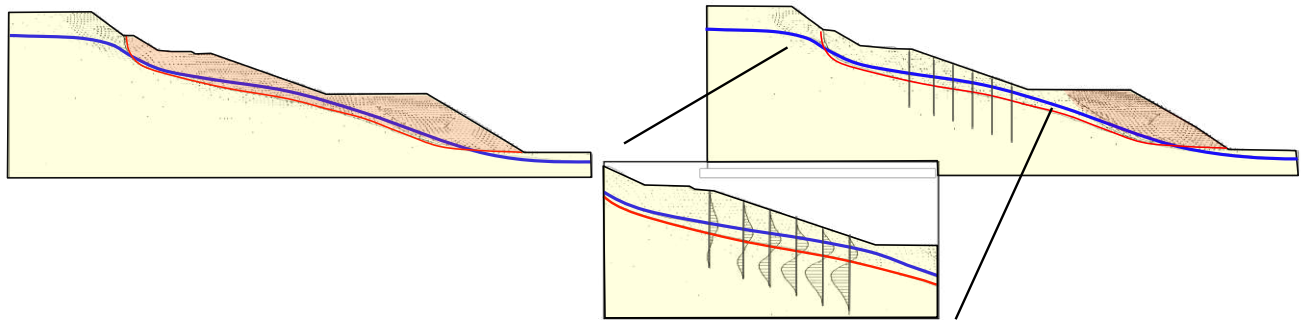
The construction of the toe buttress and the trimming of the upslope area of the landslide, lead to sufficient factors of safety (FOS=1.6) under normal conditions (low water table, static conditions), which though drop to low values with an elevated water table and very low values under seismic conditions. It was also observed that these low factors of safety are associated with mobilization of the entire sliding mass. The dowelling effect of the bored piles isolates and stabilizes the upper part of the sliding mass, while the lower part may remain more critical but still with sufficient FoS. Figure 17 depicts the critical sliding mode with and without the dowelling piles. In this case the raised water table yield a FOS = 1.6 and the seismic analysis a FOS=1.15.

Figure 17. Stability analysis of the remediated slope. Left: Without the stabilization piles the entire sliding mass mobilizes as a single body. Right: With the addition of the piles the toe buttress is more critical.
