Remediation of The Pissouri Landslide in Cyprus

Argyris Alexandris, Archirodon NV, Athens, Greece, (form. OTM SA); email: a.alexandris@archirodon.net,
Irini Katsipi Griva, OTM SA, Athens, Greece; email: otmate@otenet.gr
Maria Abarioti, OTM SA, Athens, Greece; email: otmate@otenet.gr

ABSTRACT: During the winter of 2001-2002, a landslide of 80.000 m³ was activated and moved downslope at the Northeast outskirts of the Pissouri village in Cyprus (Limassol prefecture), displacing a section of a country road that was crossing the upper part of the sliding mass and destroying three newly built residences. This paper presents the geologic and hydrogeologic regime of the landslide and its implication on the landslide's mobilization. Geotechnical site investigation and post failure monitoring, in conjunction with slope stability back analysis formed the basis for the study of the slide and subsequently guided the remediation strategy. Various possible interventions to stabilize the slope and allow the safe reconstruction of the displaced road have been investigated and compared considering both economic and environmental criteria. The performance of the remediation measures has been studie

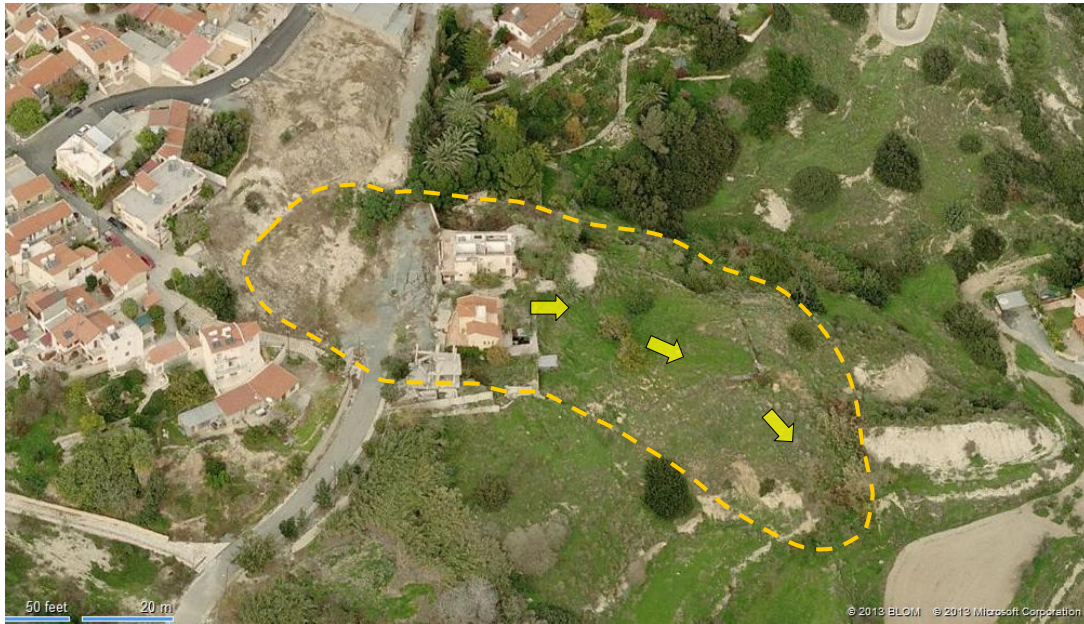
of the build-up area, approximately 80,000 m³ of ground mobilized and moved 0.5 m to 1.0 m downslope. The landslide distorted a section of a country road which was crossing the upper part of the slide and three residential buildings built adjacent to it. It continued to move the following years, at low rates during the dry seasons and at an accelerating rate during the wet seasons. With an average movement rate of 3 cm per month the landslide displacement accumulated up to 3.00 m – 3.50 m during the next 10 years. The landslide was immediately followed by water springing at the toe of the sliding mass, and continued the following years to seasonally gush out water and mud, pinpointing the significance of groundwater seepage through the sliding mass to its mobilization. An aerial view of the landslide, the distorted road and the damaged buildings is presented in figure 1, which can also be seen on the photographs of figure 2.

Figure 1. Aerial view of the Pissouri landslide. Dashed line indicates the border of the sliding mass. Notice the distorted road and the damaged residential buildings resting on the sliding mass.

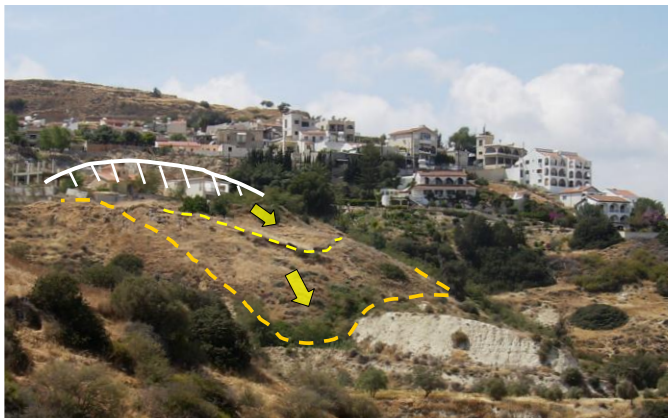
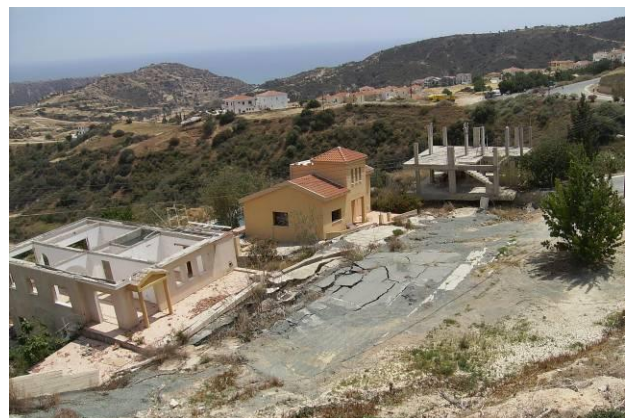
Figure 2. Left: Northward view of the Pissouri landslide. Dashed line marks the border of the sliding mass. Back scarp is also marked. Right: The distorted road and damaged buildings resting at the upper part of the sliding mass.

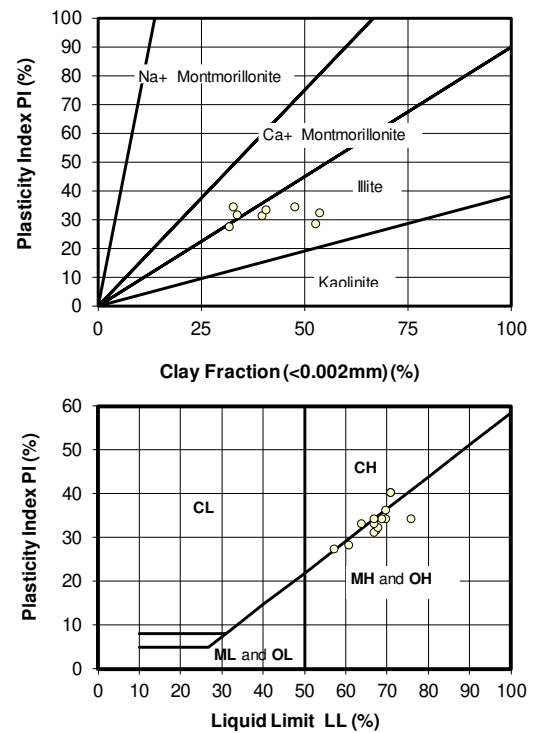
The bedrock is a low strength yellowish calcareous marlstone ($UCS \approx 10$ MPa), fairly undisturbed, but marked by a medium to thick bedding (10 - 100 cm) dipping with a low angle to south-southeast. Stress relief lead to the development of sub-verical joints and fissures and water circulation gradually resulted to the development of a capping weathered crust. Weathering is associated with oxidization and decalcification of the marlstone, the gradual increase in pore volume (further promoting seepage) and subsequent intact strength degradation to that of a stiff soil. In the landslide site the thickness of the weathered marl crust is 5 to 10 meters and the material was encountered in places disturbed and sheared by the landslide movement. The succession of sound and weathered marl is depicted on the photograph of Figure 6, where the weathered material is noted by the distinct brownish color and its intense fissility. Soil samples obtained from the weathered zone are classified as CH-MH with a plasticity index (PI) ranging from 20% to 35% and clay fraction (CF) between 30% and 60%. Natural water content of the weathered marl does not exceed 30% and the material is generally stiff with SPT values ranging from 25 blows/ft to refusal. Typical classification test results from this zone are also presented in Figure 6.

Figure 6. Left: Typical appearance of the bedded calcareous marl and the overlying weathered crust. Right: Typical soil classification test results performed on samples retrieved from the weathered marl zone.

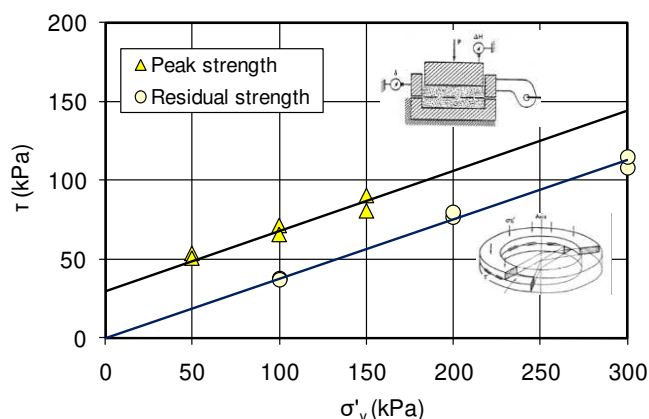
The shear strength parameters of the weathered marl, where the slip surface eventually developed, was investigated in the laboratory by means of a few slow (drained) shear box tests, which averaged to $c'=30$ kPa and $\phi'=21^\circ$ as shown in figure 7. Residual shear strength parameters, were obtained from ring shear tests (Broamhead ring shear apparatus) which yielded values of $c_r'=0$ and $\phi_r'=21^\circ$. The values of the residual angle of shearing resistance determined directly by the ring shear tests are compared with the dataset presented by Skempton (1985) (Figure 8) and are found to be in the upper bound of the scatter. This is probably due to the fact that the particular ring shear tests were carried out on fairly silty samples (classified as MH) and not on clayey ones.

Figure 7. Shear box and ring shear test results on soil samples from the weathered marl horizon. Peak strength $c'=30$ kPa, $\phi'=21^\circ$. Residual strength $c_r'=0$ kPa $\phi_r'=21^\circ$.

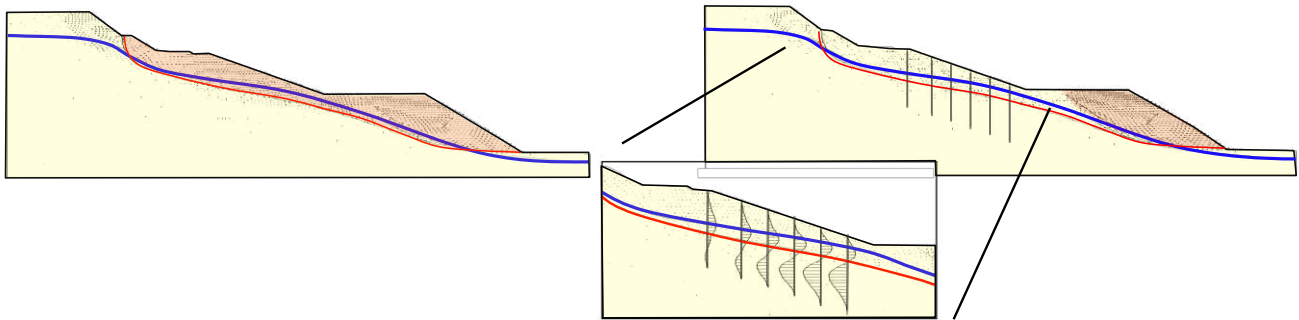
The construction of the toe buttress and the trimming of the upslope area of the landslide, lead to sufficient factors of safety (FOS=1.6) under normal conditions (low water table, static conditions), which though drop to low values with an elevated water table and very low values under seismic conditions. It was also observed that these low factors of safety are associated with mobilization of the entire sliding mass. The dowelling effect of the bored piles isolates and stabilizes the upper part of the sliding mass, while the lower part may remain more critical but still with sufficient FoS. Figure 17 depicts the critical sliding mode with and without the dowelling piles. In this case the raised water table yield a FOS = 1.6 and the seismic analysis a FOS=1.15.

Figure 17. Stability analysis of the remediated slope. Left: Without the stabilization piles the entire sliding mass mobilizes as a single body. Right: With the addition of the piles the toe buttress is more critical.
