A High Rock Cut Stabilization in Muscat City, Oman

Reference: Hayat, T.M., Bhatti, T.J. and Goldsmith, R. (2017). *A High Rock Cut Stabilization in Muscat City, Oman*.

International Journal of Geoengineering Case histories, <http://casehistories.geoengineer.org>, Vol.4, Issue 2, p.96-112.

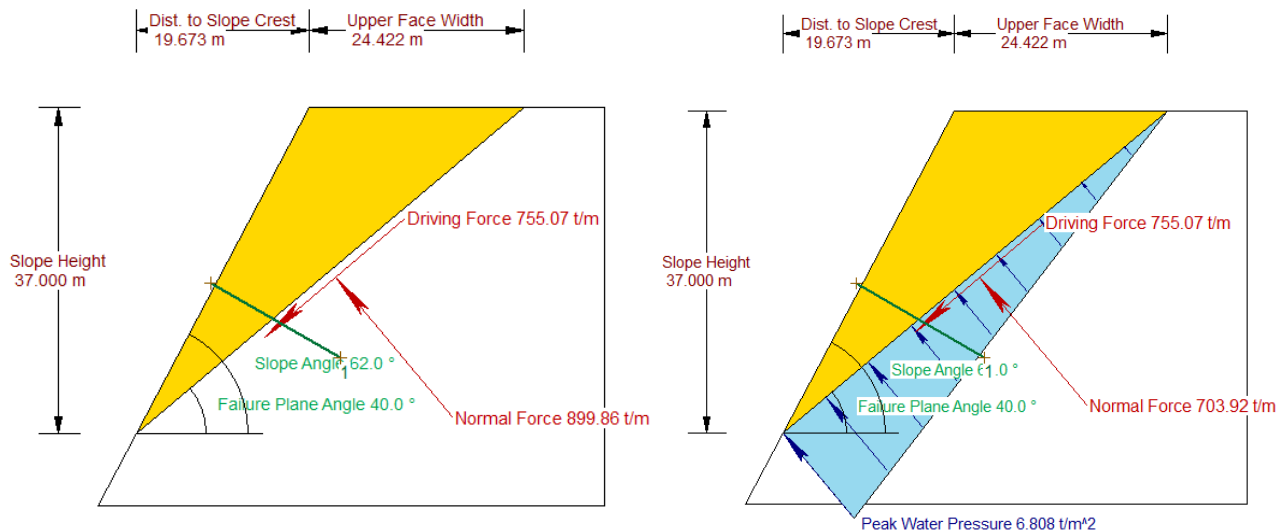
Figure 9. The driving and resisting forces against the calculated FOS 1.12 and 1.01 for dry and wet slope (15 m water head) respectively.

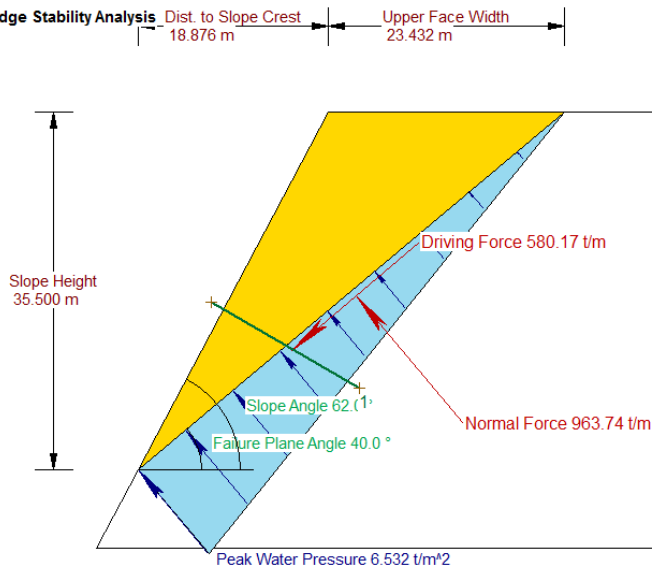
Figure 12. Factor of Safety (FOS) in wet condition under 15 m water head and 3360 KN/m external force applied through designed cable anchors.

After several trials using different applied normal stresses on the failure plane, seven strand anchors of 1200 KN working load at 2.5 x 2.5 m grid (3400 KN/m) for a 35 m high slope were selected. The results of factor of safety using the 1200 KN anchors on the deep sliding planes are presented in Figures 11 to 14 and are summarized in Table 3.

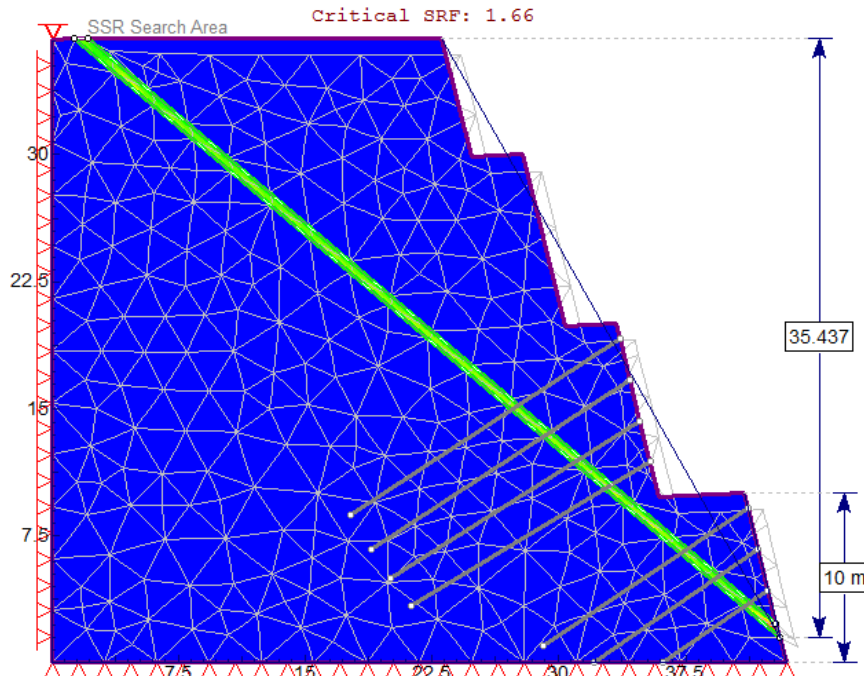
Figure 13. Deformed Mesh for the SRF =1.72 (in dry conditions) for which no FEA convergence occurred. The critical SRF for which the FEA satisfied the condition of equilibrium with 7 strand anchors of 1200 KN (2.5 x 2.5 m grid) is 1.66 as shown.
