A High Rock Cut Stabilization in Muscat City, Oman

Reference: Hayat, T.M., Bhatti, T.J. and Goldsmith, R. (2017). *A High Rock Cut Stabilization in Muscat City, Oman*.

International Journal of Geoengineering Case histories, <http://casehistories.geoengineer.org>, Vol.4, Issue 2, p.96-112.

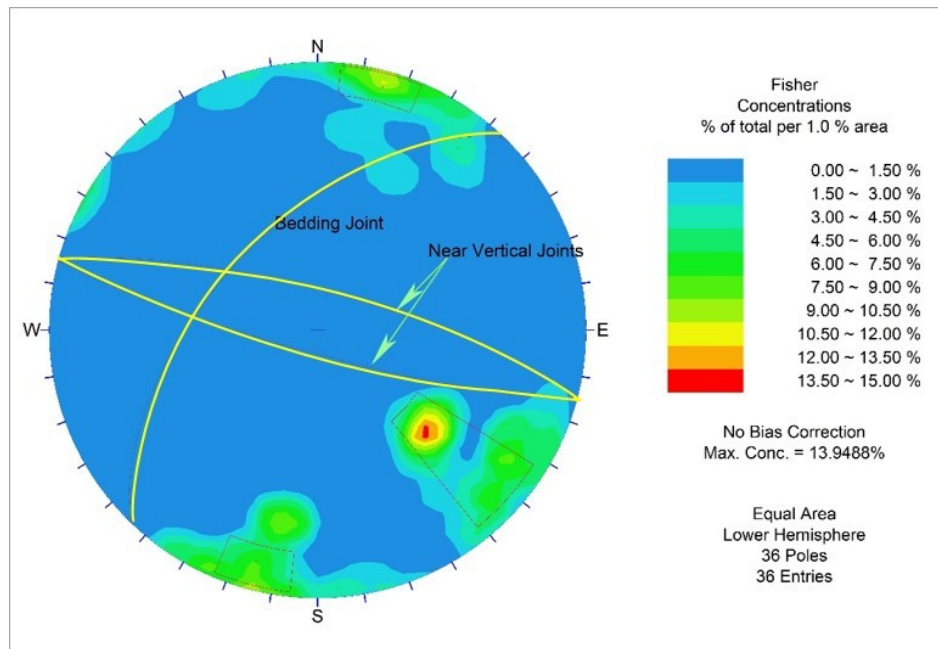
In Box Cut #1, from approximately RD 0+220 to 0+500 m, the interlayering of the beds is quite prominent and dips at 30° to 45° daylighting out of the face and within +/- 20° of the face orientation. In addition to the bedding, there are joints and faults that are steeply dipping at 70° to 90° and strike NE-SW or SSW. These joints have high persistence over all cut benches to the full 40 m height. Some of these features are faulted with noticeable displacements. Figure 5 shows the pole plot of the joints and great circles drawn through the centre of poles concentration by visual examination.

Figure 5. Stereoplot of the discontinuities representing the left slope in Box Cut 1.

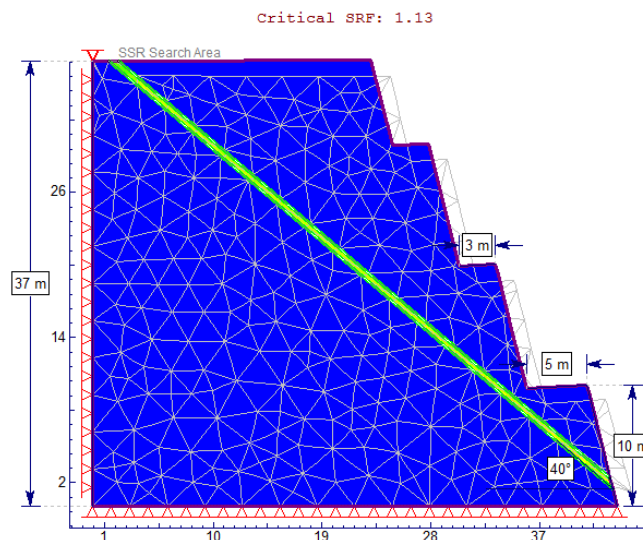
From the table above, it is can be observed that the Factors of Safety from the three approaches used are in general agreement. Figure 10 below shows the exaggerated deformed FE mesh of the upper sliding block for the $SRF = 1.2$ (In Dry Condition) for which no FEA convergence occurred.

Figure 10. Deformed mesh for the $SRF = 1.2$ (in dry conditions) for which no FEA convergence occurs. The maximum SRF for which the FEA satisfies the state of equilibrium is 1.13.

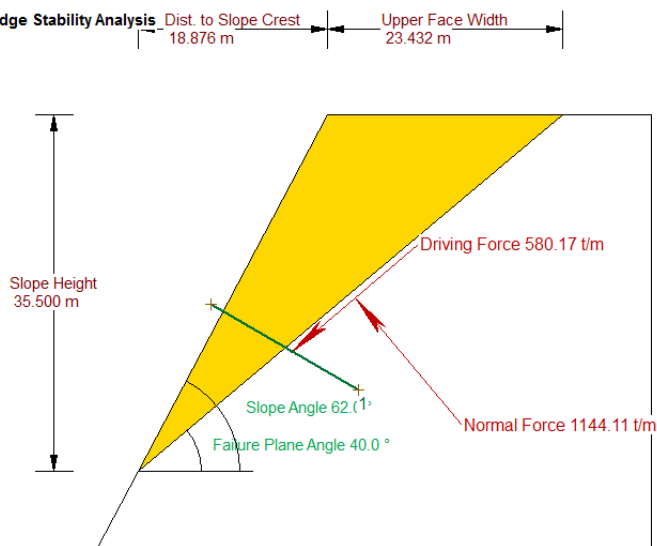
Figure 11. Factor of Safety (FOS) in dry condition with 3360 KN/m external force applied through designed cable anchors.

After several trials using different applied normal stresses on the failure plane, seven strand anchors of 1200 KN working load at 2.5 x 2.5 m grid (3400 KN/m) for a 35 m high slope were selected. The results of factor of safety using the 1200 KN anchors on the deep sliding planes are presented in Figures 11 to 14 and are summarized in Table 3.
