A High Rock Cut Stabilization in Muscat City, Oman

Reference: Hayat, T.M., Bhatti, T.J. and Goldsmith, R. (2017). *A High Rock Cut Stabilization in Muscat City, Oman*.

International Journal of Geoengineering Case histories, <http://casehistories.geoengineer.org>, Vol.4, Issue 2, p.96-112.

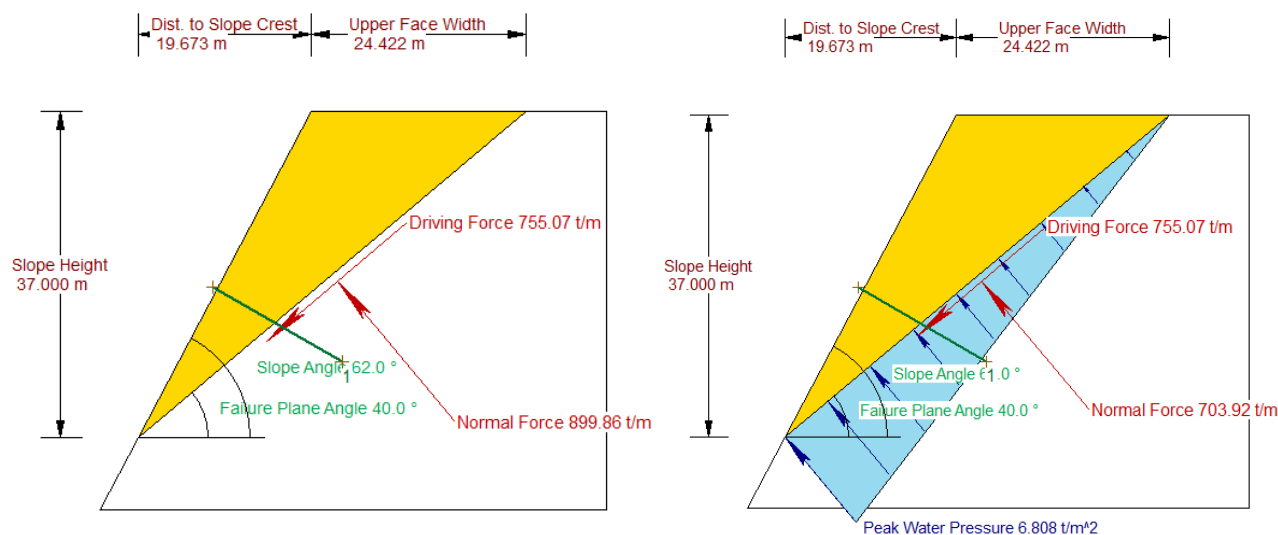
Figure 9. The driving and resisting forces against the calculated FOS 1.12 and 1.01 for dry and wet slope (15 m water head) respectively.
