Geotechnical Damage Caused by the 2016 Kumamoto Earthquake, Japan

KEYWORDS: 2016 Kumamoto earthquake, damage survey, liquefaction, embankment, landslide, volcanic soil

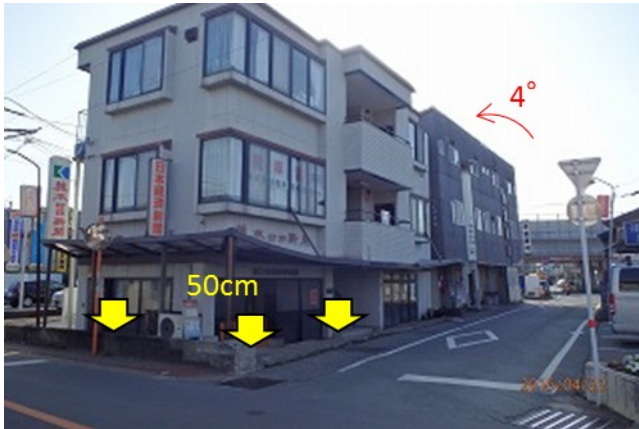
Figure 4 shows the liquefaction-induced damage to buildings in Karikusa district (site 1). The building suffered from significant settlement of about 50 cm. The adjacent building also suffered from a tilting of about four degrees. Similar damage to residential houses was observed in Majima district (Figure 5, site 2) which is a reclaimed land along the river. In addition, liquefaction as evidenced by sand boils present in Kumamoto Port, however, the liquefaction-induced damage to major facilities was not reported. As a whole impression of liquefaction during the Kumamoto earthquake, the number of damaged buildings and facilities was much fewer than in the Kanto region during the 2011 Off Pacific Coast of Tohoku Earthquake (Yasuda et al., 2012; Towhata et al., 2014).

Figure 4. Liquefaction-induced damage to buildings in Karikusa district (Site 1 in Fig. 3) ($32^{\circ} 45'35.70''N$, $130^{\circ} 40'59.76''E$).

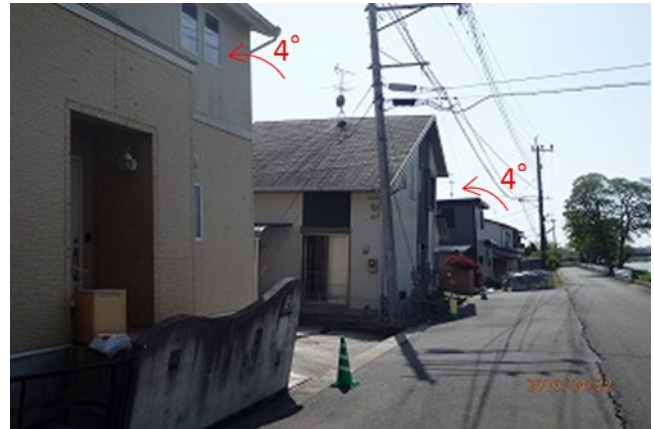
Figure 5. Liquefaction-induced damage to residential houses in Majima district (Site 2 in Fig. 3) ($32^{\circ} 45'52.69''N$, $130^{\circ} 46'7.49''E$).

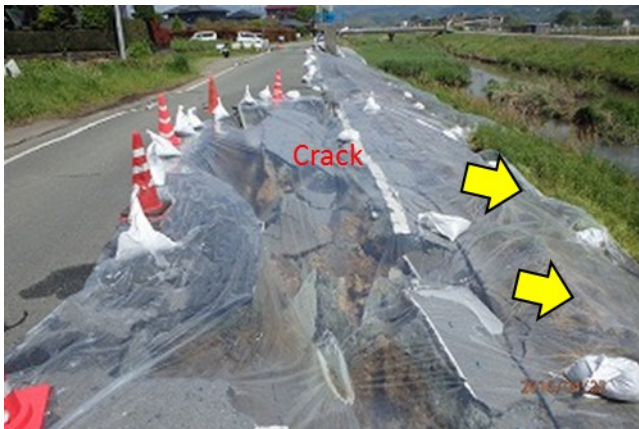
Figure 6 shows the typical liquefaction-induced damage to a river levee (site 3). Large settlement and lateral deformation was found at the levee along Akitsukawa-River. According to a landform classification map for flood control, provided by Geospatial Information Authority of Japan (GSI) shown in Fig. 7, the damaged levee is located at the old river channel, which suggests that a shallow soft deposit liquefied, inducing lateral spreading toward the river. Kyushu Regional Development Bureau of MLIT (2016) reported damage of variable severity to the levees of the Midorikawa-River and Shirakawa-River. They identified a total of 171 sites, however, their emergency restoration was almost completed as of middle of May. The settlement of levees, for example, caused a large gap between the embankment and bridge girders leading to a transportation problem (Figure 8, site 4). As of the end of April, such problems have occurred at many locations, however, they have been temporally solved by the installation of a filled slope (Figure 9, site 5). Although the locations of liquefaction are widespread in Kumamoto City (Wakamatsu et al., 2016), there have been no official report of serious liquefaction-induced damage; there are neither collapse of buildings nor washout of levees due to liquefaction.

Figure 6. Liquefaction-induced damage to levee along Akitsukawa-River (Site 3 in Figs. 3 and 7) ($32^{\circ} 46'43.56''N$, $130^{\circ} 47'40.27''E$).

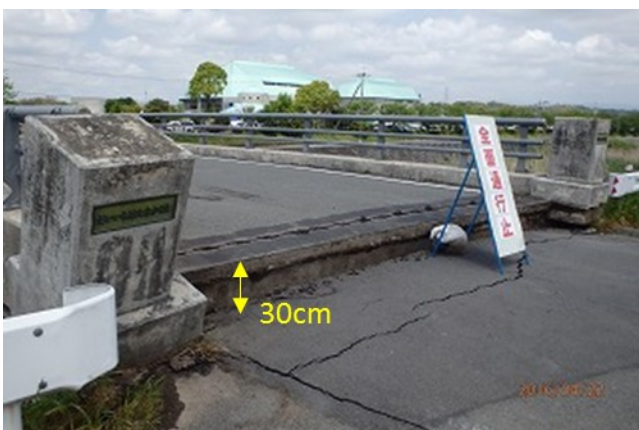
Figure 8. A large gap at bridge girder due to settlement of embankment (Site 4 in Fig. 3) ($32^{\circ} 47'2.15''N$, $130^{\circ} 49'17.70''E$).

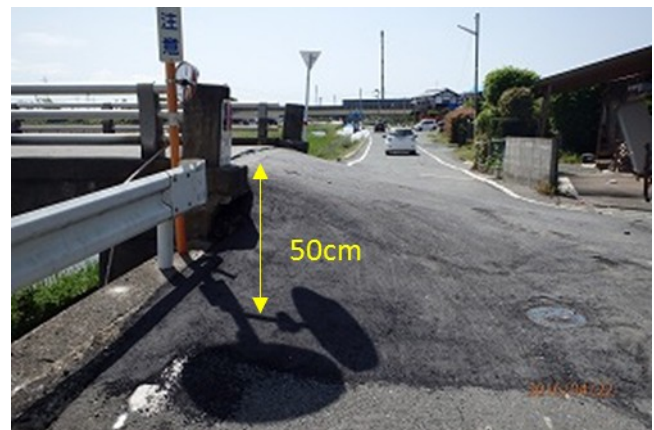
Figure 9. Temporary restoration work (filled slope) for settlement of levee (Site 5 in Figs. 3 and 7) ($32^{\circ} 46'44.47''N$, $130^{\circ} 47'45.43''E$).

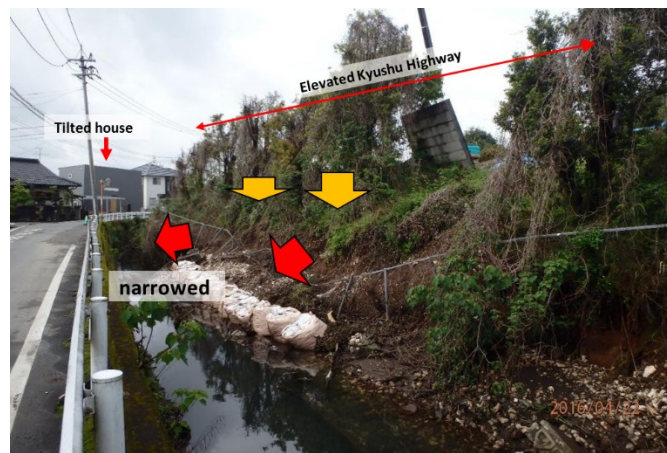
At site 6 in Fig. 3, a 50 m-long embankment on one side of Kyushu Highway, which connects Fukuoka to Kagoshima, suffered from significant damage (Fig. 10). The damage was caused by the earthquake on the 14th of April, in the form of subsidence and lateral flow. The highway was closed to traffic until the end of April, which disrupted emergency distributions in the affected areas. According to the land classification map (Fig. 7) and old aerial photos taken before the construction of the highway provided by GSI (2016) (Fig. 11), the exact location of the damaged embankment used to be a small river channel, which suggests that the process of liquefaction of saturated loose filled soil was the potential cause of damage to the embankment. In fact, the residential house near the damaged embankment suffered from large tilting as shown in Figure 10, indicating a bearing capacity lowering of foundation ground due to liquefaction.

Figure 10. Damage to Kyushu Highway embankment (Site 6 in Figs. 3 and 7) ($32^{\circ} 46'46.80''N$, $130^{\circ} 47'39.40''E$).

Since the other side of the embankment survived the earthquake, as an emergency response, the number of driving lanes at the damaged embankment was temporarily reduced to one in each direction, and only the one-lane reopened from the 29th of April. Due to the critical importance of the Kyushu Highway, however, careful investigation shall be conducted to thoroughly understand the cause of the damage observed and to propose effective countermeasures for the conclusive restoration of the embankment.

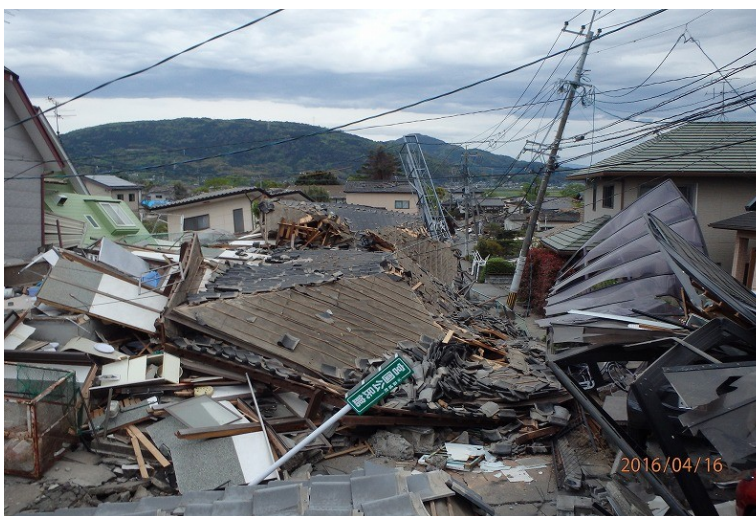
There were numerous building collapses in Mashiki Town. Fig. 13 shows the typical damage to the residential houses in the yellow-colored area in Fig. 12 (site 7). The residents in the affected area reported that a number of houses suffered from moderate to significant structural damage due to the earthquake on the 14th of April and then totally destroyed by the main shock on the 16th. It is also reported that the number of deaths in this area was fewer than expected from the damage shown in Fig. 13 because many affected residents had already fled their damaged house after the earthquake of the 14th (Fukuwa, 2016).

Figure 13. Damage to residential houses in Mashiki Town (Site 7 in Fig. 12)
($32^{\circ} 47'16.38''N$, $130^{\circ} 48'58.47''E$).

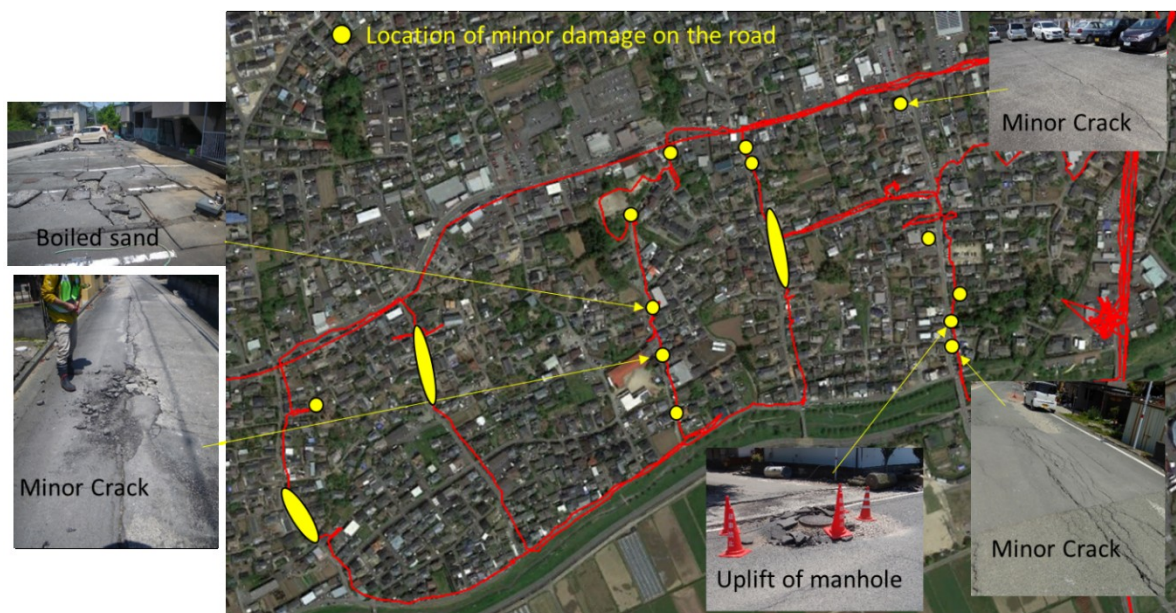
Figure 15 shows the result of the authors' quick survey. The spatial distribution of the collapsed houses was concentrated in the sloped area which consists of terrace and talus deposits, whereas ground deformation observed on the roads near the damaged houses was limited, therefore a large scale landslide might not have occurred. The cause of significant damage to the houses in this area was likely due to earthquake motion and the residual displacement of the entire sloped ground had an insignificant effect on the damaged houses. Although some houses were found to be damaged by ground deformation, as shown in Fig. 16 and 17 (sites 8 and 9), they were likely caused by localized failure of filled soil. On the other hand, the damage to the houses in the alluvial deposit area was limited whereas evidence of liquefaction was found frequently as shown in Fig. 15. It is inferred that the liquefied soil incidentally behaved like a seismic isolation system for the residential houses in this area.

Figure 15. Result of survey on ground deformation of sloped residential area in Mashiki Town (c.f. Figs. 12 and 14).

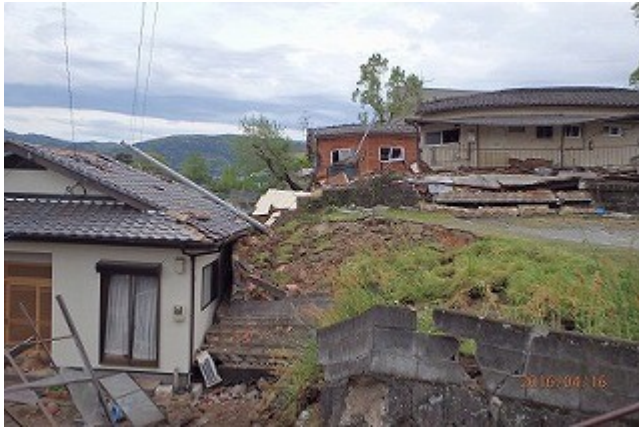
Figure 16. Ground displacement-induced damage to a residential house (Site 8 in Fig. 12) ($32^{\circ} 47'24.96''N$, $130^{\circ} 49'12.75''E$).

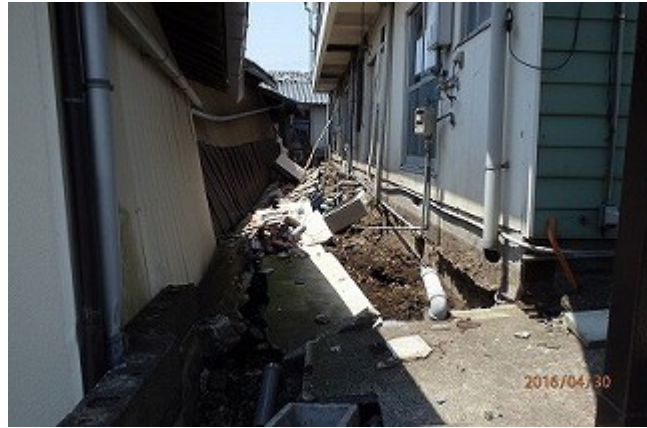
Figure 17. Ground displacement-induced damage to a residential house (Site 9 in Fig. 12) ($32^{\circ} 47'14.48''N$, $130^{\circ} 48'41.06''E$).

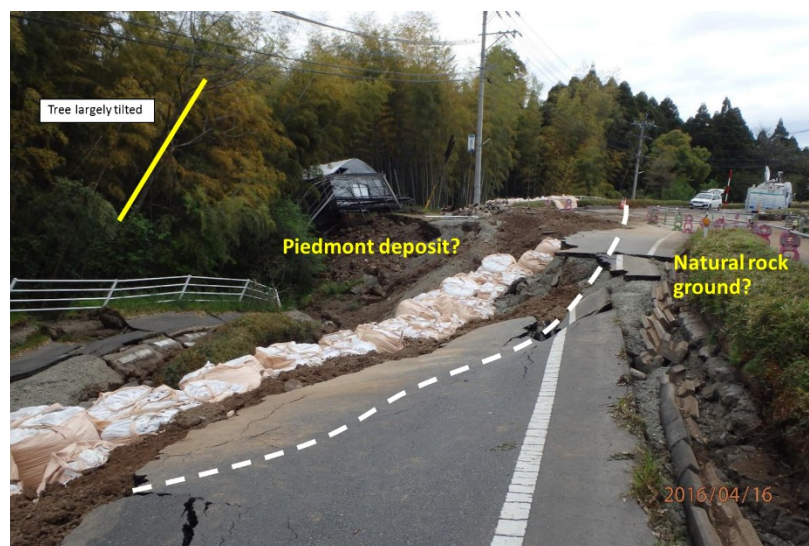
A section of Route 443 at site 10 in Fig. 12 was damaged by the earthquake on the 14th of April. The road on the left side in Fig. 18 failed and subsided by a maximum of about 2.0-2.5 m. The photo also shows the significantly tilted trees at the middle portion of the sliding mass. At the time of the survey on the 16th of April, two days after the occurrence of failure, large soil bags were placed on the exposed failure surface to prevent further damage. According to the landform classification map shown in Fig. 14, the failure was likely to have occurred in the talus deposit and the perimeter of the failure is likely to be the boundary between talus deposit and late Pleistocene volcanic rock.

Figure 18. Damage to Route 443 in Mashiki Town (Site 10 in Figs. 12 and 14) ($32^{\circ} 47'29.71''N$, $130^{\circ} 49'17.58''E$).

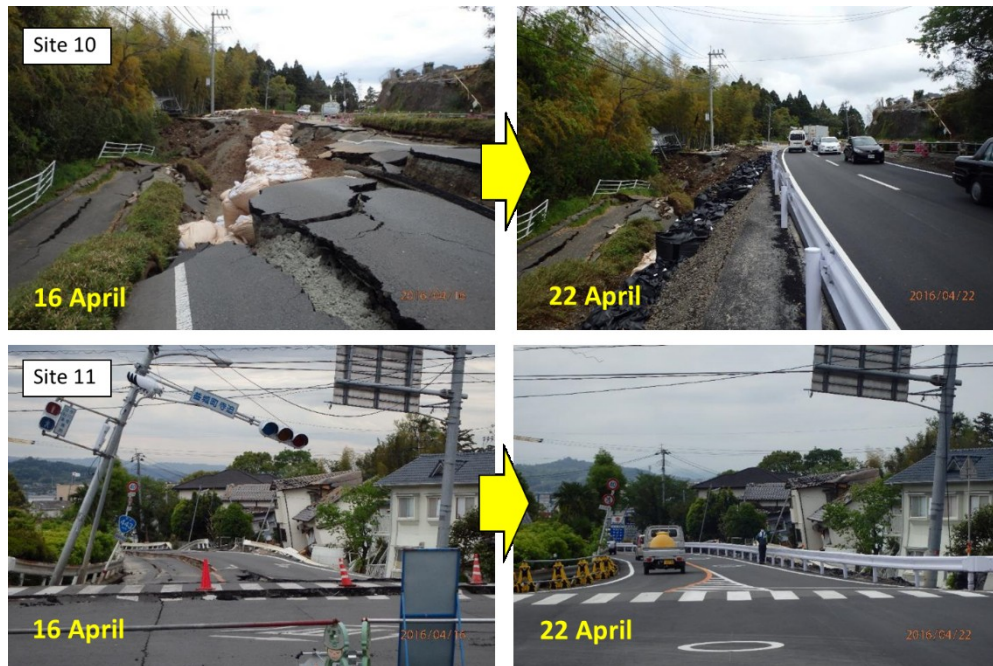
Approximately 150 m south of the above damaged site a differential settlement was observed (Photo 12b, site 11). According to the landform classification map in Fig. 14, it is indicated that the damaged site was recently constructed on the alluvial soil deposit. The damage, therefore, is attributed to strength reduction of foundation ground due to a process of liquefaction and/or that of the embankment, if the compaction work was inadequate. Immediately after the earthquake, emergency restoration work was rapidly conducted in the affected areas. As shown in Fig. 19, the restoration work for the damaged sites along Route 443 was completed a few days after the main shock.

Figure 19. Damages to Route 443 and their restoration for (a) site 10 and (b) site 11 (c.f. Figs. 12 and 14) (Site 10: $32^{\circ}47'29.71''N$, $130^{\circ}49'17.58''E$, Site 11: $32^{\circ}47'24.33''N$, $130^{\circ}49'15.82''E$).

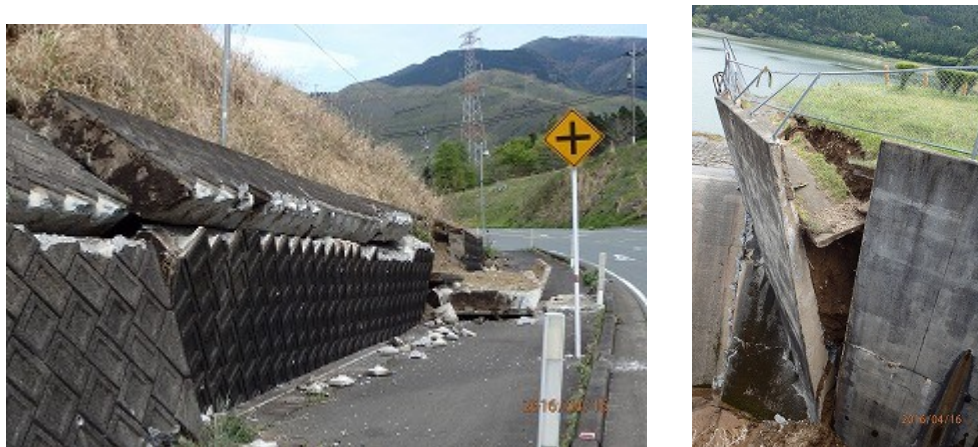
Mashiki and the surrounding areas were close to the seismic fault and suffered from a variety of geotechnical and structural damage due to the earthquakes. Damage to gravity-type and cantilever-type retaining walls (2-3 m high) was found at several locations due to surface manifestation of fault rupture. The retaining wall and dam spillway retaining wall at site 12 in Fig. 12 were structurally damaged as a result of the fault movement (Fig. 20).

Figure 20. Damage to retaining wall and spillway retaining wall (site 12 in Fig. 12) ($32^{\circ}50'29.22''N$, $130^{\circ}55'55.83''E$).

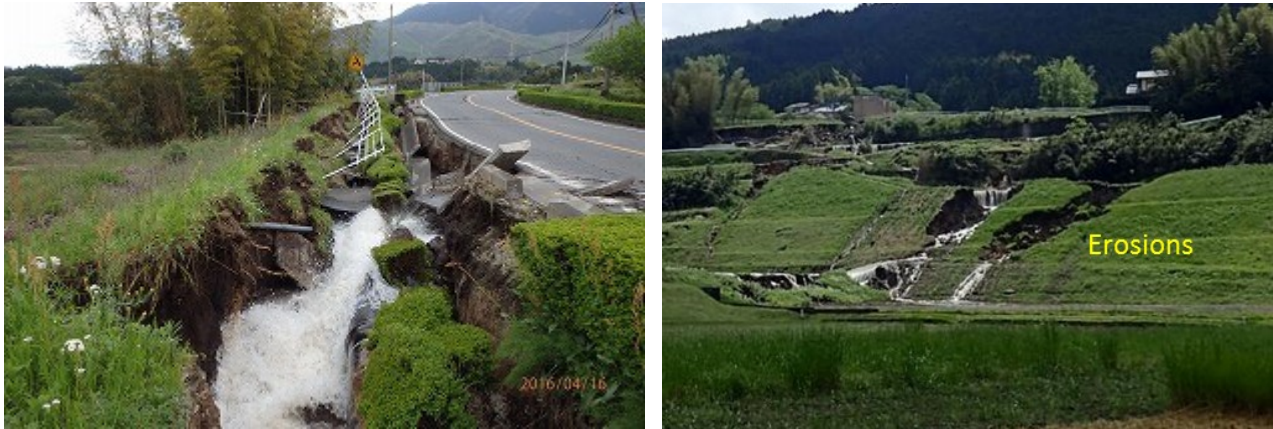
Along the prefectural road No. 28 a section built upon an embankment suffered from major cracks, settlement and outward deformation as shown in Fig. 21 (site 13). The deformation of the embankment caused damage to a water pipeline followed by a water leak which resulted in significant erosion of the embankment. A large slope failure was observed at site 14; the length of the slope failure was about 130 m. The surface of the slope has been protected by a shotcrete with a thickness of 5-10 cm. The fallen boulders and debris which consist of late Pleistocene volcanic rocks (rhyolite and dacite) blocked the road completely (Fig. 22).

Figure 21. Damage to road embankment along prefectural road No. 28 (site 13 in Fig. 12) ($32^{\circ}50'36.63''N$, $130^{\circ}55'24.48''E$).

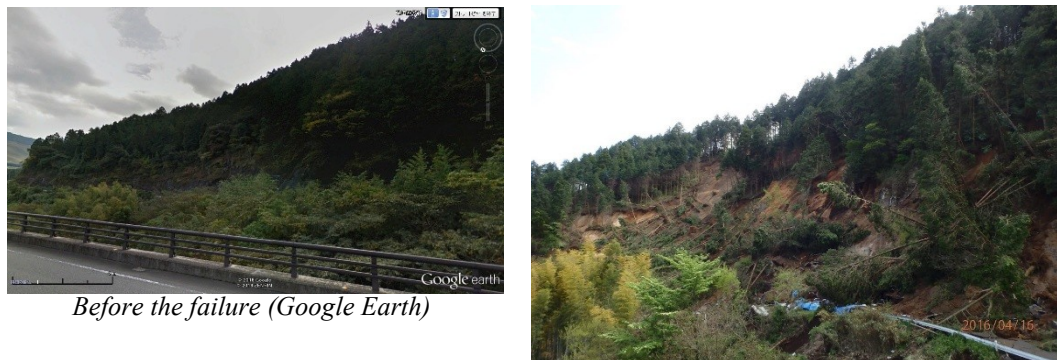
Figure 22. Slope failure along prefectural road No. 28 (site 14 in Fig. 12) ($32^{\circ}50'32.96''N$, $130^{\circ}55'40.65''E$).

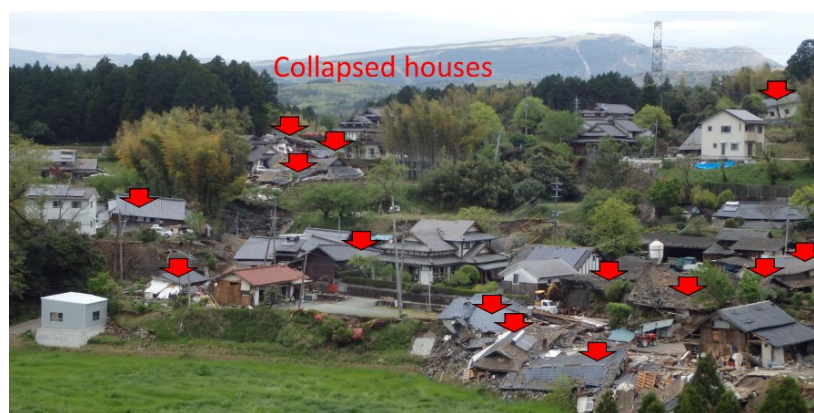
A number of residential houses along road No. 28 suffered from significant damage. As shown in Fig. 23, high collapse ratio of houses can be seen in the small village (site 15). In addition, modern bridges and a tunnel along road No. 28 suffered from serious damage. The girder of Ohkiri-hata Bridge moved about 1-1.5m and fell off its rubber bearings (Fig. 24, site 14). About 4 km north-east of Ohkiri-hata Bridge, Tawarayama tunnel suffered from a compressive axial failure and falling of lining concrete about 250 m from the tunnel portal (Fig. 25, site 16). The cause of compression of the tunnel was thought to be a surface fault movement in right lateral component, which was confirmed at the damaged location (Shirahama et al., 2016; Yoshimi, 2016). More information about the structural damages along road No. 28 due to the earthquake is reported in a separate report (Ikeda, et al., 2016).

Figure 23. Damage to residential houses in Ohkiri-hata area (site 15 in Fig. 12) ($32^{\circ}50'36.91''N$, $130^{\circ}55'43.16''E$).

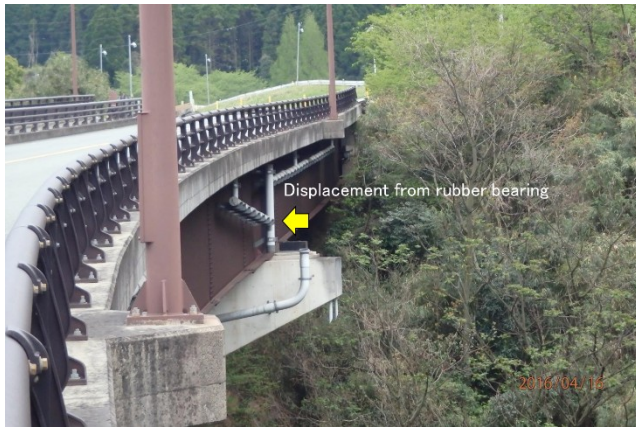
Figure 24. The girder of Ohkirihata Bridge moved about 1-1.5m (Site 14 in Fig. 12) ($32^{\circ} 50'32.63''N$, $130^{\circ} 55'43.10''E$).

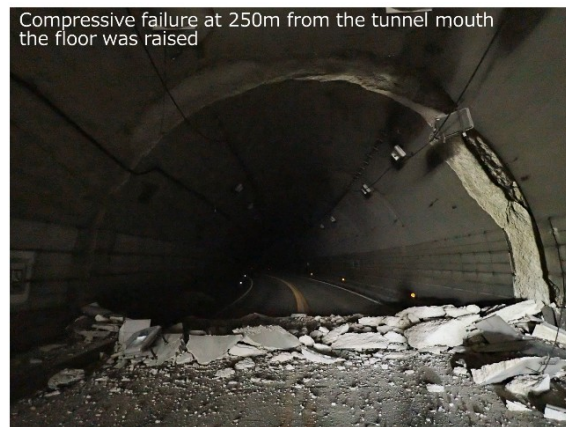
Figure 25. Tawarayama tunnel suffered from axial compression failure (Site 16 in Fig. 12) ($32^{\circ} 51'35.68''N$, $130^{\circ} 58'6.86''E$).

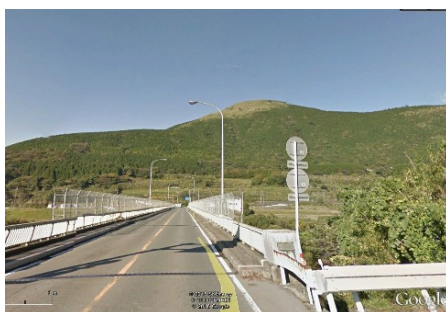
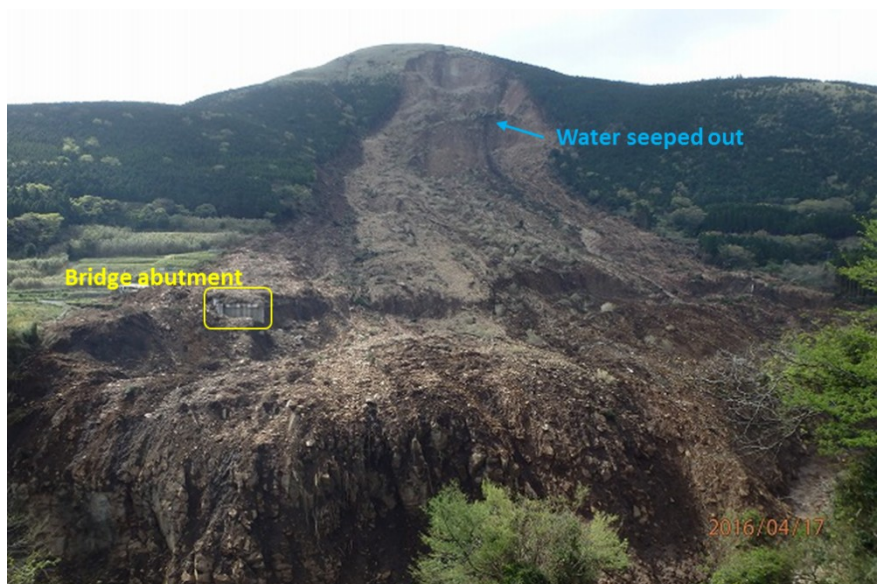
Figure 28 shows a shallow landslide near Aso Ohashi Bridge caused by the main shock on the 16th of April (site 17). The landslide had a height of about 300 m (measured from the road level to the scrap) with an inclination angle of about 50 degrees at the top and about 25 degrees at the middle and bottom of the slope. The debris was a mixture of middle Pleistocene volcanic soils and boulders (tuff breccia); Route 57 and JR Hohi Main Line (railway) was also covered by it. The debris travelled a distance exceeding 800 m and fell into the Kurokawa-River along with Aso Ohashi Bridge. Evidence of mud debris was found on the opposite side of the river which is thought to have travelled along the bridge before its collapse. For this reason, the cause of bridge failure is considered to be the impact force and/or weight of debris that flowed down from the landslide source. Moreover, in Figure 28, taken one day after the event, water seeped out from the failed surface, which may explain the reduction of shear strength of the slope ground due to increase in excess pore water pressure during the intense earthquake.

Figure 28. Landslide near Aso Ohashi Bridge (site 17 in Fig. 26).
(32° 53'0.02"N, 130° 59'22.80"E).

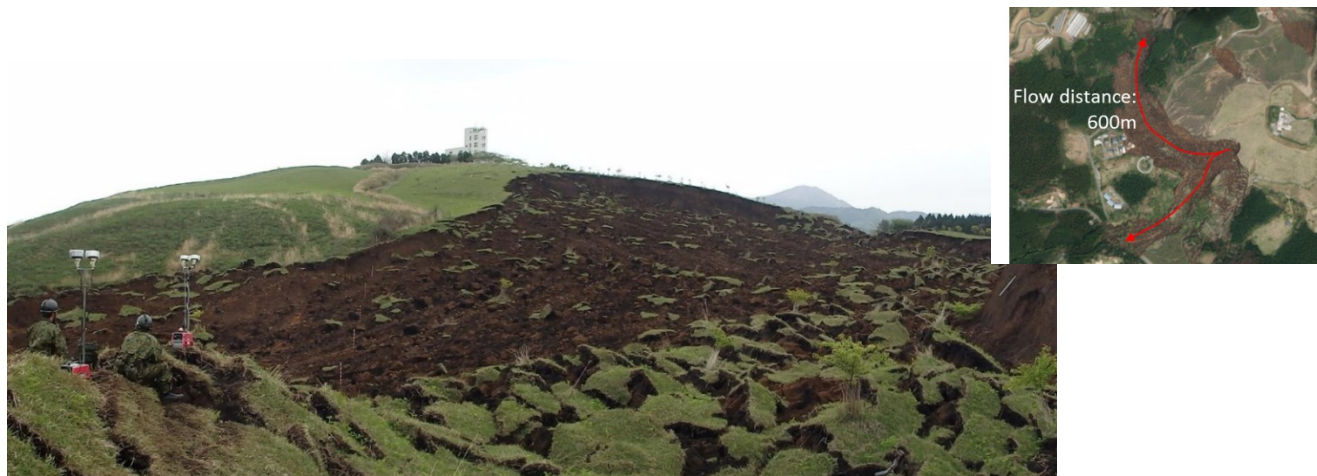
At site 18 in Fig. 26, a large scale landslide occurred at a volcanic hill (late Pleistocene) with a height in excess of 80 m from its base. The failure occurred on a relatively gentle slope with an angle of less than 10 degrees. The sliding of the slope towards the toe, however, was remarkable as shown in Figure 29. This failure killed five people who were in the house at the middle of the slope. A few hundred meters south of the above landslide another landslide occurred and caused severe damage to the residential houses as shown in Figure 30 (site 19). The length of the landslide was 70 m with an inclination angle of about 10 degrees. As the Kumamoto earthquake is an inland earthquake which caused severe damage in the mountain area, it is often compared with the 2004 Chuetsu earthquake (M_w 6.6) which hit Niigata Prefecture, Japan, and caused a number of landslides (Toyota et al., 2006). Slope failures triggered by the Chuetsu earthquake occurred at a sedimentary rock interface, and the slope angle before the failure was about 20 degrees on average (Yamasaki, 2008), which is much steeper than the cases in the Aso mountain area in the Kumamoto earthquake. The debris of the landslides in Aso Caldera area was a mixture of volcanic ash, andsol, a highly porous dark-colored material comprising of volcanic ash mixed with organic matter, and pumice. As shown in Figure 30, alternating layers were seen at the surface of the scrap. The cause of failure and long-distance flow at the gentle slope is not identified yet, however, since the natural deposited pumice is known to have high crushability, the soil may have experienced significant strength reduction associated with particle breakage during the earthquake.

Figure 29. Large scale landslide in Aso Caldera area (site 18 in Fig. 26) ($32^{\circ} 53'5.47''N$, $131^{\circ} 00'10.56''E$).

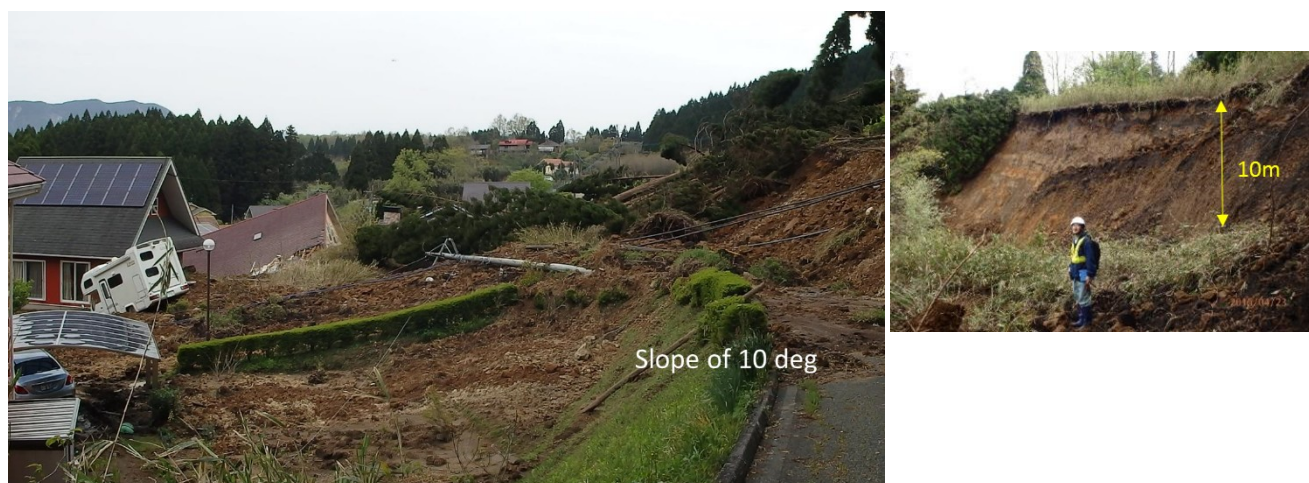
Figure 30. Landslide at gentle slope and its scrap (site 19 in Fig. 26) ($32^{\circ} 52'29.42''N$, $131^{\circ} 00'49.36''E$).

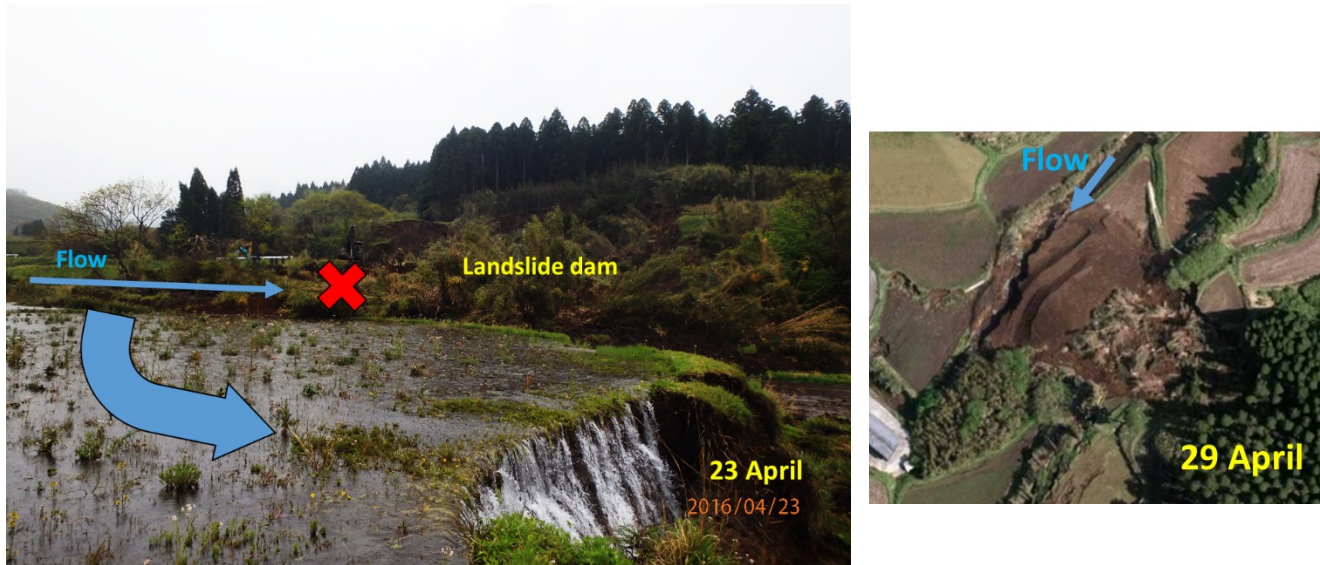
A slope failure was observed at site 20 in Fig. 26; the length of the failure was about 100 m. The debris blocked the road and a tributary of the Kurokawa River completely; the blocked tributary overflowed with water spreading into the surrounding paddy field (Figure 31). To avoid the potential risk of flooding to the downstream villages following the landslide dam breaching, the relevant authority had excavated a spillway to secure the safety of the dam. The excavation was likely finished within two weeks of the event.

Figure 31. Landslide dam formed by the earthquake and excavation work completed (site 20 in Fig. 26) ($32^{\circ} 53'14.06''N$, $130^{\circ} 59'48.90''E$).

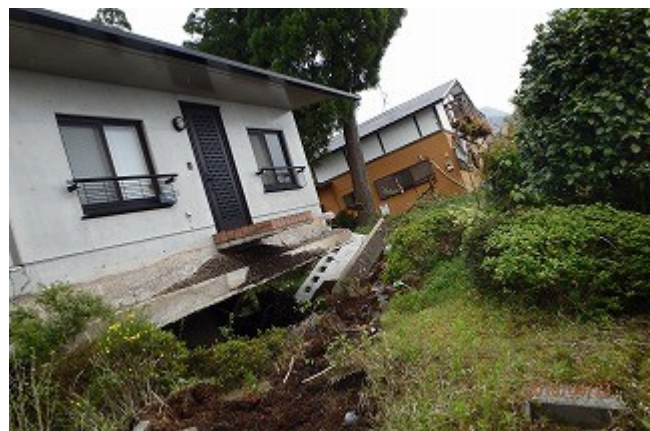
Figure 32 and 33 show damage of the road and house at site 21. Although this area reportedly survived the earthquake on the 14th of April, significant distortion of subsurface ground occurred during the main shock on the 16th of April. The spatial distribution of damage was severe at the northern part of the residential area. Figure 34 shows a comparison of aerial photos taken in 1975 and in 2016 (GSI, 2016), indicating that the damaged area used to be a paddy field but had subsequently been infilled during the construction of the housing estate. The filled soil in the damaged area is a local volcanic ash soil. Tanoue et al. (2005) reported that it is usually hard to construct a stable embankment from the ash deposited in the Central Kyushu area. It seems from Fig. 34 that the ground level of the northern part of the residential area was comparatively low in 1975, the filled soil might have been thicker for the northern side than the southern side. This might be why the earthquake-induced damage to the land was found to be severe in the northern side, however, structural damage to the residential houses in this area was negligible despite large ground deformation.

Figure 33. Damage to the house in residential area developed by filling (Site 21 in Fig. 26) ($32^{\circ} 52'45.06''N$, $131^{\circ} 00'1.44''E$).

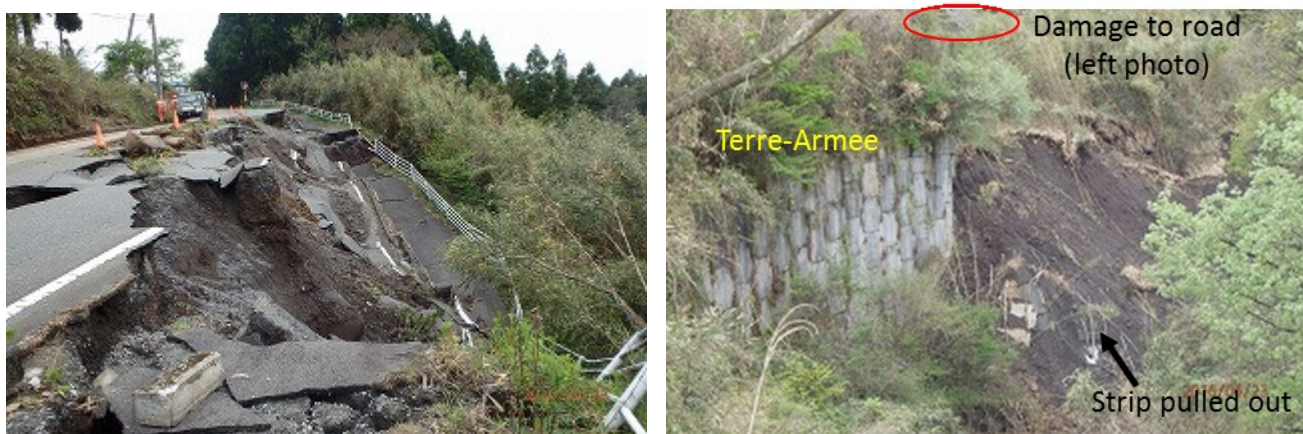
A 50 m-long embankment on prefectural road No. 149 (site 22 in Fig. 26) suffered from damage in the form of slope failure. Ground fissures and road pavement damage were also found there. This embankment (about 10-15 m high) was constructed along the small river by using a reinforced soil retaining wall technique (Terre-Armee), the wall was also damaged significantly as shown in Figure 35. Steel strip materials pulled out from the backfill soil were found on the failed slope surface. The reason for the failure of the reinforced soil retaining wall is not yet identified.

Figure 35. Damage to road embankment and reinforced retaining wall (Terre-Armee) (site 22 in Fig. 26) ($32^{\circ} 52'52.01''N$, $131^{\circ} 00'14.84''E$).

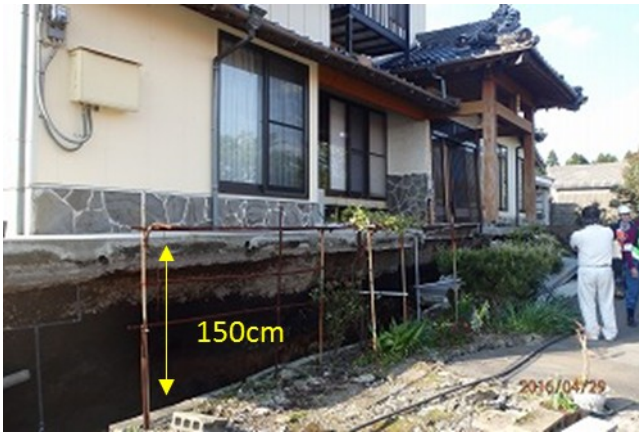
A trough-like depression was found at several locations in the basin of Aso Caldera. According to both the authors' site investigation and aerial photointerpretation of cracks on ground surface provided by the GSI (2016) and Kokusai Kogyo co. Ltd (2016), the trough-like depression, with a maximum depth of about 1-1.5 m, was found to stretch several kilometers in length, the width of the depression was several tens of meters. At site 23, the ground depression caused damage to a residential house (Fig. 36). The damage due to the depression has also been harmful to agriculture in this area (Figure 37). The mechanism of the depression, however, is not yet identified. The residents in the affected area reported that the depression occurred immediately when the main shock occurred on the 16th of April. The fact indicates that the cause of the depression was probably not liquefaction. Refer to a separate report by Konagai et al. (2016) for further information about this feature.

Figure 36. Ground depression-induced damage to the residential house (Site 23 in Fig. 26) ($32^{\circ} 57'23.84''N$, $131^{\circ} 2'12.31''E$).
