# Geotechnical Damage Caused by the 2016 Kumamoto Earthquake, Japan

**ABSTRACT:** On the 16<sup>th</sup> of April 2016, the Kumamoto earthquake ( $M_w$  7.0) hit the Central Kyushu Region, Japan, following a  $M_w$  6.2 shock on the 14<sup>th</sup> of April. The earthquake sequences caused severe damage in Kumamoto Prefecture. This paper presents quick reconnaissance results focusing on geotechnical damage features, which were observed during field investigations immediately after, one, and two weeks after the main shock. The damage surveys were carried out in southern Kumamoto City, Mashiki Town, Aso Caldera area and their suburbs. In southern Kumamoto City, evidence of liquefaction was found at many locations, and some buildings and river levees suffered from significant settlement and deformation; damage to an embankment of Kyushu Highway also seemed to be the result of liquefaction. The majority of the damaged residential houses were found in Mashiki Town and its suburbs, which may be linked to intense earthquake motions associated with the seismic fault location. In Aso Caldera area, a number of moderate to large scale landslides and their significant impact to structures wer

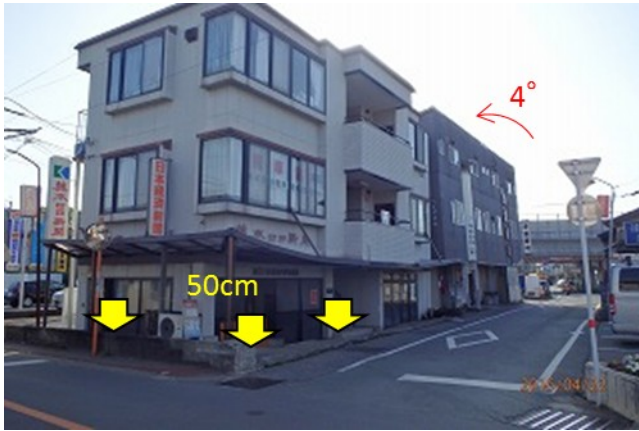
Figure 4 shows the liquefaction-induced damage to buildings in Karikusa district (site 1). The building suffered from significant settlement of about 50 cm. The adjacent building also suffered from a tilting of about four degrees. Similar damage to residential houses was observed in Majima district (Figure 5, site 2) which is a reclaimed land along the river. In addition, liquefaction as evidenced by sand boils present in Kumamoto Port, however, the liquefaction-induced damage to major facilities was not reported. As a whole impression of liquefaction during the Kumamoto earthquake, the number of damaged buildings and facilities was much fewer than in the Kanto region during the 2011 Off Pacific Coast of Tohoku Earthquake (Yasuda et al., 2012; Towhata et al., 2014).

Figure 4. Liquefaction-induced damage to buildings in Karikusa district (Site 1 in Fig. 3) ( $32^{\circ} 45'35.70''N$ ,  $130^{\circ} 40'59.76''E$ ).

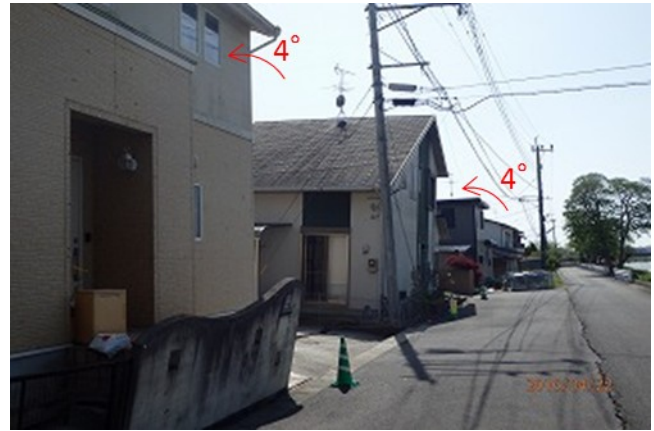
Figure 5. Liquefaction-induced damage to residential houses in Majima district (Site 2 in Fig. 3) ( $32^{\circ} 45'52.69''N$ ,  $130^{\circ} 46'7.49''E$ ).

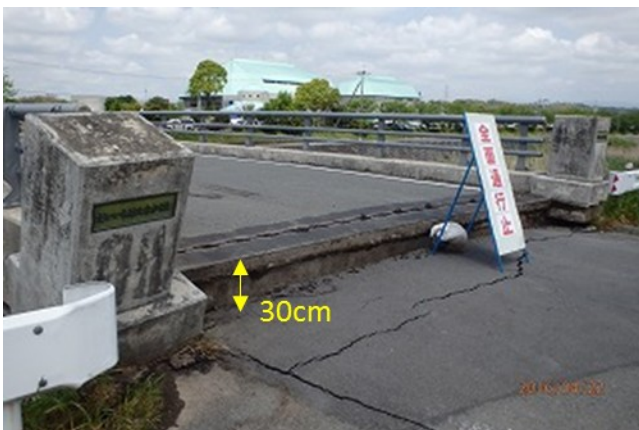
Figure 8. A large gap at bridge girder due to settlement of embankment (Site 4 in Fig. 3) ( $32^{\circ} 47'2.15''N$ ,  $130^{\circ} 49'17.70''E$ ).

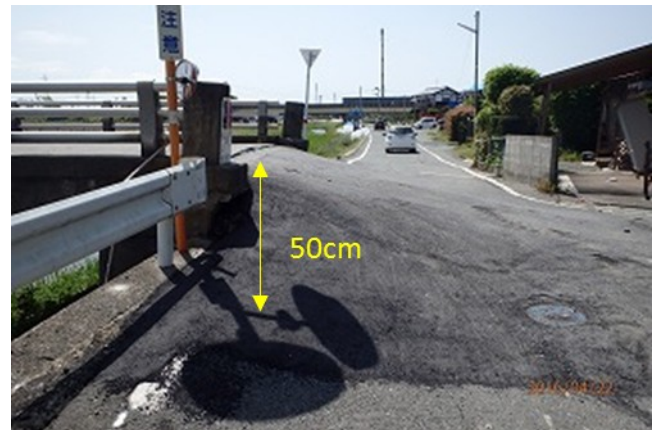
Figure 9. Temporary restoration work (filled slope) for settlement of levee (Site 5 in Figs. 3 and 7) ( $32^{\circ} 46'44.47''N$ ,  $130^{\circ} 47'45.43''E$ ).

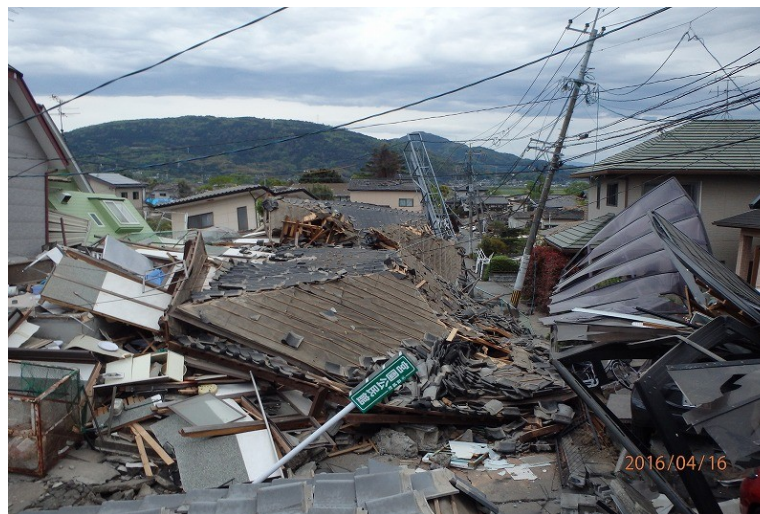
There were numerous building collapses in Mashiki Town. Fig. 13 shows the typical damage to the residential houses in the yellow-colored area in Fig. 12 (site 7). The residents in the affected area reported that a number of houses suffered from moderate to significant structural damage due to the earthquake on the 14<sup>th</sup> of April and then totally destroyed by the main shock on the 16<sup>th</sup>. It is also reported that the number of deaths in this area was fewer than expected from the damage shown in Fig. 13 because many affected residents had already fled their damaged house after the earthquake of the 14<sup>th</sup> (Fukuwa, 2016).

Figure 13. Damage to residential houses in Mashiki Town (Site 7 in Fig. 12)  
( $32^{\circ} 47'16.38''N$ ,  $130^{\circ} 48'58.47''E$ ).

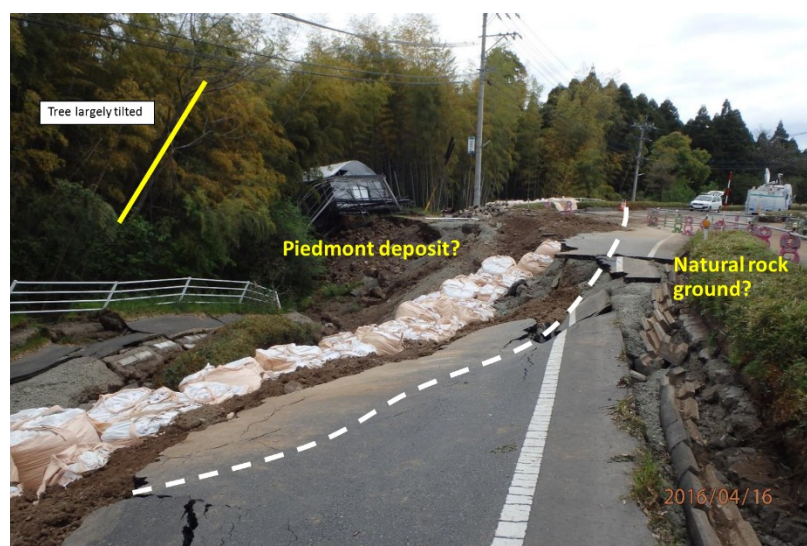
A section of Route 443 at site 10 in Fig. 12 was damaged by the earthquake on the 14<sup>th</sup> of April. The road on the left side in Fig. 18 failed and subsided by a maximum of about 2.0-2.5 m. The photo also shows the significantly tilted trees at the middle portion of the sliding mass. At the time of the survey on the 16<sup>th</sup> of April, two days after the occurrence of failure, large soil bags were placed on the exposed failure surface to prevent further damage. According to the landform classification map shown in Fig. 14, the failure was likely to have occurred in the talus deposit and the perimeter of the failure is likely to be the boundary between talus deposit and late Pleistocene volcanic rock.

Figure 18. Damage to Route 443 in Mashiki Town (Site 10 in Figs. 12 and 14) ( $32^{\circ} 47'29.71''N$ ,  $130^{\circ} 49'17.58''E$ ).

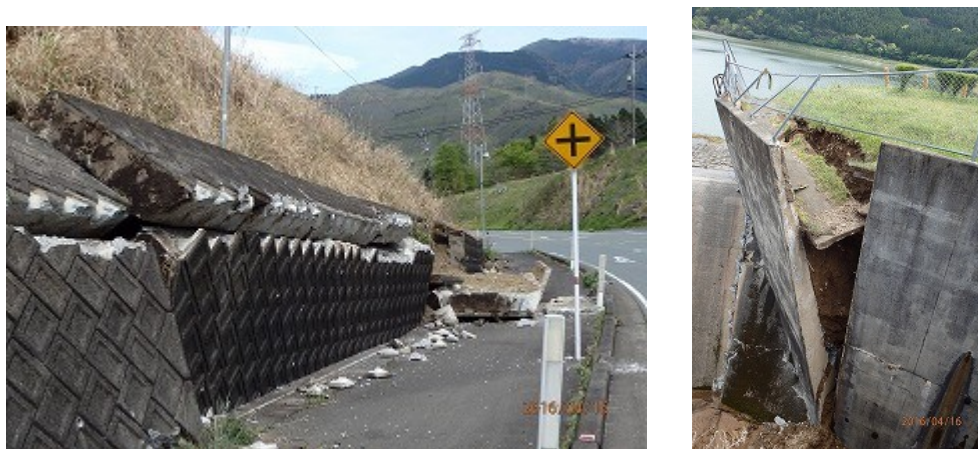
Mashiki and the surrounding areas were close to the seismic fault and suffered from a variety of geotechnical and structural damage due to the earthquakes. Damage to gravity-type and cantilever-type retaining walls (2-3 m high) was found at several locations due to surface manifestation of fault rupture. The retaining wall and dam spillway retaining wall at site 12 in Fig. 12 were structurally damaged as a result of the fault movement (Fig. 20).

Figure 20. Damage to retaining wall and spillway retaining wall (site 12 in Fig. 12) ( $32^{\circ}50'29.22''N$ ,  $130^{\circ}55'55.83''E$ ).

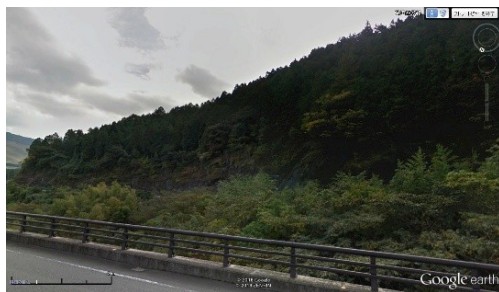
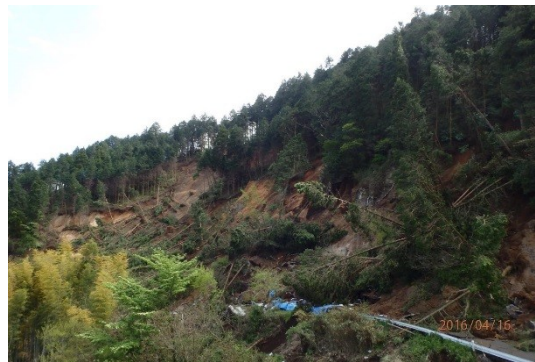
Figure 22. Slope failure along prefectural road No. 28 (site 14 in Fig. 12) ( $32^{\circ}50'32.96''N$ ,  $130^{\circ}55'40.65''E$ ).

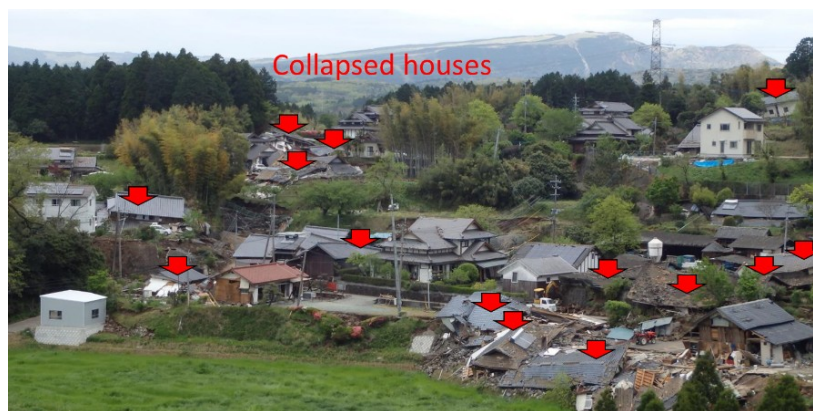
A number of residential houses along road No. 28 suffered from significant damage. As shown in Fig. 23, high collapse ratio of houses can be seen in the small village (site 15). In addition, modern bridges and a tunnel along road No. 28 suffered from serious damage. The girder of Ohkiri-hata Bridge moved about 1-1.5m and fell off its rubber bearings (Fig. 24, site 14). About 4 km north-east of Ohkiri-hata Bridge, Tawarayama tunnel suffered from a compressive axial failure and falling of lining concrete about 250 m from the tunnel portal (Fig. 25, site 16). The cause of compression of the tunnel was thought to be a surface fault movement in right lateral component, which was confirmed at the damaged location (Shirahama et al., 2016; Yoshimi, 2016). More information about the structural damages along road No. 28 due to the earthquake is reported in a separate report (Ikeda, et al., 2016).

Figure 23. Damage to residential houses in Ohkiri-hata area (site 15 in Fig. 12) ( $32^{\circ}50'36.91''N$ ,  $130^{\circ}55'43.16''E$ ).

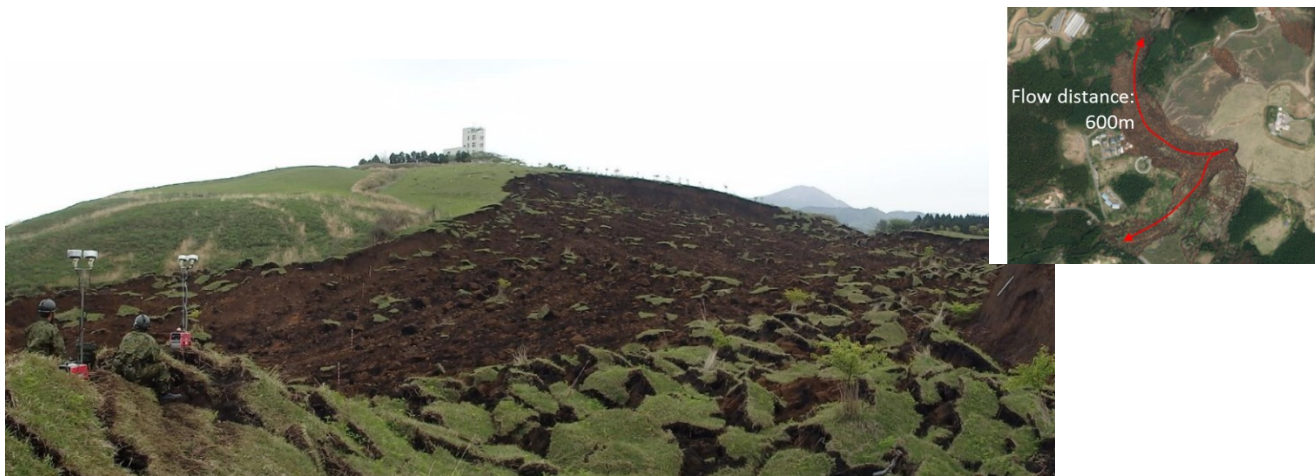
At site 18 in Fig. 26, a large scale landslide occurred at a volcanic hill (late Pleistocene) with a height in excess of 80 m from its base. The failure occurred on a relatively gentle slope with an angle of less than 10 degrees. The sliding of the slope towards the toe, however, was remarkable as shown in Figure 29. This failure killed five people who were in the house at the middle of the slope. A few hundred meters south of the above landslide another landslide occurred and caused severe damage to the residential houses as shown in Figure 30 (site 19). The length of the landslide was 70 m with an inclination angle of about 10 degrees. As the Kumamoto earthquake is an inland earthquake which caused severe damage in the mountain area, it is often compared with the 2004 Chuetsu earthquake ( $M_w$  6.6) which hit Niigata Prefecture, Japan, and caused a number of landslides (Toyota et al., 2006). Slope failures triggered by the Chuetsu earthquake occurred at a sedimentary rock interface, and the slope angle before the failure was about 20 degrees on average (Yamasaki, 2008), which is much steeper than the cases in the Aso mountain area in the Kumamoto earthquake. The debris of the landslides in Aso Caldera area was a mixture of volcanic ash, andsol, a highly porous dark-colored material comprising of volcanic ash mixed with organic matter, and pumice. As shown in Figure 30, alternating layers were seen at the surface of the scrap. The cause of failure and long-distance flow at the gentle slope is not identified yet, however, since the natural deposited pumice is known to have high crushability, the soil may have experienced significant strength reduction associated with particle breakage during the earthquake.

Figure 29. Large scale landslide in Aso Caldera area (site 18 in Fig. 26) ( $32^{\circ} 53'5.47''N$ ,  $131^{\circ} 00'10.56''E$ ).

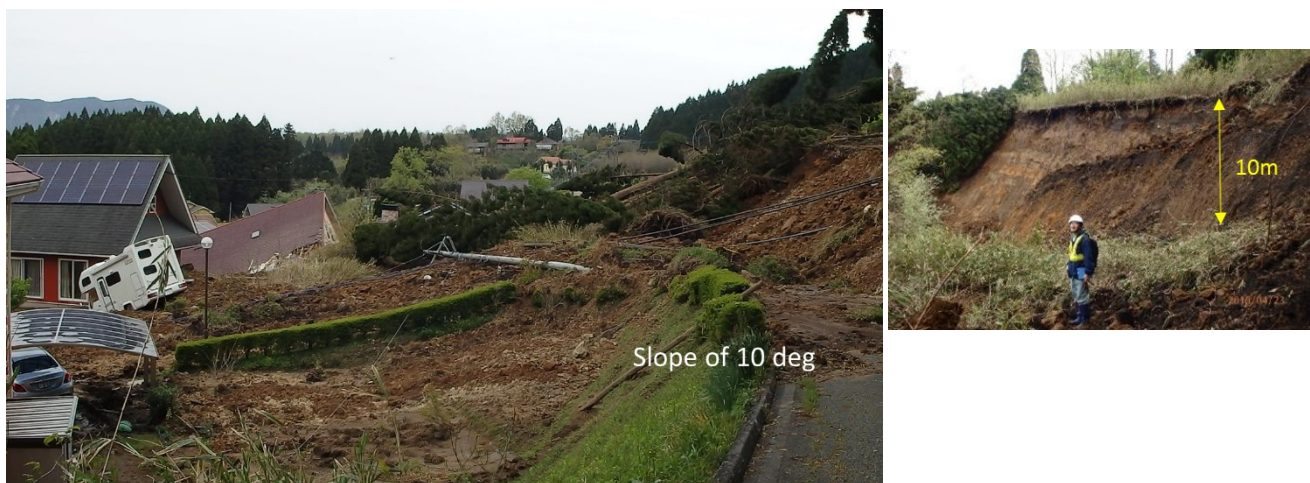
Figure 30. Landslide at gentle slope and its scrap (site 19 in Fig. 26) ( $32^{\circ} 52'29.42''N$ ,  $131^{\circ} 00'49.36''E$ ).

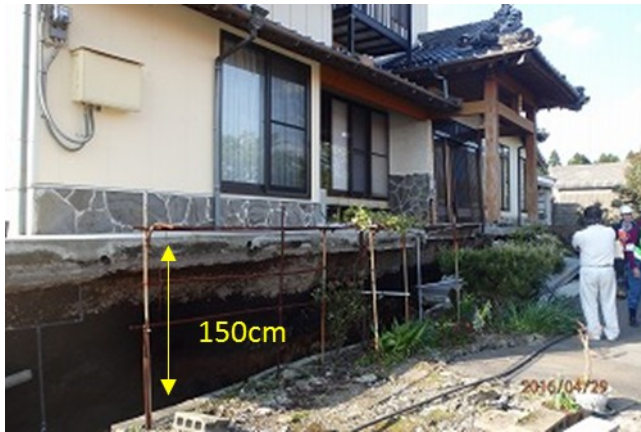
A trough-like depression was found at several locations in the basin of Aso Caldera. According to both the authors' site investigation and aerial photointerpretation of cracks on ground surface provided by the GSI (2016) and Kokusai Kogyo co. Ltd (2016), the trough-like depression, with a maximum depth of about 1-1.5 m, was found to stretch several kilometers in length, the width of the depression was several tens of meters. At site 23, the ground depression caused damage to a residential house (Fig. 36). The damage due to the depression has also been harmful to agriculture in this area (Figure 37). The mechanism of the depression, however, is not yet identified. The residents in the affected area reported that the depression occurred immediately when the main shock occurred on the 16<sup>th</sup> of April. The fact indicates that the cause of the depression was probably not liquefaction. Refer to a separate report by Konagai et al. (2016) for further information about this feature.

Figure 36. Ground depression-induced damage to the residential house (Site 23 in Fig. 26) ( $32^{\circ} 57'23.84''N$ ,  $131^{\circ} 2'12.31''E$ ).
