Geotechnical Damage Caused by the 2016 Kumamoto Earthquake, Japan

ABSTRACT: On the 16th of April 2016, the Kumamoto earthquake (M_w 7.0) hit the Central Kyushu Region, Japan, following a M_w 6.2 shock on the 14th of April. The earthquake sequences caused severe damage in Kumamoto Prefecture. This paper presents quick reconnaissance results focusing on geotechnical damage features, which were observed during field investigations immediately after, one, and two weeks after the main shock. The damage surveys were carried out in southern Kumamoto City, Mashiki Town, Aso Caldera area and their suburbs. In southern Kumamoto City, evidence of liquefaction was found at many locations, and some buildings and river levees suffered from significant settlement and deformation; damage to an embankment of Kyushu Highway also seemed to be the result of liquefaction. The majority of the damaged residential houses were found in Mashiki Town and its suburbs, which may be linked to intense earthquake motions associated with the seismic fault location. In Aso Caldera area, a number of moderate to large scale landslides and their significant impact to structures were observed. The greater part of land

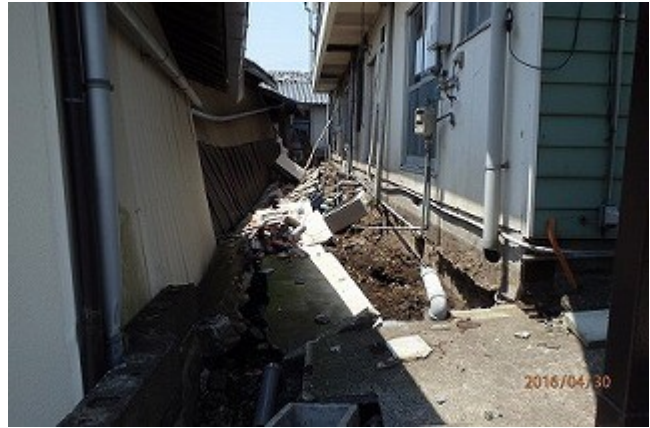
Figure 17. Ground displacement-induced damage to a residential house (Site 9 in Fig. 12) ($32^{\circ} 47'14.48''N$, $130^{\circ} 48'41.06''E$).

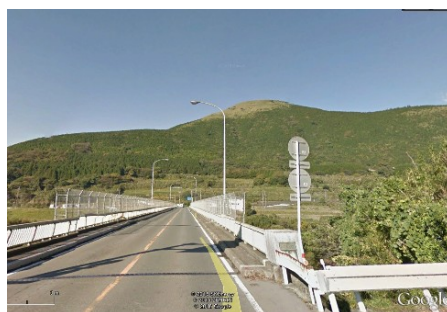
Before the failure (Google Earth)

Figure 28 shows a shallow landslide near Aso Ohashi Bridge caused by the main shock on the 16th of April (site 17). The landslide had a height of about 300 m (measured from the road level to the scrap) with an inclination angle of about 50 degrees at the top and about 25 degrees at the middle and bottom of the slope. The debris was a mixture of middle Pleistocene volcanic soils and boulders (tuff breccia); Route 57 and JR Hohi Main Line (railway) was also covered by it. The debris travelled a distance exceeding 800 m and fell into the Kurokawa-River along with Aso Ohashi Bridge. Evidence of mud debris was found on the opposite side of the river which is thought to have travelled along the bridge before its collapse. For this reason, the cause of bridge failure is considered to be the impact force and/or weight of debris that flowed down from the landslide source. Moreover, in Figure 28, taken one day after the event, water seeped out from the failed surface, which may explain the reduction of shear strength of the slope ground due to increase in excess pore water pressure during the intense earthquake.

Figure 28. Landslide near Aso Ohashi Bridge (site 17 in Fig. 26).
(32° 53'0.02"N, 130° 59'22.80"E).
