Geotechnical Damage Caused by the 2016 Kumamoto Earthquake, Japan

ABSTRACT: On the 16th of April 2016, the Kumamoto earthquake (M_w 7.0) hit the Central Kyushu Region, Japan, following a M_w 6.2 shock on the 14th of April. The earthquake sequences caused severe damage in Kumamoto Prefecture. This paper presents quick reconnaissance results focusing on geotechnical damage features, which were observed during field investigations immediately after, one, and two weeks after the main shock. The damage surveys were carried out in southern Kumamoto City, Mashiki Town, Aso Caldera area and their suburbs. In southern Kumamoto City, evidence of liquefaction was found at many locations, and some buildings and river levees suffered from significant settlement and deformation; damage to an embankment of Kyushu Highway also seemed to be the result of liquefaction. The majority of the damaged residential houses were found in Mashiki Town and its suburbs, which may be linked to intense earthquake motions associated with the seismic fault location. In Aso Caldera area, a number of moderate to large scale landslides and their significant impact to structures were observed. The greater part of land

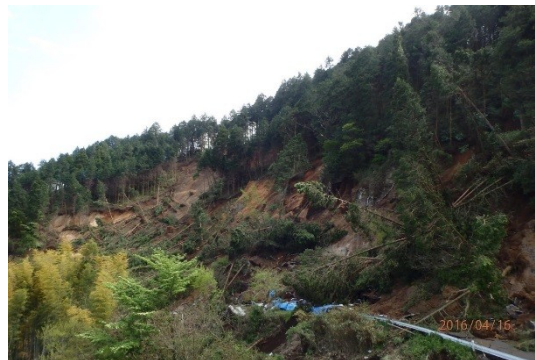
Figure 22. Slope failure along prefectural road No. 28 (site 14 in Fig. 12) ($32^{\circ}50'32.96''N$, $130^{\circ}55'40.65''E$).

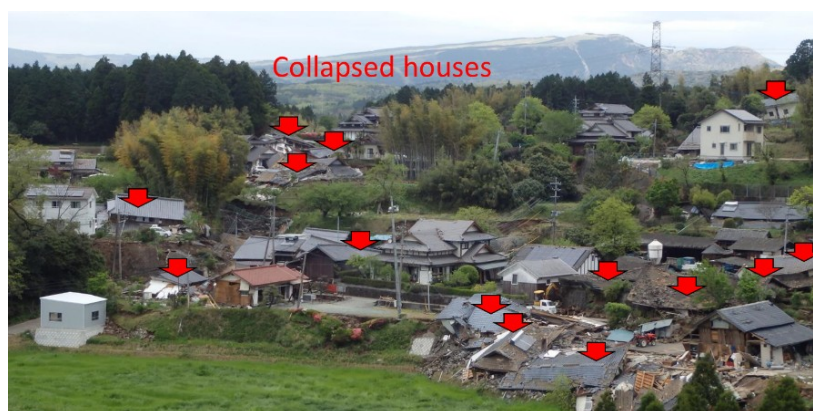
A number of residential houses along road No. 28 suffered from significant damage. As shown in Fig. 23, high collapse ratio of houses can be seen in the small village (site 15). In addition, modern bridges and a tunnel along road No. 28 suffered from serious damage. The girder of Ohkiri-hata Bridge moved about 1-1.5m and fell off its rubber bearings (Fig. 24, site 14). About 4 km north-east of Ohkiri-hata Bridge, Tawarayama tunnel suffered from a compressive axial failure and falling of lining concrete about 250 m from the tunnel portal (Fig. 25, site 16). The cause of compression of the tunnel was thought to be a surface fault movement in right lateral component, which was confirmed at the damaged location (Shirahama et al., 2016; Yoshimi, 2016). More information about the structural damages along road No. 28 due to the earthquake is reported in a separate report (Ikeda, et al., 2016).

Figure 23. Damage to residential houses in Ohkiri-hata area (site 15 in Fig. 12) ($32^{\circ}50'36.91''N$, $130^{\circ}55'43.16''E$).

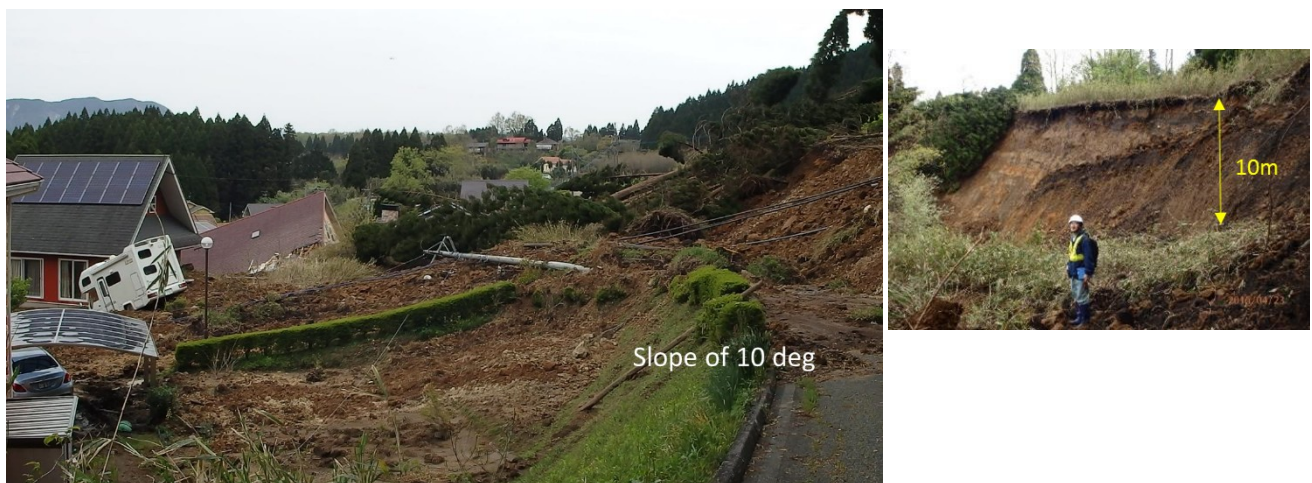
Figure 30. Landslide at gentle slope and its scrap (site 19 in Fig. 26) ($32^{\circ} 52'29.42''N$, $131^{\circ} 00'49.36''E$).

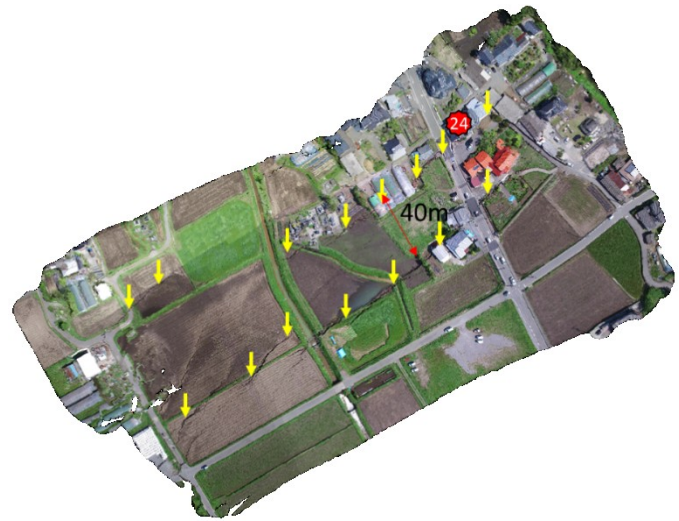
Figure 37. Digital image obtained by UAV around the trough-like depression area (c.f. Fig. 26).
