Uplift of an Underground Tank in Northern Malabar Region, India

ABSTRACT: *An underground reinforced concrete tank was constructed for a project in the southwest region of India. The tank was 90 m x 35 m in plan and 7.3 m deep resting on partly filled-up and partly native soil. During the peak monsoon, a sudden uplifting of the base slab by about 300 mm and subsequent failure of the foundation raft and a partition wall was observed. Laboratory testing was executed and hydrogeological survey was carried out using ground penetrating radar, seismic refraction and infiltrometer testing, and an analytical study was carried out to identify the root cause of the tank uplifting. Based on this study, it was observed that the uplifting and structural failure was essentially due to the peculiar land terrain and soil properties and the development of excess hydraulic head below the bottom of the tank. After considering different options, the rectification measures were carried out by provision of dewatering wells along the tank periphery to release the excess hydrostatic pressure and stabilize the foundation raft. The structural repair of the top of the foundation raft and partition wall was

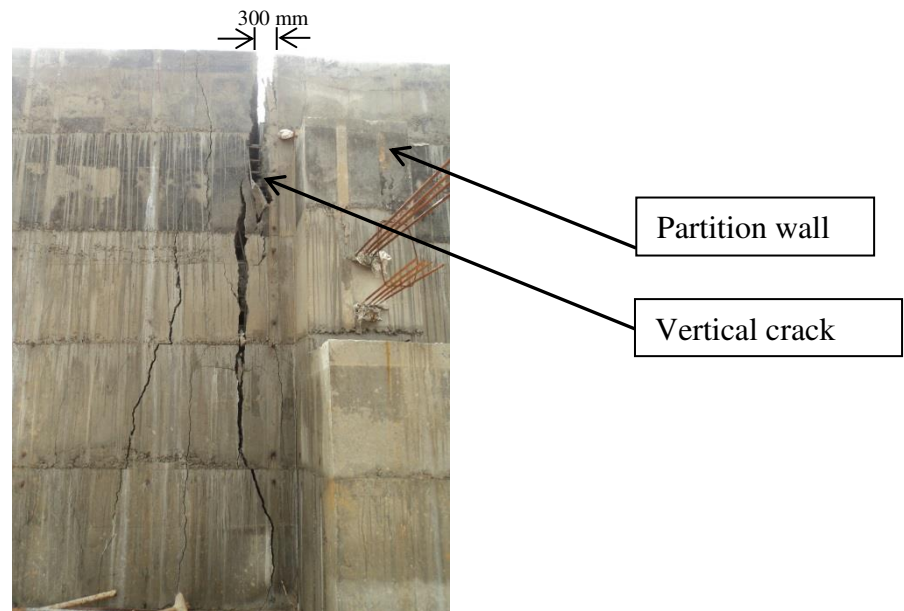
In the southern part of India, the monsoon is at its peak in the months of June & July every year. In mid-June of 2013, the foundation raft of the tank suddenly got uplifted by approximately 300 mm at the center. The review of past rainfall data revealed higher rainfall intensity in June 2013 compared to rainfall in the previous three years as shown in Table 2. During the failure of the tank, the 0.9 m thick reinforced cement concrete (RCC) partition wall inside the tank got cracked in tension at the center due to the uplifting and bending of the foundation raft. However, no uplifting was noticed at the four edges of the tank. Thus, the tank took an inverse saucer shape due to the uplifting at the center.

Fig 2 indicates the curved and cracked partition wall due to the tank uplifting. Several other cracks were observed along the height of the partition wall on either side of the middle 300 mm wide crack, with the crack width decreasing away from the center. Based on daily measurements taken on top of the partition wall after the failure, the uplifting of bottom slab and the crack width of partition wall was observed to be increasing at a rate of 30 mm per day. The cracks, which were observed on top of the foundation raft inside the tank, had maximum width of 12 mm. The seepage of groundwater inside the tank was not observed through these cracks. Thus, the depth of cracks was limited only to the top portion and not penetrating the entire thickness of the foundation raft.

Figure 2. Uplifting and cracking of tank partition wall.

As the crack width in the partition wall was increasing at a rate of 30 mm per day, it was necessary to take immediate corrective measures to stop the cracks from further widening. It was therefore suggested to drill boreholes of 200 mm diameter up to 8 m depth (as the depth of tank is 7.3 m) around the tank periphery so as to reduce the water pressure acting on the bottom of foundation raft by allowing the water under pressure to get released through these boreholes. However, due to the heavy rains, the contractor could not position the drilling equipment near the tank to drill the boreholes. Considering the practical delays in carrying out the borehole activity, another suggested option was to fill the tank with water up to approximately 5.5 m height which would generate additional weight within the tank, to counter the upward buoyant force of groundwater. Thus the accumulated water within the surrounding area was diverted inside the tank. As soon as the tank started filling with water, the settlement of the tank started taking place due to the weight of water. It took more than a month to fill the tank with water up to a height of 5.50 m after which the tank was observed to be completely settled to its original position and the crack width in the partition wall was reduced to 25 mm from 300 mm.

While the peripheral dewatering wells were in continuous operation, the tank was emptied to conduct the structural repairing work. The gaps under the base slab which were formed by the tank uplift were filled with cement grout. The surface cracks developed within the base raft were also treated using epoxy bonding agent and cement grout.

The structural rectification of damaged partition wall was carried out by demolishing the damaged portion, providing new reinforcement, applying epoxy bonding coating on old concrete and reconstructing the demolished portion of the wall.
