Uplift of an Underground Tank in Northern Malabar Region, India

ABSTRACT: *An underground reinforced concrete tank was constructed for a project in the southwest region of India. The tank was 90 m x 35 m in plan and 7.3 m deep resting on partly filled-up and partly native soil. During the peak monsoon, a sudden uplifting of the base slab by about 300 mm and subsequent failure of the foundation raft and a partition wall was observed. Laboratory testing was executed and hydrogeological survey was carried out using ground penetrating radar, seismic refraction and infiltrometer testing, and an analytical study was carried out to identify the root cause of the tank uplifting. Based on this study, it was observed that the uplifting and structural failure was essentially due to the peculiar land terrain and soil properties and the development of excess hydraulic head below the bottom of the tank. After considering different options, the rectification measures were carried out by provision of dewatering wells along the tank periphery to release the excess hydrostatic pressure and stabilize the foundation raft. The structural repair of the top of the foundation raft and partition wall was

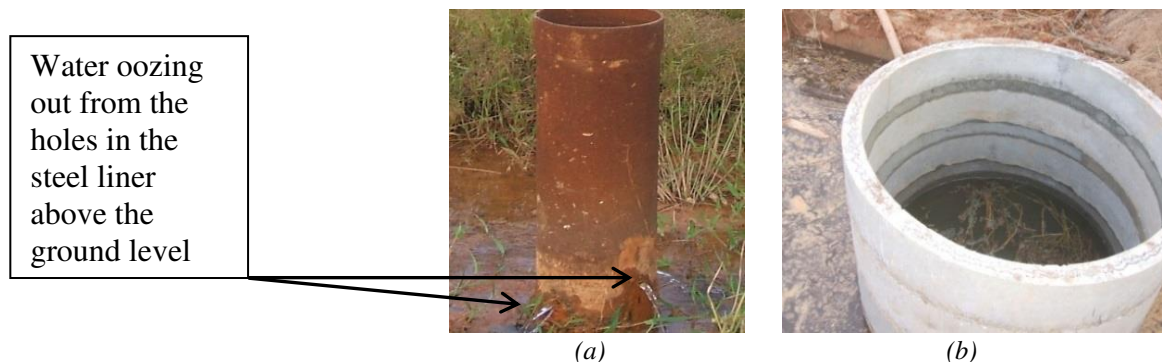
In the meantime, when the tank filling was ongoing and the rainfall intensity reduced, the boreholes with steel liner were drilled along the tank periphery and a 1.2 m diameter and 4 m deep ring well was also dug near the tank. The groundwater was observed to be coming out from the perforations in steel liner above the ground level due to high hydraulic head (Fig. 3a). The water level in an open well was also observed to be at the ground level (Fig. 3b).

Figure 3. Groundwater level in (a) borehole with steel liner and (b) ring well

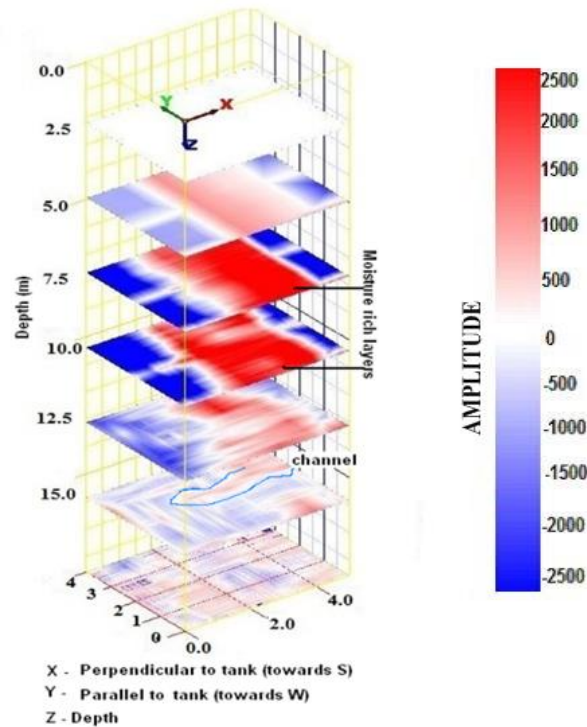
3D data near the tank clearly indicates the clay rich strata at the depth of 2.5 m below ground level and the moisture is more concentrated at the depth of 7.5 m to 10 m from ground level (see Fig. 10). This visualization assisted in confirming the presence of water channels between the well and the tank.

Figure 10. 3D view of the grid from GPR2 near the tank, data collected with 2 m interval at X axis and 1 m interval at Y axis. X is the direction perpendicular to the tank; Y is direction parallel to the tank and Z is the depth of penetration of the GPR2 antenna, i.e., 20 m.
