## Uplift of an Underground Tank in Northern Malabar Region, India

**ABSTRACT:** An underground reinforced concrete tank was constructed for a project in the southwest region of India. The tank was 90 m x 35 m in plan and 7.3 m deep resting on partly filled-up and partly native soil. During the peak monsoon, a sudden uplifting of the base slab by about 300 mm and subsequent failure of the foundation raft and a partition wall was observed. Laboratory testing was executed and hydrogeological survey was carried out using ground penetrating radar, seismic refraction and infiltrometer testing, and an analytical study was carried out to identify the root cause of the tank uplifting. Based on this study, it was observed that the uplifting and structural failure was essentially due to the peculiar land terrain and soil properties and the development of excess hydraulic head below the bottom of the tank. After considering different options, the rectification measures were carried out by provision of dewatering wells along the tank periphery to release the excess hydrostatic pressure and stabilize the foundation raft. The structural repair of the top of the foundation raft and partition wal

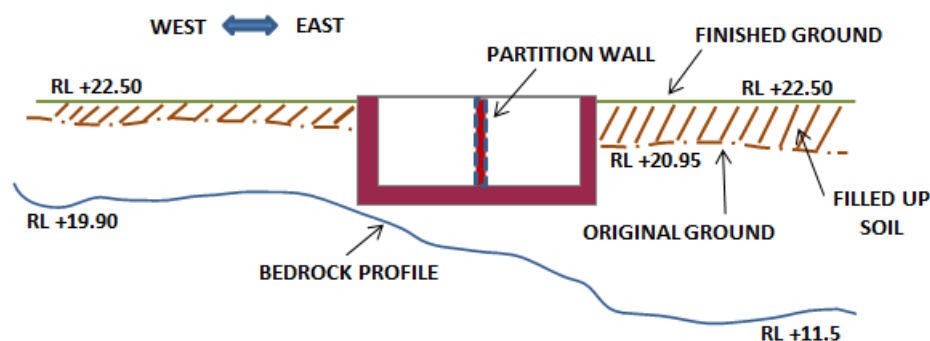
The overall topography of the project site was sloping from west towards the east. The profile of bedrock was also dipping down from west towards the east as shown with varying reduced levels (RL) in Fig. 1 along with the relative location of the tank.

Figure 1. Topographic features near the tank.

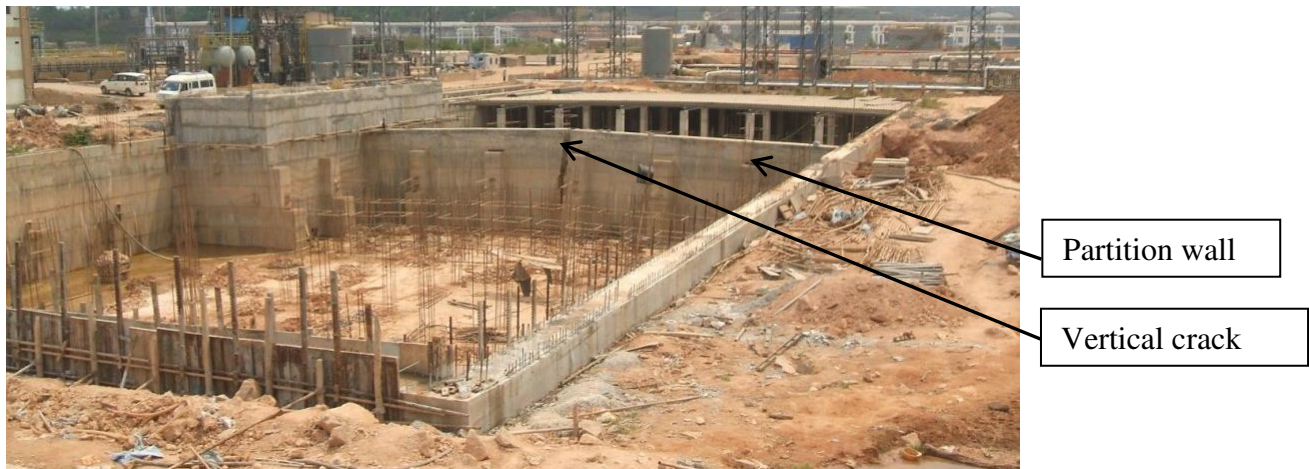
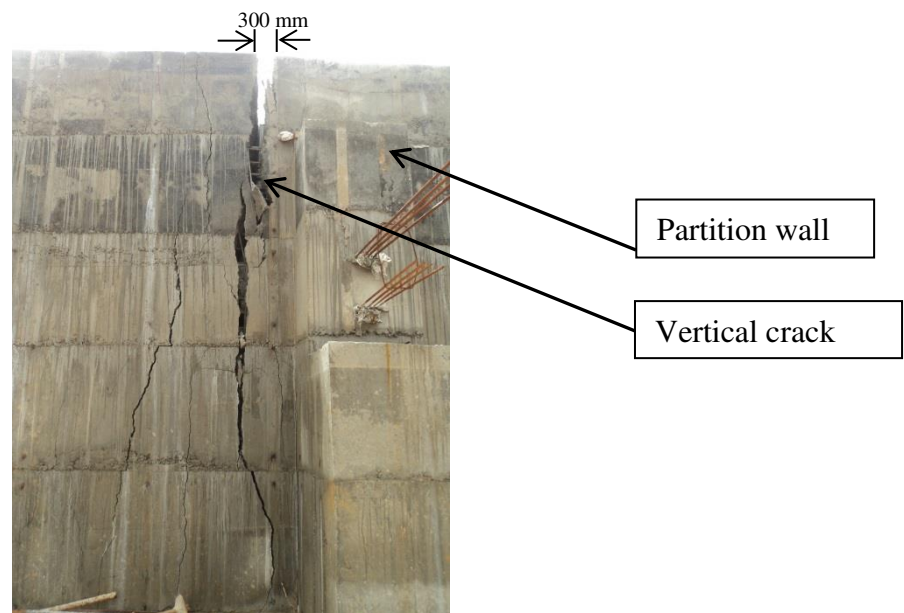
In the southern part of India, the monsoon is at its peak in the months of June & July every year. In mid-June of 2013, the foundation raft of the tank suddenly got uplifted by approximately 300 mm at the center. The review of past rainfall data revealed higher rainfall intensity in June 2013 compared to rainfall in the previous three years as shown in Table 2. During the failure of the tank, the 0.9 m thick reinforced cement concrete (RCC) partition wall inside the tank got cracked in tension at the center due to the uplifting and bending of the foundation raft. However, no uplifting was noticed at the four edges of the tank. Thus, the tank took an inverse saucer shape due to the uplifting at the center.

Fig 2 indicates the curved and cracked partition wall due to the tank uplifting. Several other cracks were observed along the height of the partition wall on either side of the middle 300 mm wide crack, with the crack width decreasing away from the center. Based on daily measurements taken on top of the partition wall after the failure, the uplifting of bottom slab and the crack width of partition wall was observed to be increasing at a rate of 30 mm per day. The cracks, which were observed on top of the foundation raft inside the tank, had maximum width of 12 mm. The seepage of groundwater inside the tank was not observed through these cracks. Thus, the depth of cracks was limited only to the top portion and not penetrating the entire thickness of the foundation raft.

Figure 2. Uplifting and cracking of tank partition wall.

As the crack width in the partition wall was increasing at a rate of 30 mm per day, it was necessary to take immediate corrective measures to stop the cracks from further widening. It was therefore suggested to drill boreholes of 200 mm diameter up to 8 m depth (as the depth of tank is 7.3 m) around the tank periphery so as to reduce the water pressure acting on the bottom of foundation raft by allowing the water under pressure to get released through these boreholes. However, due to the heavy rains, the contractor could not position the drilling equipment near the tank to drill the boreholes. Considering the practical delays in carrying out the borehole activity, another suggested option was to fill the tank with water up to approximately 5.5 m height which would generate additional weight within the tank, to counter the upward buoyant force of groundwater. Thus the accumulated water within the surrounding area was diverted inside the tank. As soon as the tank started filling with water, the settlement of the tank started taking place due to the weight of water. It took more than a month to fill the tank with water up to a height of 5.50 m after which the tank was observed to be completely settled to its original position and the crack width in the partition wall was reduced to 25 mm from 300 mm.

The structural rectification of damaged partition wall was carried out by demolishing the damaged portion, providing new reinforcement, applying epoxy bonding coating on old concrete and reconstructing the demolished portion of the wall.

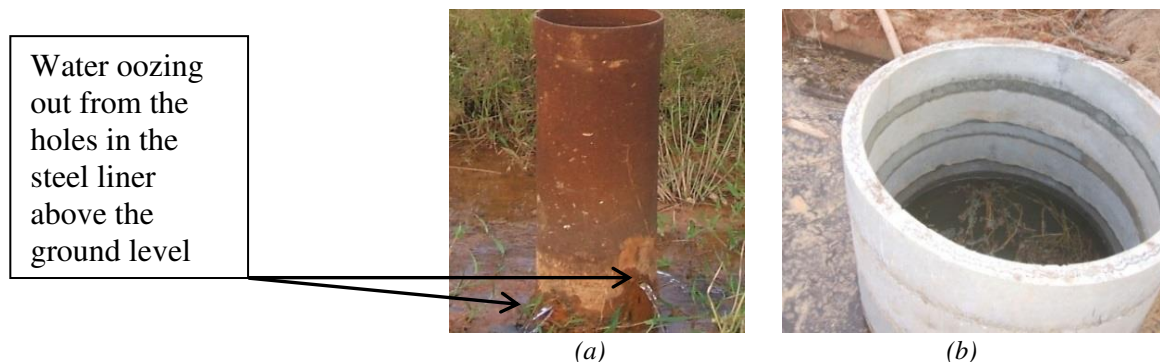
In the meantime, when the tank filling was ongoing and the rainfall intensity reduced, the boreholes with steel liner were drilled along the tank periphery and a 1.2 m diameter and 4 m deep ring well was also dug near the tank. The groundwater was observed to be coming out from the perforations in steel liner above the ground level due to high hydraulic head (Fig. 3a). The water level in an open well was also observed to be at the ground level (Fig. 3b).

Figure 3. Groundwater level in (a) borehole with steel liner and (b) ring well

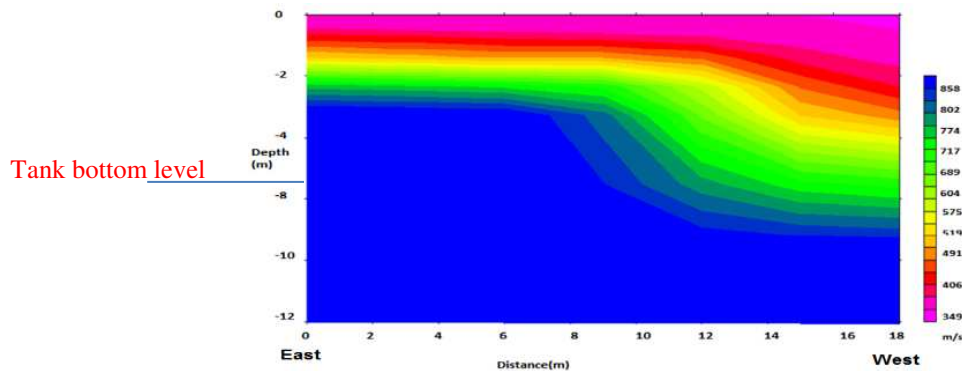
The seismic refraction survey data was used to classify the soil using correlations between typical velocities, type of formations and the density as suggested by Bourbie et al. (1987). Based on this classification, the top layer consists of clayey soil, which is moderately compacted up to a depth of 1.5 m with P-wave velocity of 349 m/s. It is followed by a layer of clay and gravel with a thickness of 1.5 m, having a velocity range from 377 m/s to 482 m/s and a layer of sandy silt strata up to 10 m with a thickness of about 7.5 m and a seismic velocity range from 491 m/s to 858 m/s, as shown in Fig. 6.

Figure 6. The soil strata profile obtained from SR2 data conducted on the south side of the tank near the closed water well (see Fig. 5 for survey location with respect to the tank).

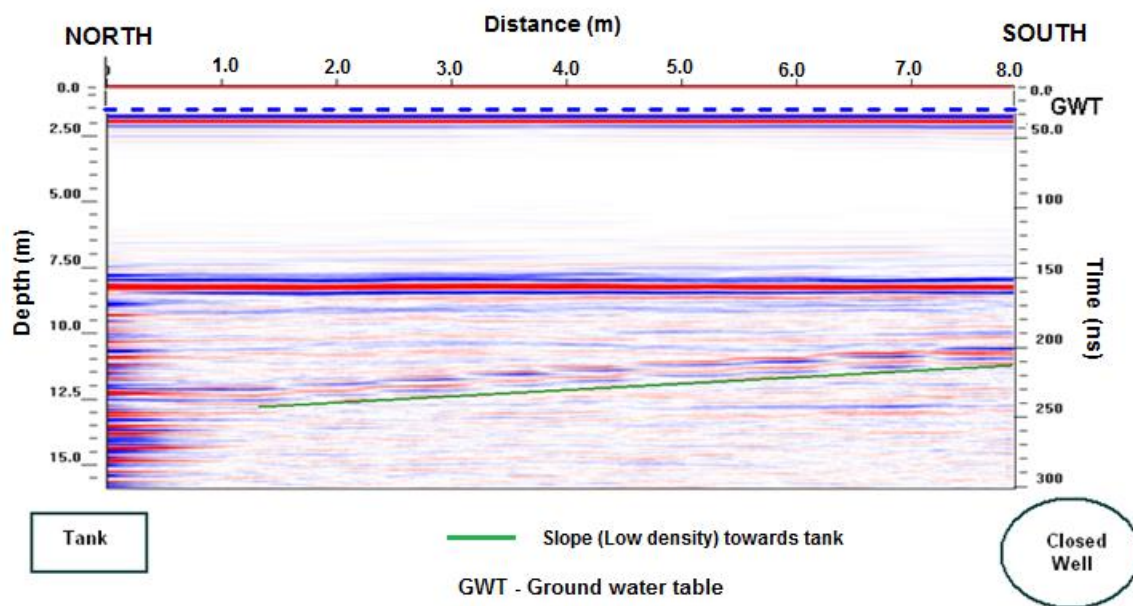
Close to the side wall of the tank, the discontinuous sloping feature towards the tank at depths of 11 m to 12.5 m below existing ground level (EGL) was observed. The observed sloping feature was identified as water channel with the direction of flow from closed water well (south direction) towards the tank (north direction) as highlighted by the green line in Fig. 7.

Figure 7. GPR2 profile collected using 200 MHZ antenna outside the tank along North - South direction by placing the antenna inside the floating body. This profile is located between the tank and closed water well i.e., close to the wall of tank. (see Fig. 5 for survey location with respect to the tank).

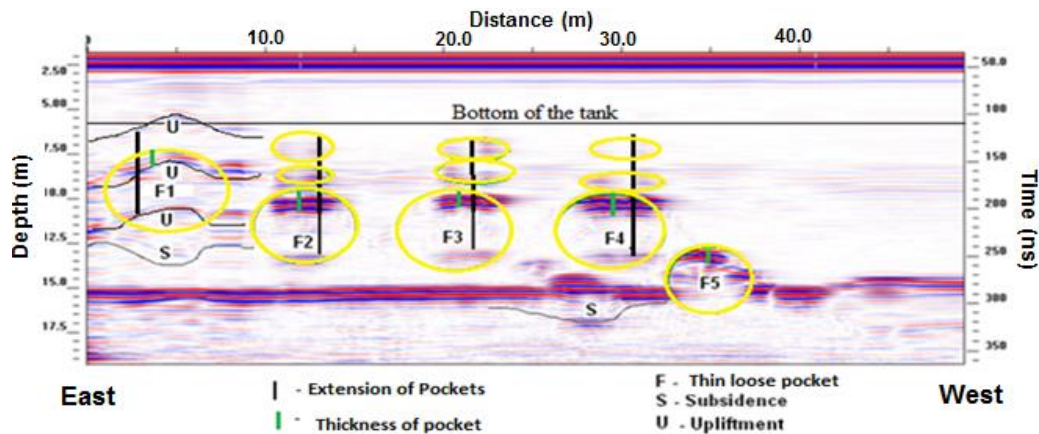
Loose pockets in the substrata were observed along the East-West direction beneath the tank bottom. The horizontal length of loose pockets below the bottom of the tank (F1 to F5) are observed to be varying between 0.5 m to 5.5 m at different locations. (see Fig. 7). The vertical thicknesses of the loose pockets are approximately 0.5 m each.

Figure 7. GPR3 profile collected using a 200 MHZ antenna inside the tank along East - West direction by placing antenna inside the floating body.

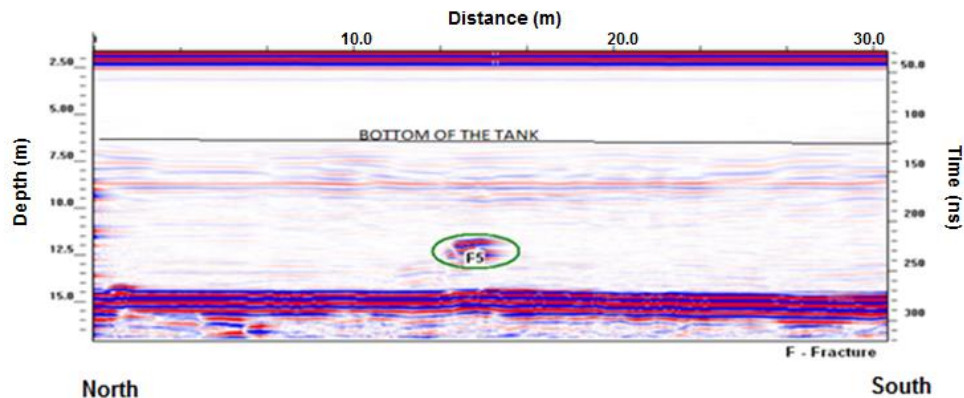
Fracture F5 is visible at the depth of 12.5 m in the profile along North-South direction (shown in Fig. 9). High amplitude reflections at 7.5 m depth are interpreted as rock formations and very high amplitude thick reflections encountered at depth of 14.5 m are interpreted as hard bedrock.

Figure 9. GPR4 profile collected using a 200 MHZ antenna inside the tank along North - South direction by placing antenna inside the floating body.

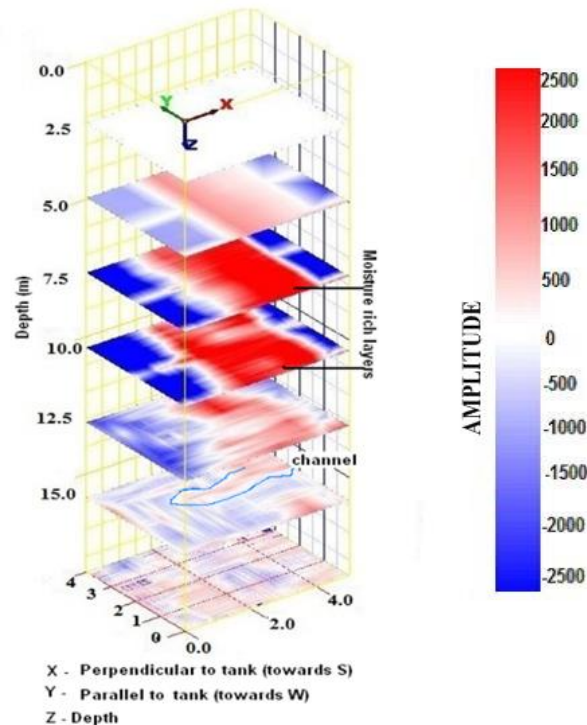
3D data near the tank clearly indicates the clay rich strata at the depth of 2.5 m below ground level and the moisture is more concentrated at the depth of 7.5 m to 10 m from ground level (see Fig. 10). This visualization assisted in confirming the presence of water channels between the well and the tank.

Figure 10. 3D view of the grid from GPR2 near the tank, data collected with 2 m interval at X axis and 1 m interval at Y axis. X is the direction perpendicular to the tank; Y is direction parallel to the tank and Z is the depth of penetration of the GPR2 antenna, i.e., 20 m.
