Uplift of an Underground Tank in Northern Malabar Region, India

ABSTRACT: *An underground reinforced concrete tank was constructed for a project in the southwest region of India. The tank was 90 m x 35 m in plan and 7.3 m deep resting on partly filled-up and partly native soil. During the peak monsoon, a sudden uplifting of the base slab by about 300 mm and subsequent failure of the foundation raft and a partition wall was observed. Laboratory testing was executed and hydrogeological survey was carried out using ground penetrating radar, seismic refraction and infiltrometer testing, and an analytical study was carried out to identify the root cause of the tank uplifting. Based on this study, it was observed that the uplifting and structural failure was essentially due to the peculiar land terrain and soil properties and the development of excess hydraulic head below the bottom of the tank. After considering different options, the rectification measures were carried out by provision of dewatering wells along the tank periphery to release the excess hydrostatic pressure and stabilize the foundation raft. The structural repair of the top of the foundation raft and partition wall was

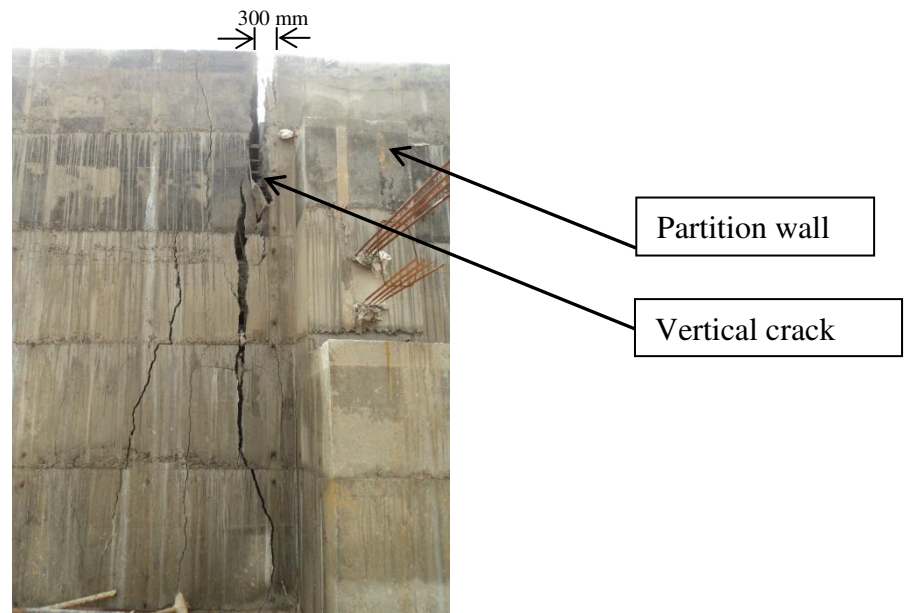
Figure 2. Uplifting and cracking of tank partition wall.

In the southern part of India, the monsoon is at its peak in the months of June & July every year. In mid-June of 2013, the foundation raft of the tank suddenly got uplifted by approximately 300 mm at the center. The review of past rainfall data revealed higher rainfall intensity in June 2013 compared to rainfall in the previous three years as shown in Table 2. During the failure of the tank, the 0.9 m thick reinforced cement concrete (RCC) partition wall inside the tank got cracked in tension at the center due to the uplifting and bending of the foundation raft. However, no uplifting was noticed at the four edges of the tank. Thus, the tank took an inverse saucer shape due to the uplifting at the center.

Fig 2 indicates the curved and cracked partition wall due to the tank uplifting. Several other cracks were observed along the height of the partition wall on either side of the middle 300 mm wide crack, with the crack width decreasing away from the center. Based on daily measurements taken on top of the partition wall after the failure, the uplifting of bottom slab and the crack width of partition wall was observed to be increasing at a rate of 30 mm per day. The cracks, which were observed on top of the foundation raft inside the tank, had maximum width of 12 mm. The seepage of groundwater inside the tank was not observed through these cracks. Thus, the depth of cracks was limited only to the top portion and not penetrating the entire thickness of the foundation raft.

As the crack width in the partition wall was increasing at a rate of 30 mm per day, it was necessary to take immediate corrective measures to stop the cracks from further widening. It was therefore suggested to drill boreholes of 200 mm diameter up to 8 m depth (as the depth of tank is 7.3 m) around the tank periphery so as to reduce the water pressure acting on the bottom of foundation raft by allowing the water under pressure to get released through these boreholes. However, due to the heavy rains, the contractor could not position the drilling equipment near the tank to drill the boreholes. Considering the practical delays in carrying out the borehole activity, another suggested option was to fill the tank with water up to approximately 5.5 m height which would generate additional weight within the tank, to counter the upward buoyant force of groundwater. Thus the accumulated water within the surrounding area was diverted inside the tank. As soon as the tank started filling with water, the settlement of the tank started taking place due to the weight of water. It took more than a month to fill the tank with water up to a height of 5.50 m after which the tank was observed to be completely settled to its original position and the crack width in the partition wall was reduced to 25 mm from 300 mm.

The structural rectification of damaged partition wall was carried out by demolishing the damaged portion, providing new reinforcement, applying epoxy bonding coating on old concrete and reconstructing the demolished portion of the wall.
