Lessons Learned from Dike Failures in Recent Decades

ABSTRACT: *The paper describes five different dike failures that occurred in recent decades. The case histories were located on different rivers and involved different loading conditions. The observed failure mechanisms involved erosion and stability problems. The types of erosion observed were both internal erosion due to extreme groundwater flow and external erosion caused by the river flow and wave action. The case involving instability was caused by uplift, i.e., increased hydraulic head led to a sharp reduction in maximum shear strength between subsoil layers. Two cases demonstrate the importance of dike management and maintenance. Despite the variations in the loading conditions and failure mechanisms, all the cases show that the strength of a dike depends not only on the material used to build the dike but also on the strength of the subsoil.*

Reference: Zwanenburg, C., López-Acosta, N.P., Tourment, R., Tarantino, A., Pozzato, A. and Pinto, A. (2018).

Lessons Learned from Dike Failures in Recent Decades. International Journal of Geoenvironment Case histories, Vol.4, Issue 3, p.203-229. doi: 10.4417/IJGCH-04-03-04

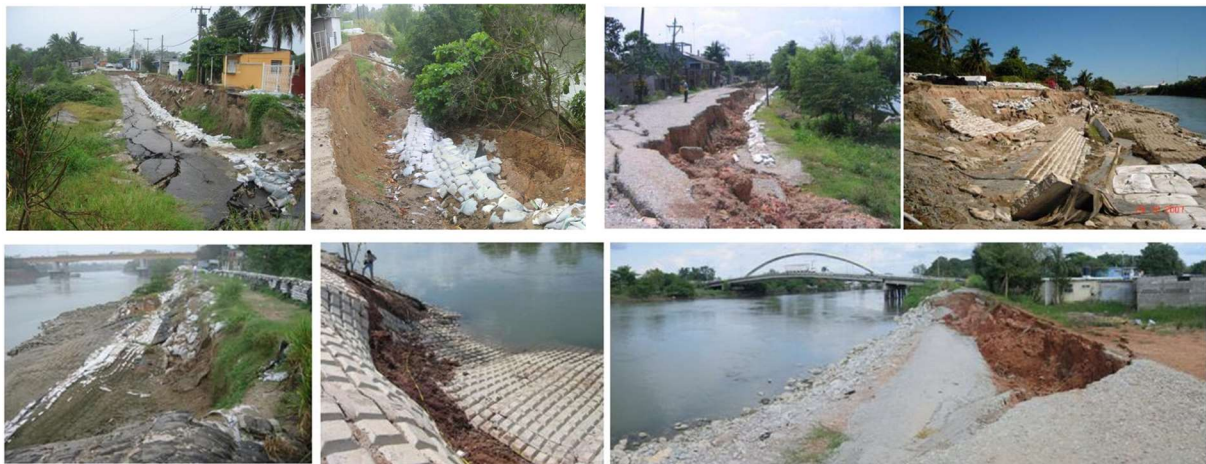
gradients generated by these fluctuations – and rain infiltration in the crests of the dikes (Figure 3). Auvinet et al. (2008) observed that problems in river banks commonly begin with erosion which, depending on the type of soil, can cause piping in some areas, possibly resulting in landslides (Figure 4). These eroded sections are generally protected with dikes consisting of clayey material. Elements that can better withstand erosion by river water are also used, examples being rock fill, systems with concrete bags (*bolsacreto* or *colchacreto*), breakwaters or sheet pile walls. River embankments may also fail when the weight of these structures exceeds the bearing capacity of the foundation soil (Figure 3). Generally, failure occurs in layers with low shear strength such as the highly compressible clays and peats which are found in unpredictable locations along the banks of the rivers in Villahermosa (Figure 1). It has also been found that factors such as scour of the riverbed and overloading caused by the weight of additional protection such as sand bags result in dike instability. In addition, intense rainfall in the region can cause large and rapid variations in the levels of local rivers, lagoons and reservoirs.

Figure 3. Consequences of water drawdown in Tabasco State, Mexico

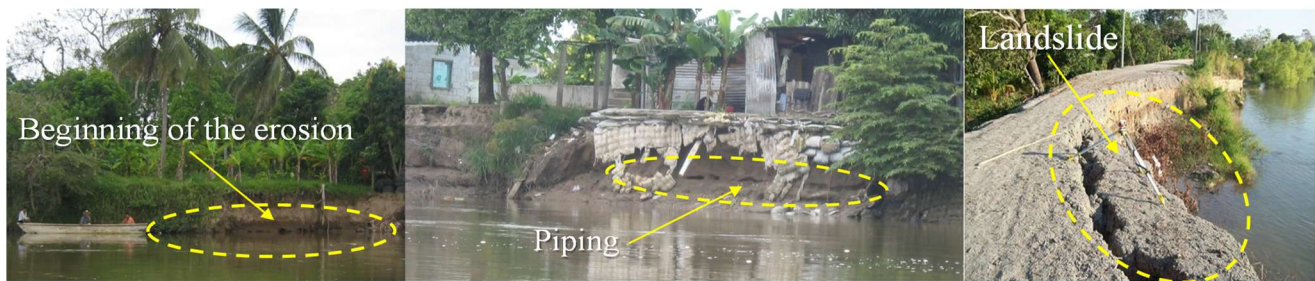
Figure 4. Evidence of instability in river banks and dikes induced by rapid drawdown in Villahermosa.

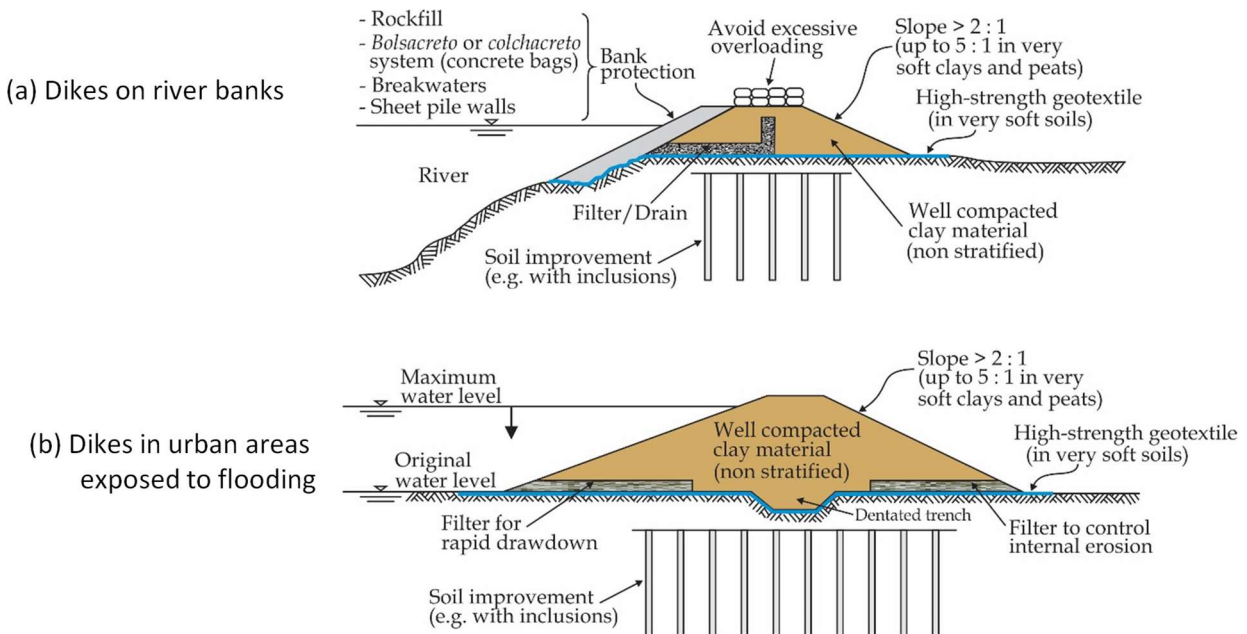
Figure 10. General recommendations to protect Tabasco dikes

This study focused on one of the main problems affecting the stability of Tabasco dikes: the water drawdown phenomenon caused by sudden changes in the levels of rivers, lagoons and reservoirs. Particular emphasis was placed on the study of exit hydraulic gradients at the toe of homogeneous and isotropic dikes. The effects of different parameters (drawdown rate, hydraulic conductivity and slope ratio) for the dikes were assessed in unsaturated, transient-state, flow analyses based on numerical modelling with the finite element method. Based on the results, it is concluded that analyses should consider the susceptibility to erosion of the material used to build the dike. However, analyses should also include measures – such as the installation of drains and filters – to reduce the hydraulic gradients and seepage forces generated inside the soil mass. The results of the analysis led to the practical recommendations shown in Figure 10, which should be taken into consideration for the protection of the Tabasco dikes.

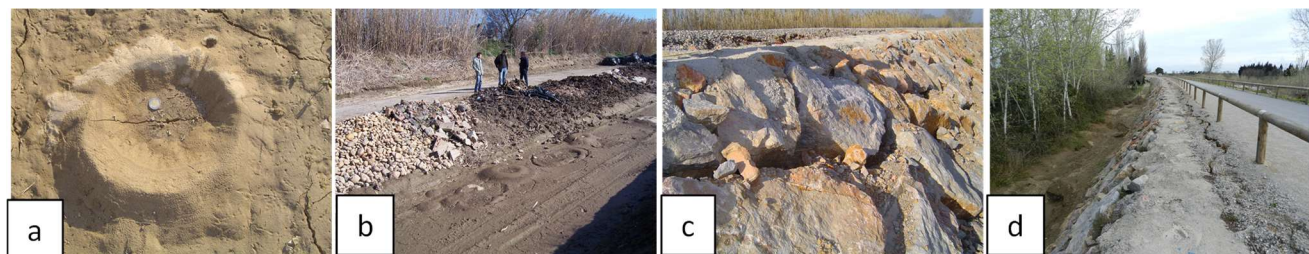
This was also a moderate event: about 800 m³/s at Rivesaltes. However, it lasted longer: 18 hours rather than the 12 hours in the November 2005 event. The dikes were loaded up to 1/2 to 2/3 of their height. CEMAGREF quickly conducted an inspection of a section of 500 m which had been identified in 1999 as being prone to sand boils. A recommendation had been made to install a drainage and seepage system on the landward side. Some of this work had been completed in 2000 with supervision from the managing authority at the time (an association of local authorities). During the winter of 2004-2005, the landward side of the dike was reinforced with concreted riprap to render it resilient to overtopping. During the 2006 event, a section of 130 m in the same location suffered damage caused by internal erosion in the form of sand boils (Figures 13a, b) and subsidence over a strip of up to 1-2 m wide in the protected plain close to the dike, including the maintenance track, and cracking of the concreted riprap (Figures 13c, d).

Figure 13. a) Sand boil (photo: Pierre Philippe, CEMAGREF), b) Multiple sand boils close to the maintenance track on the landward side of the dike (photo: Patrice Mériaux, CEMAGREF), c) Damage to the dike itself: cracks on the crest and in the riprap landside revetment (photo: Pierre Philippe, CEMAGREF), d) Damage to the dike itself: crack on the crest; this picture was taken in 2013 but similar damage occurred in 2006 (photo: Patrice Mériaux, Irstea).

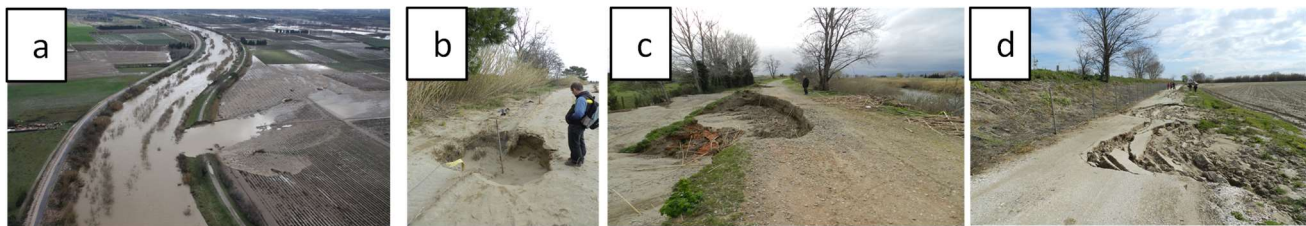
The discharge during this event is also estimated to have been approximately 1000 m³/s. There was a breach over a 75-m section in one of the areas prone to sand boils (Figure 14a). The dike itself was eroded, as well as its foundations down to the depth of the minor river bed. The exact cause of the breach is not known because there were no eyewitnesses close to the dike at the time of the breach initiation about 2 hours after the maximum discharge. The breach may have been caused by internal erosion in the dike or the foundation soils, with possible local overtopping following internal erosion and collapse. A large sinkhole was found close to the breach (Figure 14b). Significant additional damage was observed as a result of overflowing (Figure 14c), internal erosion and foundation instability (Figure 14d), as well as internal erosion in the dike itself at one location.

Figure 14. a) The March 2013 breach at the Pia location on the right of the river (photo: DREAL Languedoc-Roussillon), b) A sinkhole close to the breach (photo: Patrice Mériaux, Irstea), c) Damage caused by overflowing (photo: Patrice Mériaux, Irstea), d) Damage to a track on the landward side of the dike caused by under-seepage (photo: Patrice Mériaux, Irstea)

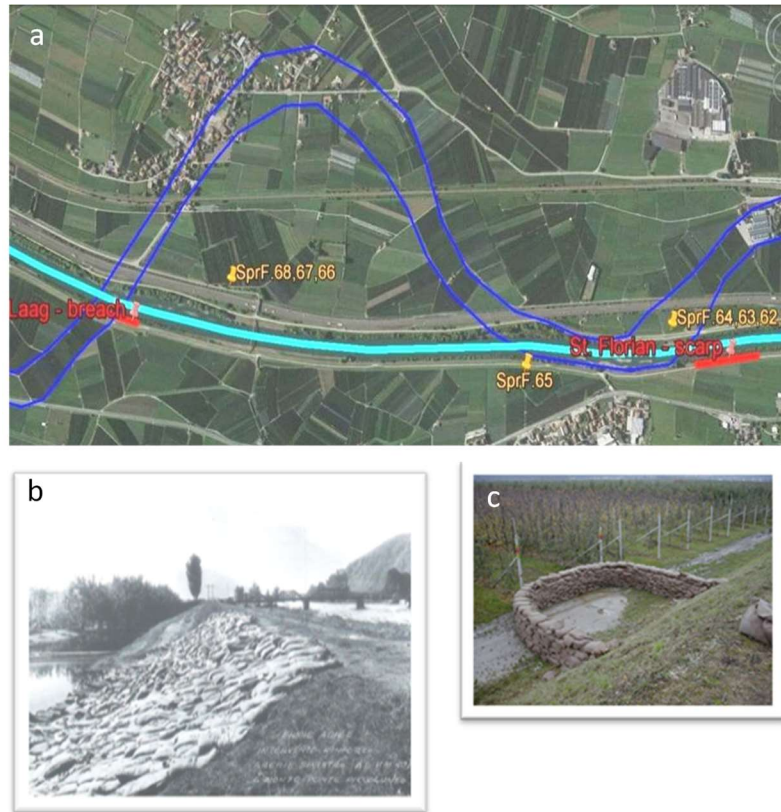
Evidence of water flowing through or underneath the embankment is provided in Figure 18b, c. Pounded backwater often accumulates during a flood event and springs form at the toe of the embankment on the landward side.

The original riverbed meandered through the Adige valley and was straightened at the end of the 19th century, as shown in Figure 18a, by constructing the current embankments. The ancient river bed is filled with material that is coarser than the surrounding clayey and silty deposits. At some places the current riverbed intersects the ancient river beds and locally the embankments are founded on the coarse-grained filling. As a result, the hydraulic conductivity of the embankment foundation at these intersections is relatively high and groundwater flows preferentially through these layers.

Figure 18. (a) Current and ancient river bed profiles and spring formation during the flood events in 1997 and 2000 (b) Backwater areas during the 1966 flood (c) Spring formation during the 1997 flood event

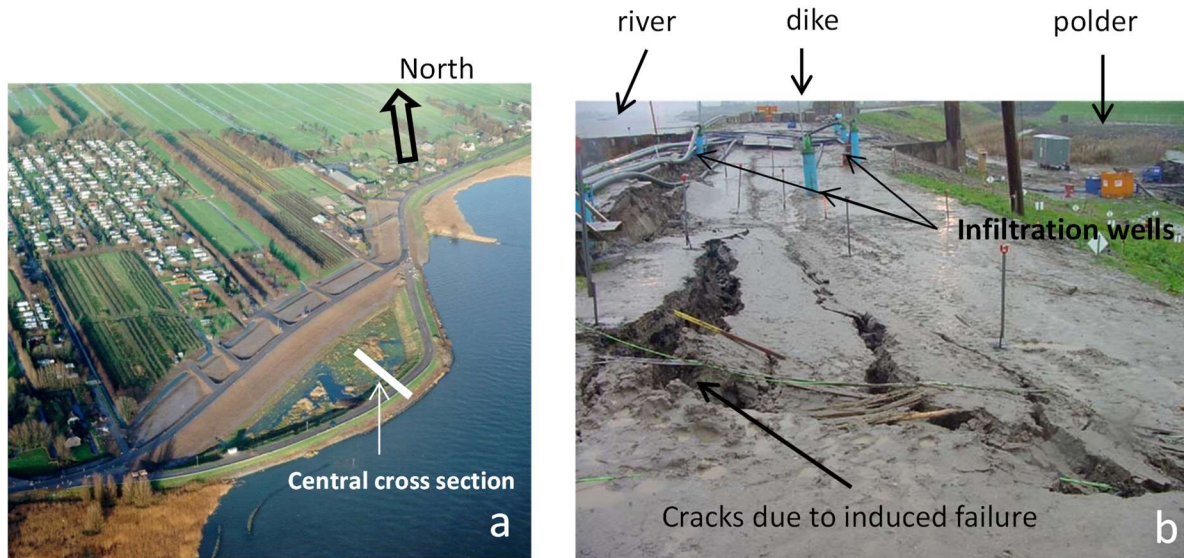
Figure 27. Test site, a; aerial photograph before testing, arrow indicates North direction, white line indicates the location of the central cross section shown by Figure 29, b; failed dike body after testing

The test began at 06.00 on 26 November 2000, $t = 0$ in the graphs below. Figure 32 shows the river level and the average head in the nine infiltration wells. Infiltration started at $t = 370$ min, 6 hours after the start of the test. Initially, the hydraulic head in the wells followed the fluctuations in the river level. It should be noted that the test site is close to the sea and that the tidal wave has a pronounced influence on the water level in front of the dike. Although drinking water was used for infiltration, the infiltration wells clogged up after 26 hours, $t = 1580$ min, reducing well capacity. Due to maintenance, required to regain the full pumping capacity, the hydraulic head was seen to fall between $t = 1580$ and 2260 min, a period of 11.3 hours (Figure 32). Maintenance was also needed between $t = 3090$ and 3308 min, a period of 3.6 hours. Failure was observed at $t = 3450$ min, approximately 2.5 days after the start of the test, in the form of large longitudinal cracks in the dike body accompanied by major subsoil deformation (see Figures 33 and 34). The difference in height at the location of the cracks increased to more than 1.0 m (Figure 27b).

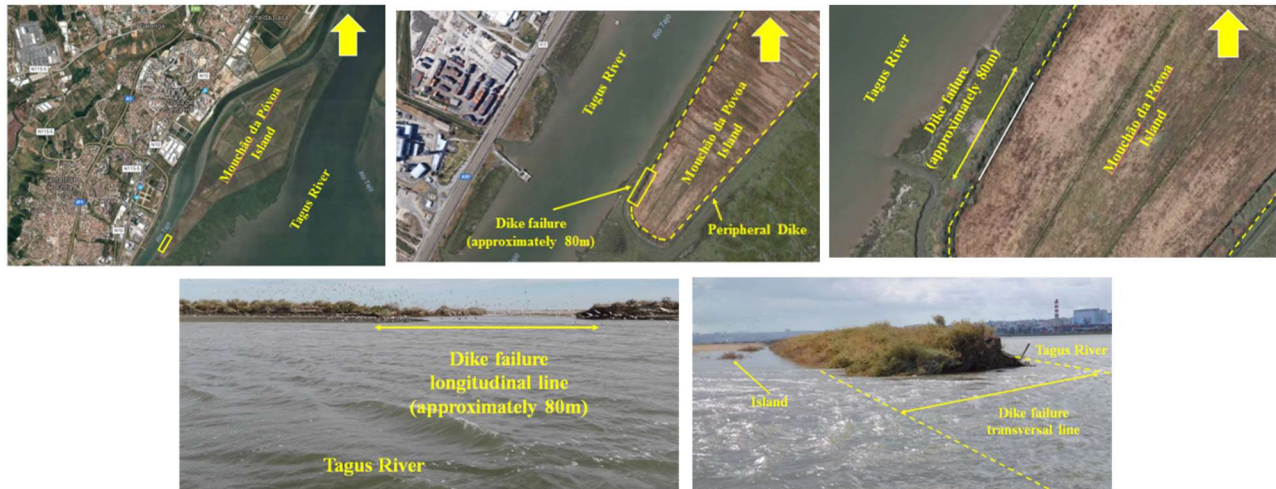
on an alluvium layer protected on the outer face by riprap (rock armour) revetment. The island has been used for agriculture for at least the last 80 years. Figure 38 provides views of the failure that occurred on March 2016.

Figure 38. Location and view of the dike failure.

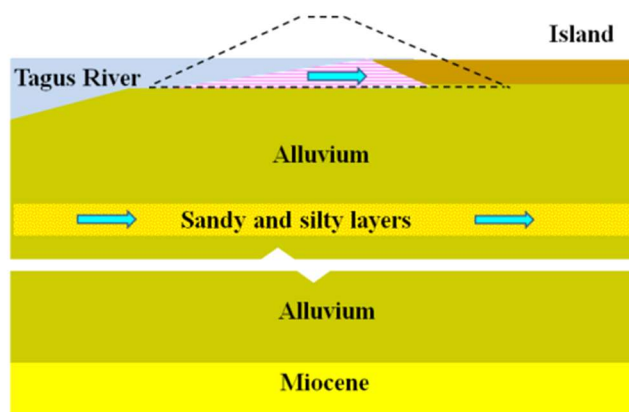
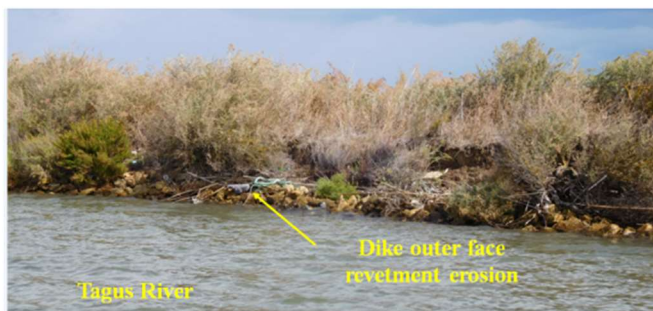
The main failure mechanism is related to the erosion of the clay fill due to water inflow and the mechanical action of the waves on the outer face of the dike. Failure originated with the erosion of the riprap revetment (Figure 39). The presence of a permeable sandy layer below the dike foundations also contributed to the failure mechanism. The actual dike failure began during the severe winter of 2015 - 2016 and involved a section with an overall length of approximately 30 m. When the failure occurred, the water level in the Tagus River was approximately Mean Sea Level, MSL, +4.20 m. In October 2016, the overall length of the dike failure line had increased to approximately 80 m.

Dike Cross Section – Failure
 Failure due to the clay fill erosion (Tagus river waves start to erode the rip rap revetment)

Figure 40. Dike failure due to the erosion of the clay fill, cross-section and view of the outer face.

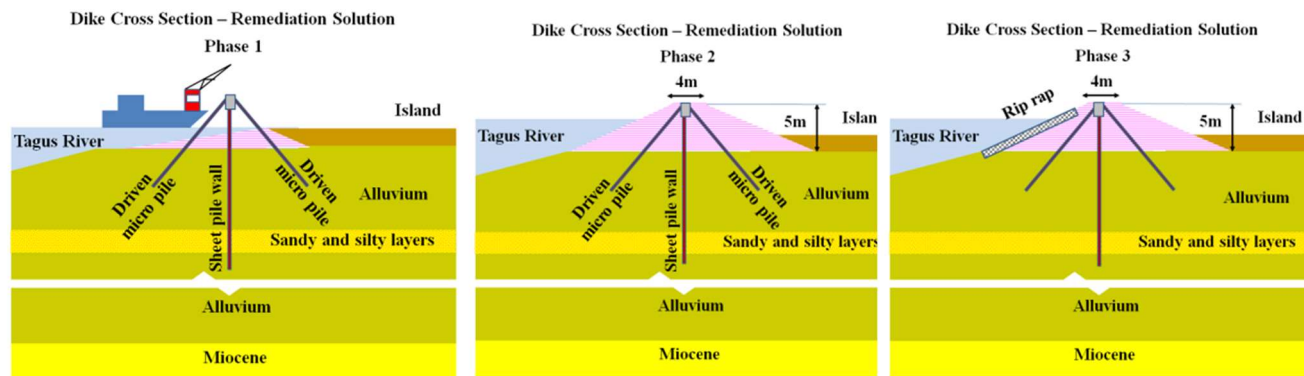
Figure 41. Dike remediation: main construction phases.

The proposed dike remediation solutions comprised the use of a driven sheet-pile wall braced by inclined driven steel micro-piles, all capped with a top and a central, reinforced, concrete beam. Those works are to be performed from a barge at high tide. The depth of the sheet pile walls will have to be enough to pass through the silty and sandy alluvial layers. A protection and stabilisation fill will be required on both the outer and inner sides of the sheet piling. On the outer face of the fill, a riprap protection revetment will be required to protect the fill from hydraulic erosion. Figure 41 illustrates the reconstruction works.
