Lessons Learned from Dike Failures in Recent Decades

ABSTRACT: *The paper describes five different dike failures that occurred in recent decades. The case histories were located on different rivers and involved different loading conditions. The observed failure mechanisms involved erosion and stability problems. The types of erosion observed were both internal erosion due to extreme groundwater flow and external erosion caused by the river flow and wave action. The case involving instability was caused by uplift, i.e., increased hydraulic head led to a sharp reduction in maximum shear strength between subsoil layers. Two cases demonstrate the importance of dike management and maintenance. Despite the variations in the loading conditions and failure mechanisms, all the cases show that the strength of a dike depends not only on the material used to build the dike but also on the strength of the subsoil.*

Lessons Learned from Dike Failures in Recent Decades. International Journal of Geoenvironment Case histories, Vol.4, Issue 3, p.203-229. doi: 10.4417/IJGCH-04-03-04

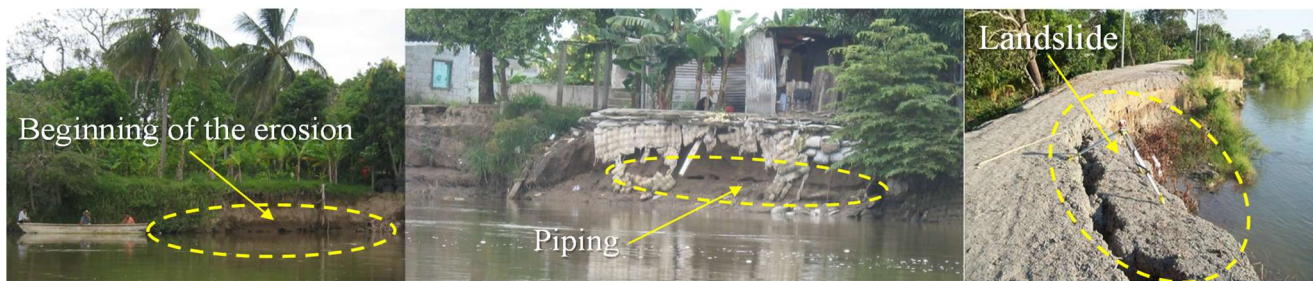
Figure 4. Evidence of instability in river banks and dikes induced by rapid drawdown in Villahermosa.

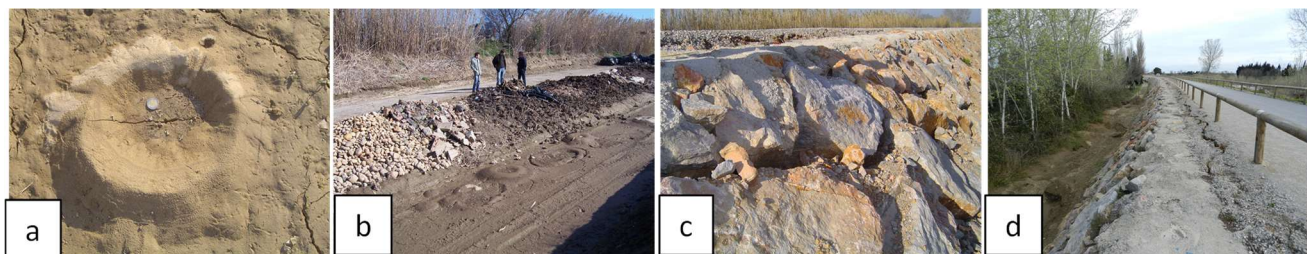
This was also a moderate event: about 800 m³/s at Rivesaltes. However, it lasted longer: 18 hours rather than the 12 hours in the November 2005 event. The dikes were loaded up to 1/2 to 2/3 of their height. CEMAGREF quickly conducted an inspection of a section of 500 m which had been identified in 1999 as being prone to sand boils. A recommendation had been made to install a drainage and seepage system on the landward side. Some of this work had been completed in 2000 with supervision from the managing authority at the time (an association of local authorities). During the winter of 2004-2005, the landward side of the dike was reinforced with concreted riprap to render it resilient to overtopping. During the 2006 event, a section of 130 m in the same location suffered damage caused by internal erosion in the form of sand boils (Figures 13a, b) and subsidence over a strip of up to 1-2 m wide in the protected plain close to the dike, including the maintenance track, and cracking of the concreted riprap (Figures 13c, d).

Figure 13. a) Sand boil (photo: Pierre Philippe, CEMAGREF), b) Multiple sand boils close to the maintenance track on the landward side of the dike (photo: Patrice Mériaux, CEMAGREF), c) Damage to the dike itself: cracks on the crest and in the riprap landside revetment (photo: Pierre Philippe, CEMAGREF), d) Damage to the dike itself: crack on the crest; this picture was taken in 2013 but similar damage occurred in 2006 (photo: Patrice Mériaux, Irstea).

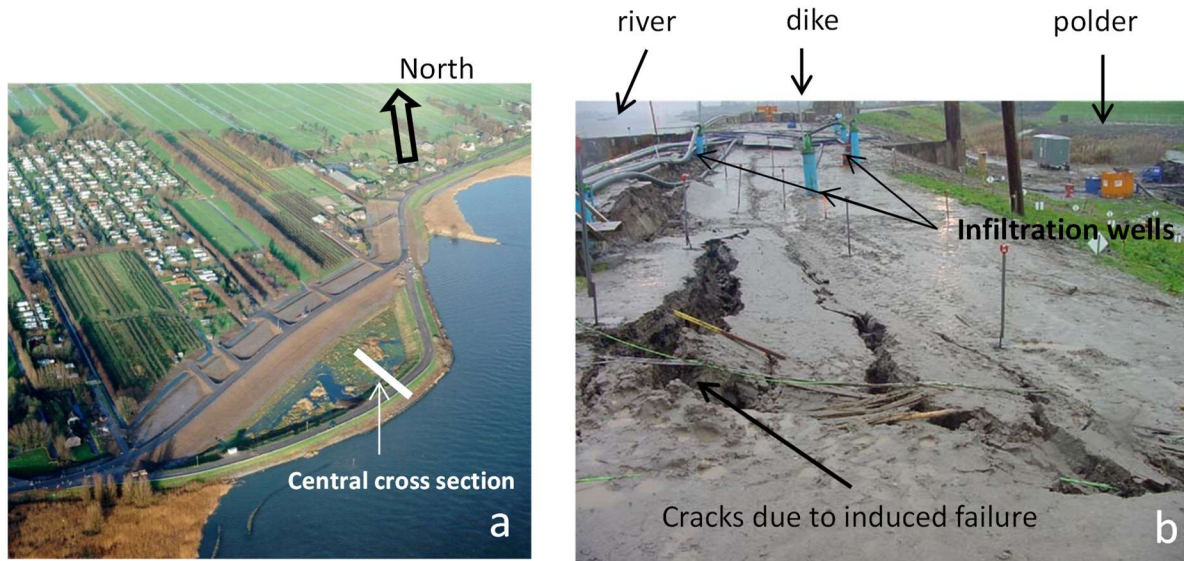
Figure 27. Test site, a; aerial photograph before testing, arrow indicates North direction, white line indicates the location of the central cross section shown by Figure 29, b; failed dike body after testing

The test began at 06.00 on 26 November 2000, $t = 0$ in the graphs below. Figure 32 shows the river level and the average head in the nine infiltration wells. Infiltration started at $t = 370$ min, 6 hours after the start of the test. Initially, the hydraulic head in the wells followed the fluctuations in the river level. It should be noted that the test site is close to the sea and that the tidal wave has a pronounced influence on the water level in front of the dike. Although drinking water was used for infiltration, the infiltration wells clogged up after 26 hours, $t = 1580$ min, reducing well capacity. Due to maintenance, required to regain the full pumping capacity, the hydraulic head was seen to fall between $t = 1580$ and 2260 min, a period of 11.3 hours (Figure 32). Maintenance was also needed between $t = 3090$ and 3308 min, a period of 3.6 hours. Failure was observed at $t = 3450$ min, approximately 2.5 days after the start of the test, in the form of large longitudinal cracks in the dike body accompanied by major subsoil deformation (see Figures 33 and 34). The difference in height at the location of the cracks increased to more than 1.0 m (Figure 27b).

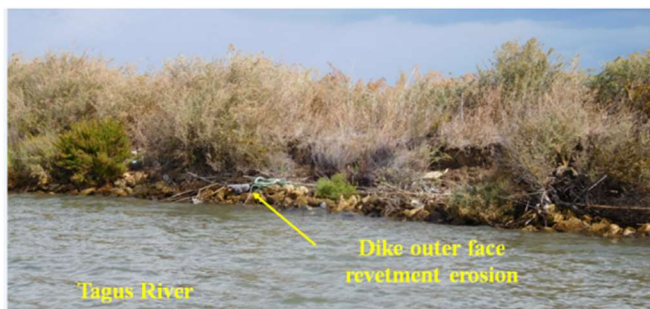
The main failure mechanism is related to the erosion of the clay fill due to water inflow and the mechanical action of the waves on the outer face of the dike. Failure originated with the erosion of the riprap revetment (Figure 39). The presence of a permeable sandy layer below the dike foundations also contributed to the failure mechanism. The actual dike failure began during the severe winter of 2015 - 2016 and involved a section with an overall length of approximately 30 m. When the failure occurred, the water level in the Tagus River was approximately Mean Sea Level, MSL, +4.20 m. In October 2016, the overall length of the dike failure line had increased to approximately 80 m.

Dike Cross Section – Failure
Failure due to the clay fill erosion (Tagus river waves start to erode the rip rap revetment)

Figure 40. Dike failure due to the erosion of the clay fill, cross-section and view of the outer face.
