Lessons Learned from Dike Failures in Recent Decades

ABSTRACT: *The paper describes five different dike failures that occurred in recent decades. The case histories were located on different rivers and involved different loading conditions. The observed failure mechanisms involved erosion and stability problems. The types of erosion observed were both internal erosion due to extreme groundwater flow and external erosion caused by the river flow and wave action. The case involving instability was caused by uplift, i.e., increased hydraulic head led to a sharp reduction in maximum shear strength between subsoil layers. Two cases demonstrate the importance of dike management and maintenance. Despite the variations in the loading conditions and failure mechanisms, all the cases show that the strength of a dike depends not only on the material used to build the dike but also on the strength of the subsoil.*

Lessons Learned from Dike Failures in Recent Decades. International Journal of Geoenvironment Case histories, Vol.4, Issue 3, p.203-229. doi: 10.4417/IJGCH-04-03-04

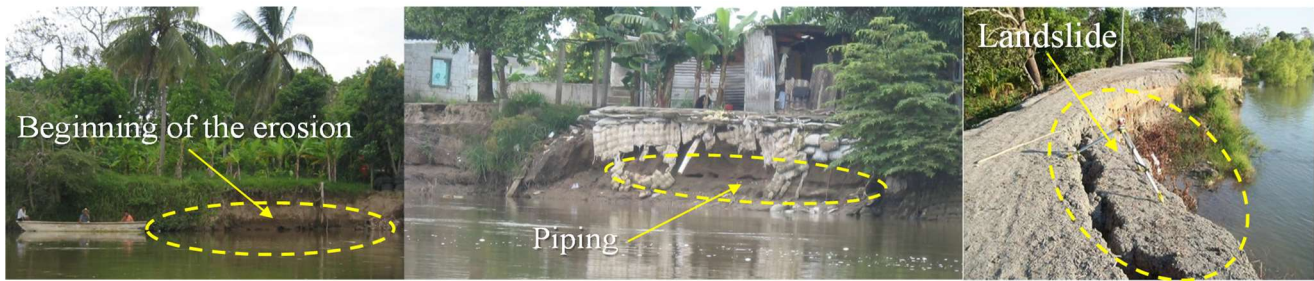
Figure 4. Evidence of instability in river banks and dikes induced by rapid drawdown in Villahermosa.

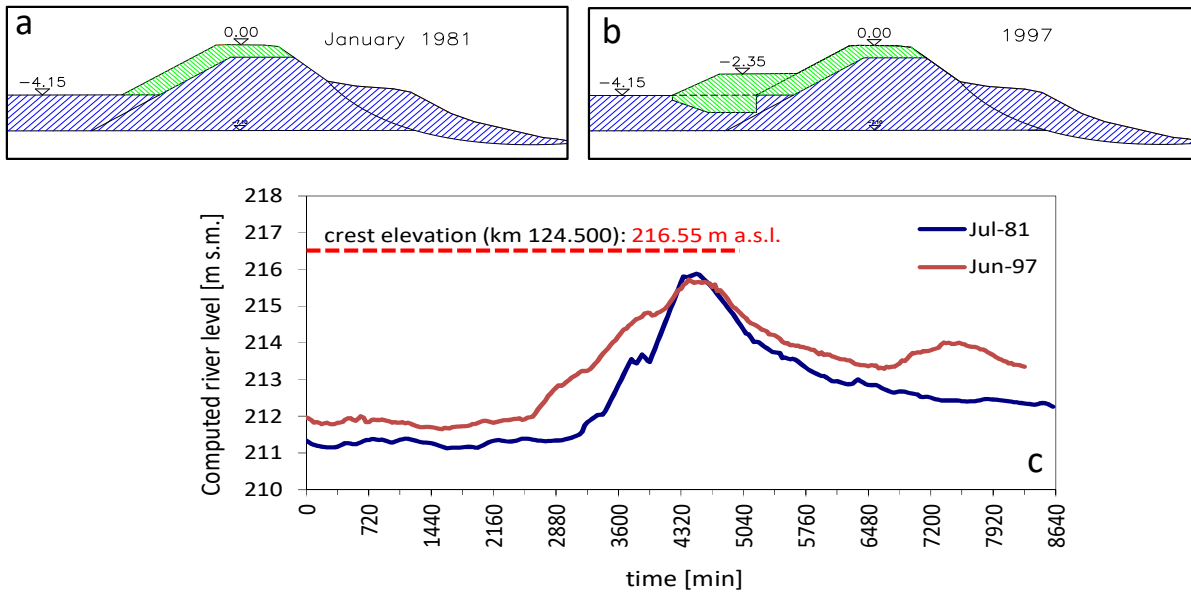
During the flood event in 1997, which was even more intense than the one in 1981 (Figure 19c) no collapse phenomena were observed in the segments that had experienced instability in 1981. This can be attributed to the construction of the berm and the increased stability on the landward side.

Figure 19. a) cross section during the flood event in 1981 b) remedial works consisting of a berm on the landward side, c) the river level during the flood events in 1981 and 1997 The elevation of the embankment crest is also reported as a reference.

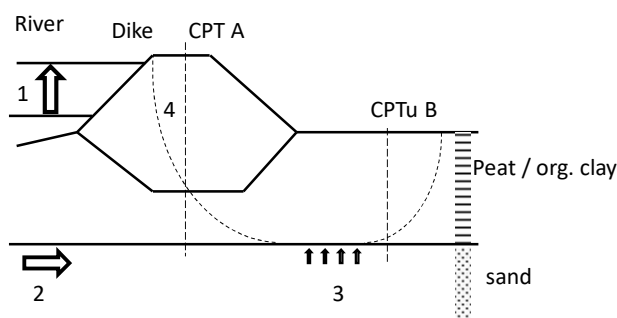
Figure 28. Impression of the uplift failure mechanism, 1: river level rise, 2: hydraulic connection to sand layer, 3: pore pressure rise until uplift top layer, 4: failure plane.

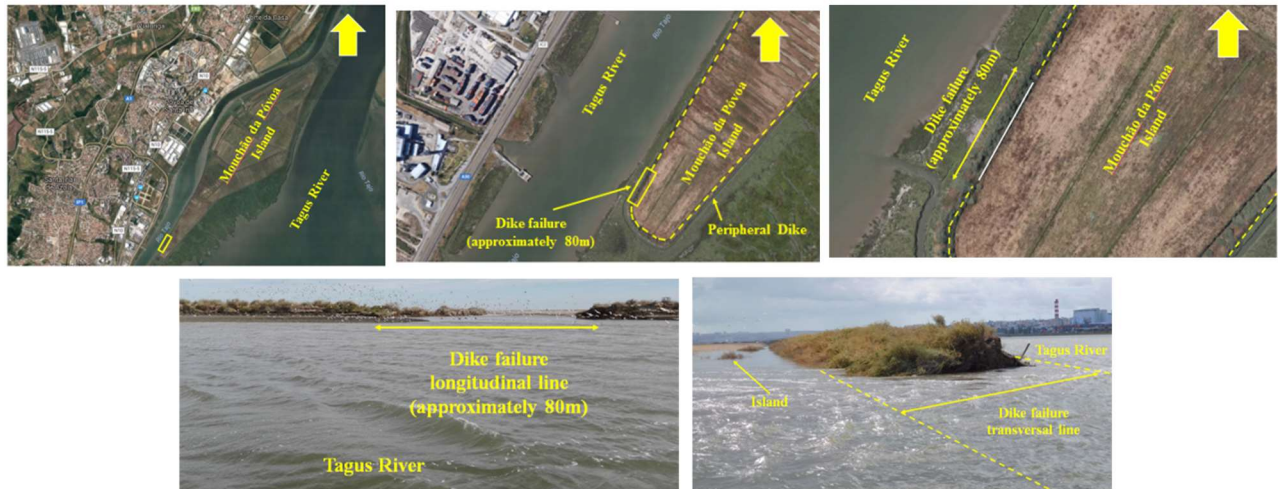
on an alluvium layer protected on the outer face by riprap (rock armour) revetment. The island has been used for agriculture for at least the last 80 years. Figure 38 provides views of the failure that occurred on March 2016.

Figure 38. Location and view of the dike failure.
