Lessons Learned from Dike Failures in Recent Decades

ABSTRACT: *The paper describes five different dike failures that occurred in recent decades. The case histories were located on different rivers and involved different loading conditions. The observed failure mechanisms involved erosion and stability problems. The types of erosion observed were both internal erosion due to extreme groundwater flow and external erosion caused by the river flow and wave action. The case involving instability was caused by uplift, i.e., increased hydraulic head led to a sharp reduction in maximum shear strength between subsoil layers. Two cases demonstrate the importance of dike management and maintenance. Despite the variations in the loading conditions and failure mechanisms, all the cases show that the strength of a dike depends not only on the material used to build the dike but also on the strength of the subsoil.*

Lessons Learned from Dike Failures in Recent Decades. International Journal of Geoengineering Case histories, Vol.4, Issue 3, p.203-229. doi: 10.4417/IJGCH-04-03-04

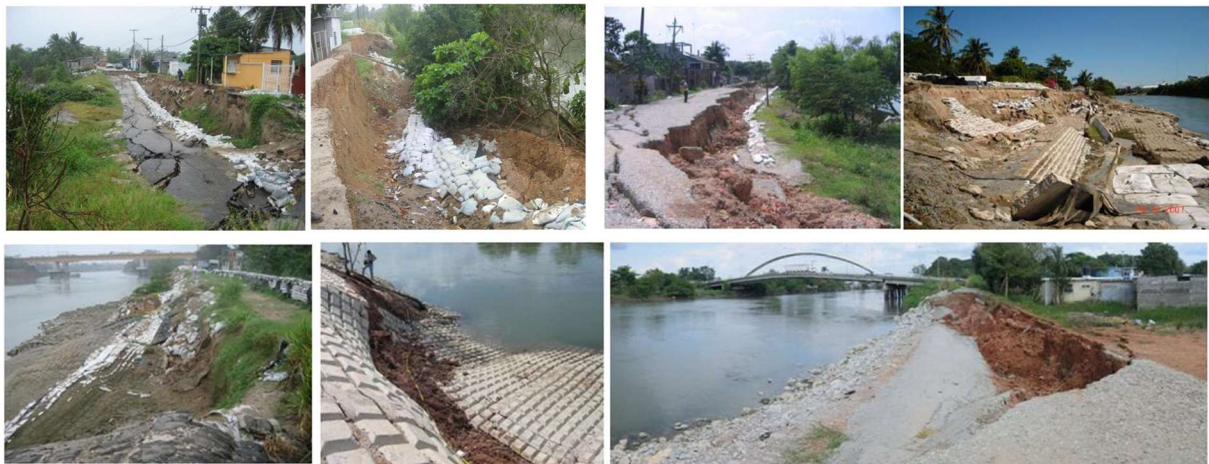
gradients generated by these fluctuations – and rain infiltration in the crests of the dikes (Figure 3). Auvinet et al. (2008) observed that problems in river banks commonly begin with erosion which, depending on the type of soil, can cause piping in some areas, possibly resulting in landslides (Figure 4). These eroded sections are generally protected with dikes consisting of clayey material. Elements that can better withstand erosion by river water are also used, examples being rock fill, systems with concrete bags (*bolsacreto* or *colchacreto*), breakwaters or sheet pile walls. River embankments may also fail when the weight of these structures exceeds the bearing capacity of the foundation soil (Figure 3). Generally, failure occurs in layers with low shear strength such as the highly compressible clays and peats which are found in unpredictable locations along the banks of the rivers in Villahermosa (Figure 1). It has also been found that factors such as scour of the riverbed and overloading caused by the weight of additional protection such as sand bags result in dike instability. In addition, intense rainfall in the region can cause large and rapid variations in the levels of local rivers, lagoons and reservoirs.

Figure 3. Consequences of water drawdown in Tabasco State, Mexico

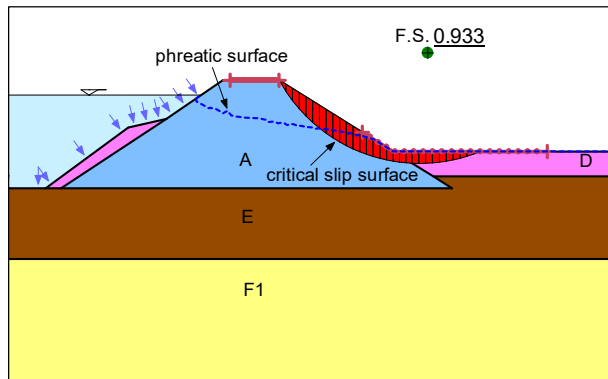
Figure 24. Stability analysis and relevant soil parameters at flood peak and transient flow condition of the section at km 124.62 in Laag; $c' = 0 \text{ kN/m}^2$

where σ_n is the normal stress, θ_w is the volumetric water content, θ_s is the saturated volumetric water content and θ_r is the residual volumetric water content. The results of the stability analyses at flood peak for the two cross-sections based on transient flow conditions are shown in Figures 24 and 25. The stability analysis consistently returns factors of safety < 1 for these sections, which proved to be unstable in 1981.

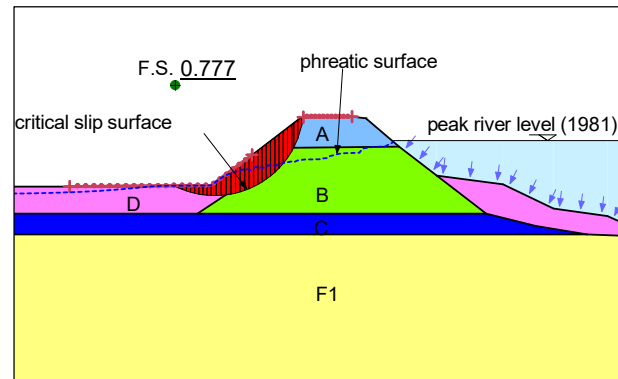
Figure 25. Stability analysis and relevant soil parameters at flood peak and transient flow conditions of the section at km 122.248 in St. Florian; $c' = 0 \text{ kN/m}^2$.

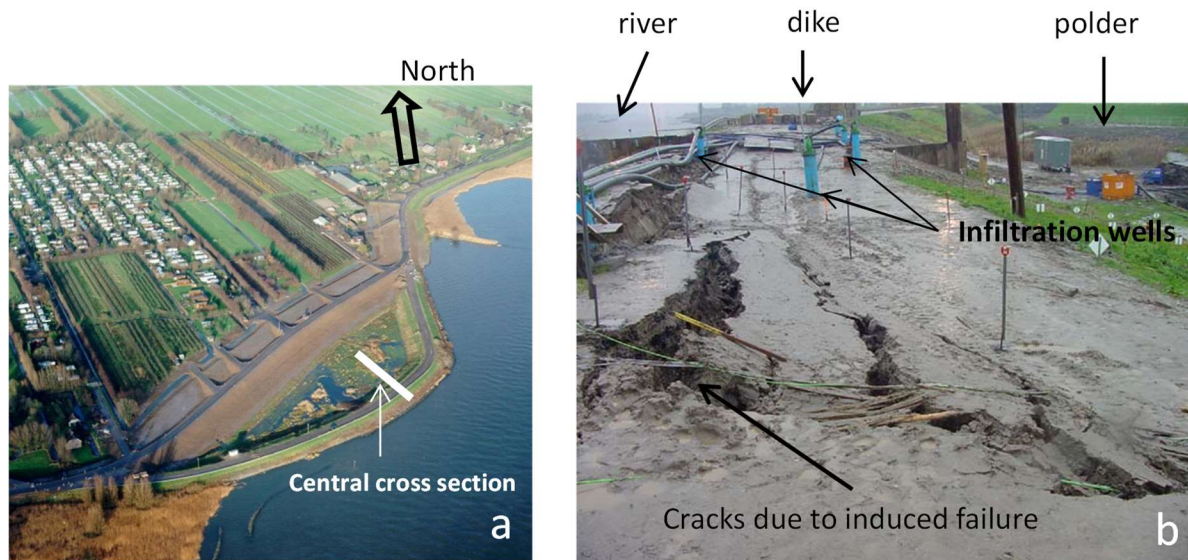
Figure 27. Test site, a; aerial photograph before testing, arrow indicates North direction, white line indicates the location of the central cross section shown by Figure 29, b; failed dike body after testing

The test began at 06.00 on 26 November 2000, $t = 0$ in the graphs below. Figure 32 shows the river level and the average head in the nine infiltration wells. Infiltration started at $t = 370$ min, 6 hours after the start of the test. Initially, the hydraulic head in the wells followed the fluctuations in the river level. It should be noted that the test site is close to the sea and that the tidal wave has a pronounced influence on the water level in front of the dike. Although drinking water was used for infiltration, the infiltration wells clogged up after 26 hours, $t = 1580$ min, reducing well capacity. Due to maintenance, required to regain the full pumping capacity, the hydraulic head was seen to fall between $t = 1580$ and 2260 min, a period of 11.3 hours (Figure 32). Maintenance was also needed between $t = 3090$ and 3308 min, a period of 3.6 hours. Failure was observed at $t = 3450$ min, approximately 2.5 days after the start of the test, in the form of large longitudinal cracks in the dike body accompanied by major subsoil deformation (see Figures 33 and 34). The difference in height at the location of the cracks increased to more than 1.0 m (Figure 27b).

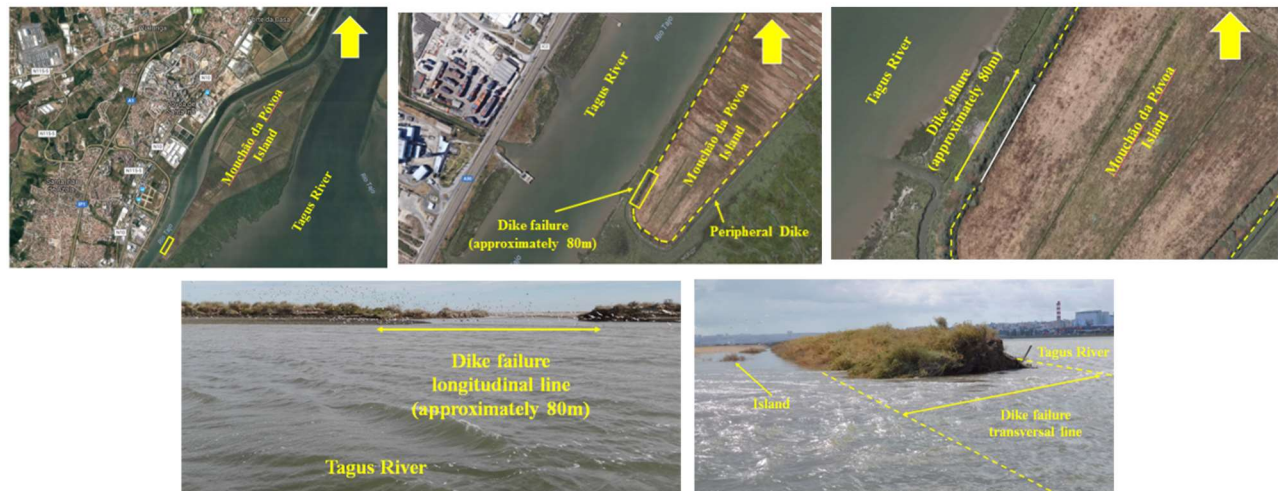
on an alluvium layer protected on the outer face by riprap (rock armour) revetment. The island has been used for agriculture for at least the last 80 years. Figure 38 provides views of the failure that occurred on March 2016.

Figure 38. Location and view of the dike failure.

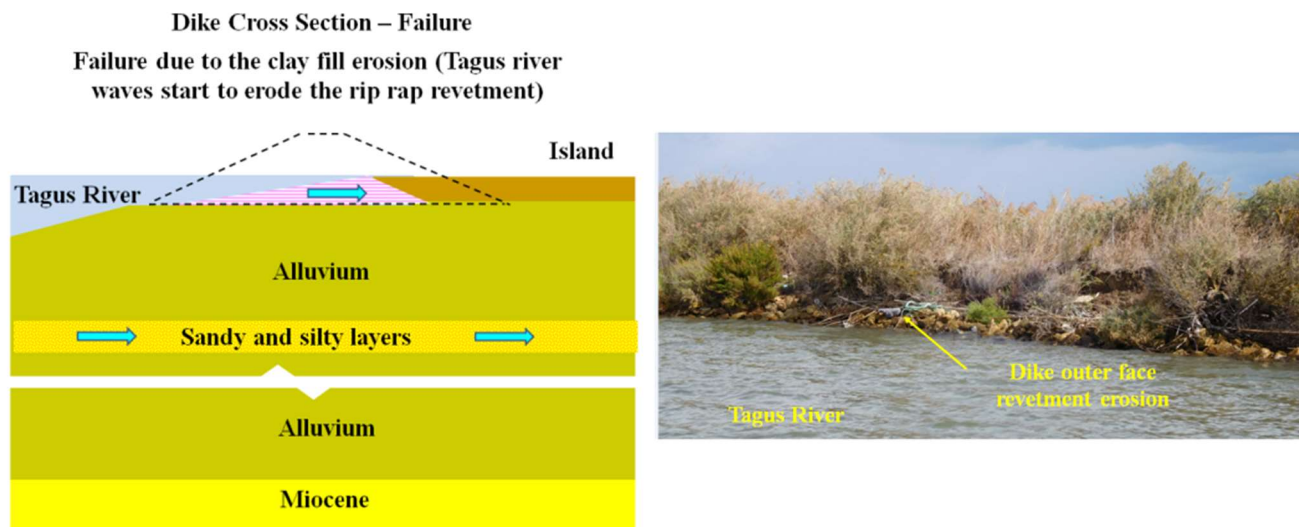
The main failure mechanism is related to the erosion of the clay fill due to water inflow and the mechanical action of the waves on the outer face of the dike. Failure originated with the erosion of the riprap revetment (Figure 39). The presence of a permeable sandy layer below the dike foundations also contributed to the failure mechanism. The actual dike failure began during the severe winter of 2015 - 2016 and involved a section with an overall length of approximately 30 m. When the failure occurred, the water level in the Tagus River was approximately Mean Sea Level, MSL, +4.20 m. In October 2016, the overall length of the dike failure line had increased to approximately 80 m.

Figure 40. Dike failure due to the erosion of the clay fill, cross-section and view of the outer face.

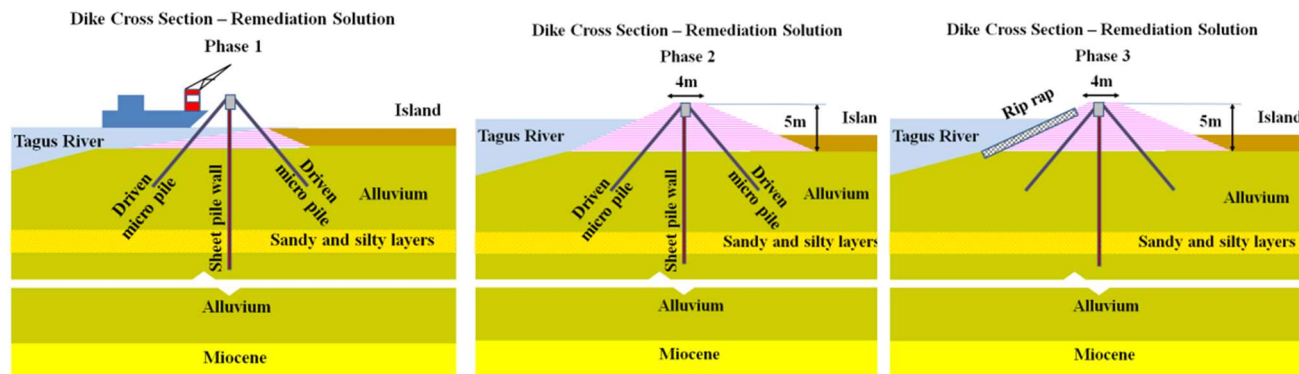
Figure 41. Dike remediation: main construction phases.

The proposed dike remediation solutions comprised the use of a driven sheet-pile wall braced by inclined driven steel micro-piles, all capped with a top and a central, reinforced, concrete beam. Those works are to be performed from a barge at high tide. The depth of the sheet pile walls will have to be enough to pass through the silty and sandy alluvial layers. A protection and stabilisation fill will be required on both the outer and inner sides of the sheet piling. On the outer face of the fill, a riprap protection revetment will be required to protect the fill from hydraulic erosion. Figure 41 illustrates the reconstruction works.
