Geotechnical Observations of Dams Failed During the 2015 Historic Flooding in South Carolina

ABSTRACT: *This paper presents a description of post-flood reconnaissance and geotechnical investigation of four earthen dams that were breached or damaged following an extreme flooding event in South Carolina in 2015. As a result of unprecedented rainfall and flooding that occurred during a five-day period at the beginning of October in 2015, a total of 51 earthen dams failed and nearly 200 were damaged. Many of these dams failed due to overtopping that led to a breach of the dam. Among the four dams investigated, full breach was observed at three dams; two of which were overtopped, and one was not. The fourth dam was not breached but was severely damaged. For each of these dams, the paper documents background information, pre-flood conditions, post-flood field observations and measurements, and laboratory testing results of collected soil samples. Impacts of vegetation on the dams and the effects of dam failure on critical infrastructure are also presented. The detailed descriptions and geotechnical investigations of the dam failures presented herein serve as case histories that can be u

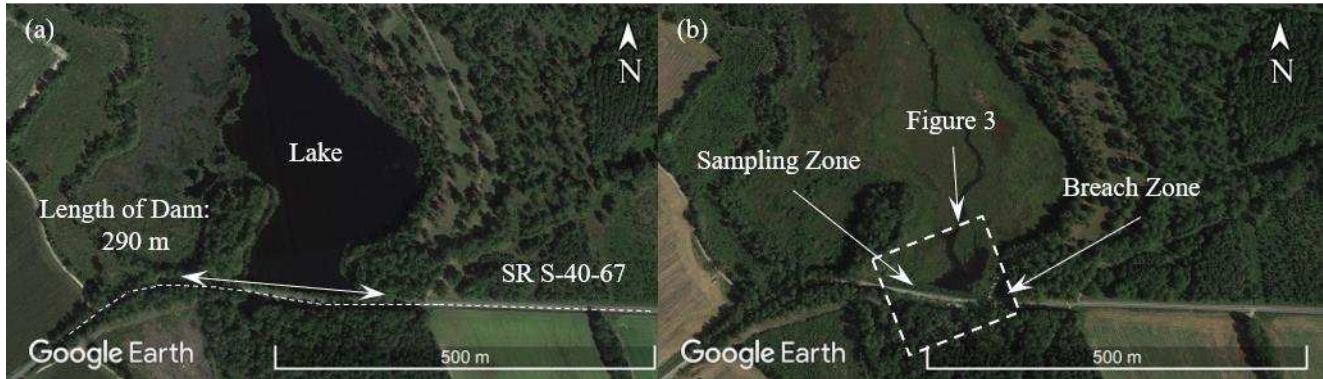
Figure 2. Dam A (a) before and (b) after failure (Google Earth, accessed on April 8, 2018).

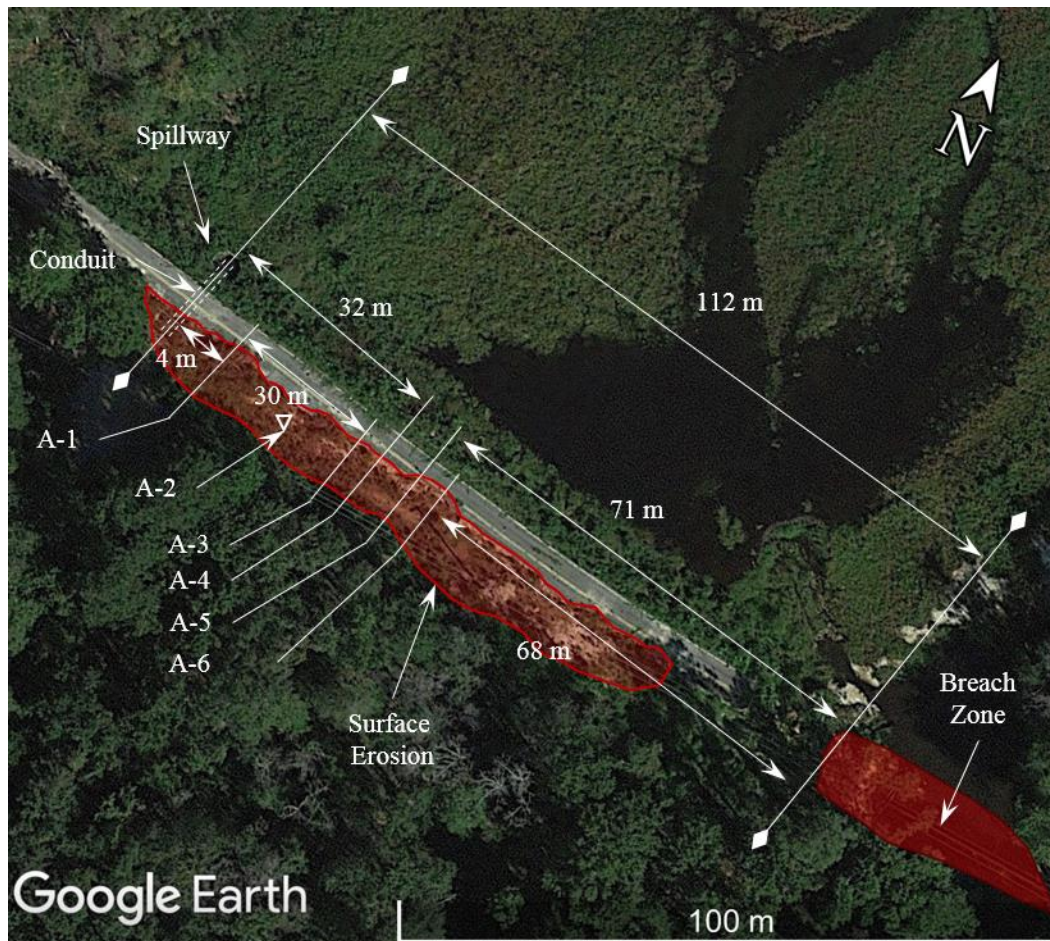
Figure 3. Location of spillway, surface erosion, breach, and sampling locations in Dam A (Google Earth, accessed on April 8, 2018).

The spillway structure of this dam is located on the west side of the dam and about 112 m from the breach zone, as shown in Figure 3. Sampling locations relative to the spillway and the breach zone are also presented in this figure. The spillway is a conduit made of a 1.2 m diameter concrete pipe, as shown in Figure 4a, with a maximum discharge capacity of approximately 17 m³/s (USACE 2016). The soil above the pipe on the downstream side was washed out, as shown in Figure 4b. It is unknown whether this structure worked as the primary spillway of the dam, or if an additional spillway structure existed before the breach.

Damage to this dam includes a complete breach and a large zone of surface erosion separate from the breach, as shown in Figure 3. The breach is located near to the east end of the dam. The breach extended approximately 50 m of the total 290 m length of the dam, and nearly 7,300 m³ of material, including soil and pavement, were washed out (see Figure 6). In the breach zone, several trees on the upstream side slope tipped over the road in the direction of water flow (see Figures 6 and 8), which provides some evidence of overtopping. In the surface erosion zone, the soil erosion along the downstream side slope extended over 60 m parallel to and 20 m perpendicular to the road, as shown in Figures 3, 5b and 7b. As shown in Figure 7a, part of the asphalt shoulder and roadway collapsed above the zone of surface erosion.

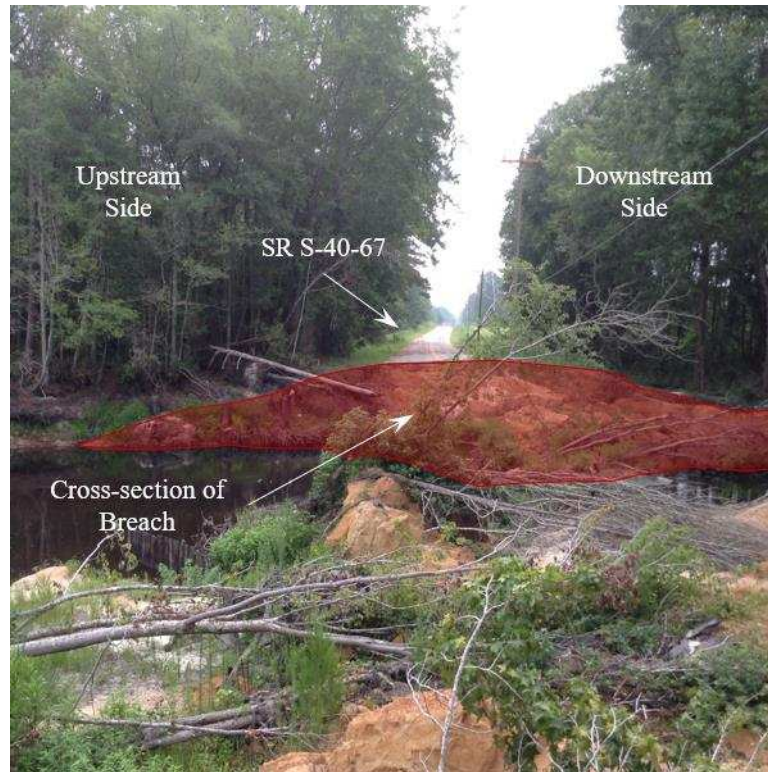
Figure 6. Cross-sectional area of breach in Dam A (east view from SR-40-67).

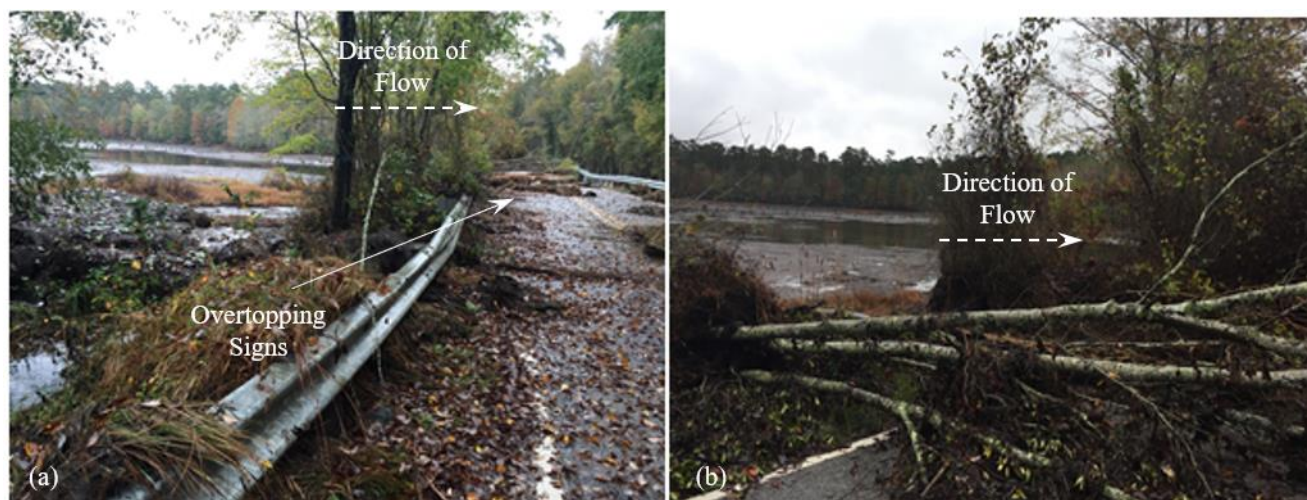
Figure 8. Evidence of overtopping during the flood for Dam A: (a) eroded vegetation and debris on the crest (east view from SR-40-67); and (b) fallen trees on the crest (north view from SR-40-67).

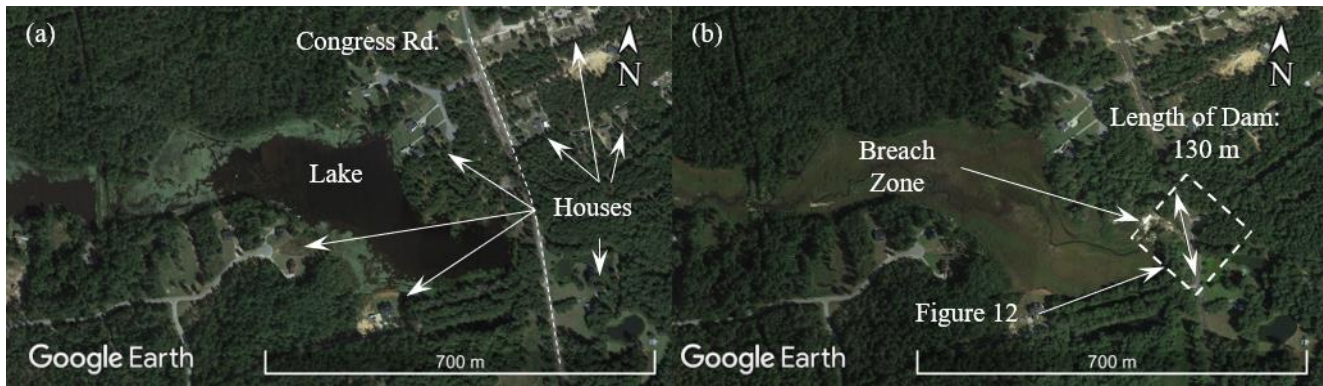
Figure 10. Dam B (a) before and (b) after failure (Google Earth, accessed on April 8, 2018).

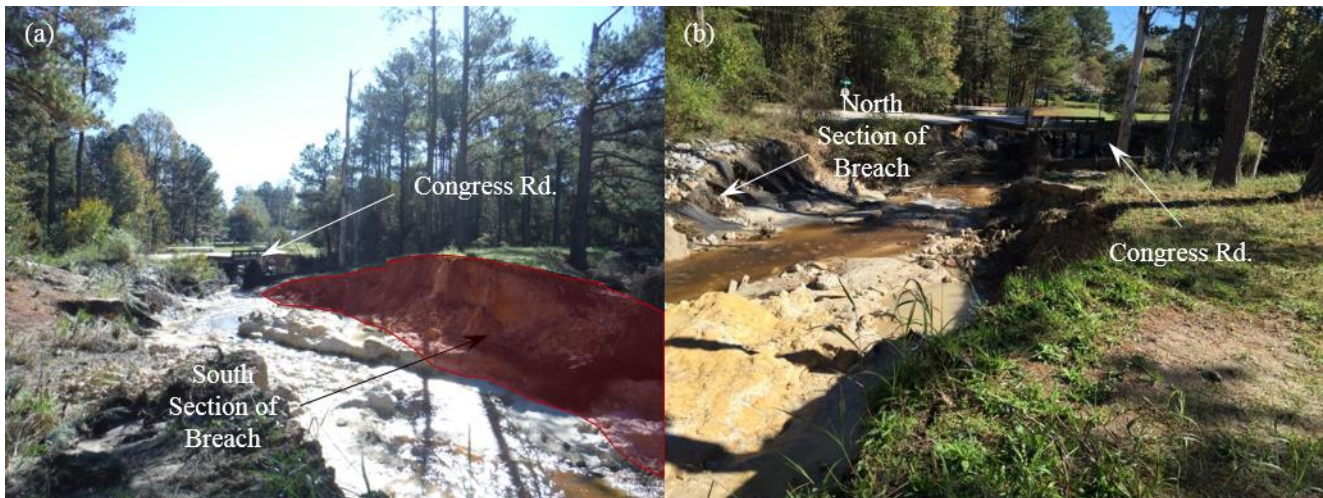
Figure 11. Breach section in Dam B: southeast views from (a) the north section of breach and (b) the south sections of the breach.

The dam was completely breached during the flood as shown in Figure 11. The location of the breach (see Figure 12) was close to the north end of the dam and close to the supposed original location of the second spillway riser pipe. The breach was approximately 15 m of the total 130 m length of the dam. Nearly 1,050 m³ of embankment material was washed out during the flood event. Surface erosion was observed along the downstream side slope extending along the entire length of the dam, as shown in Figure 16. Trees on the downstream side slope of the dam were partially or fully tipped over and some appeared to be displaced (Figure 15b). These observations might indicate overtopping of the dam.

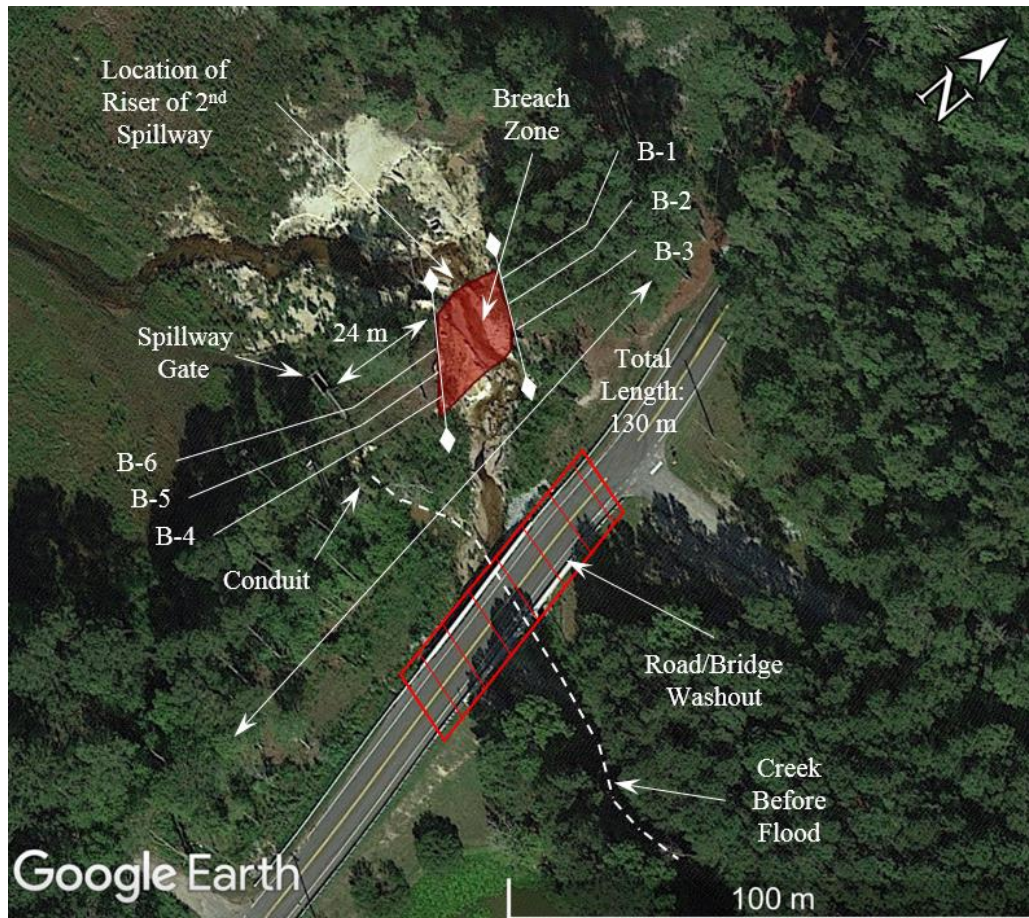
Figure 12. Location of spillways and breach in Dam B (Google Earth, accessed on April 8, 2018).

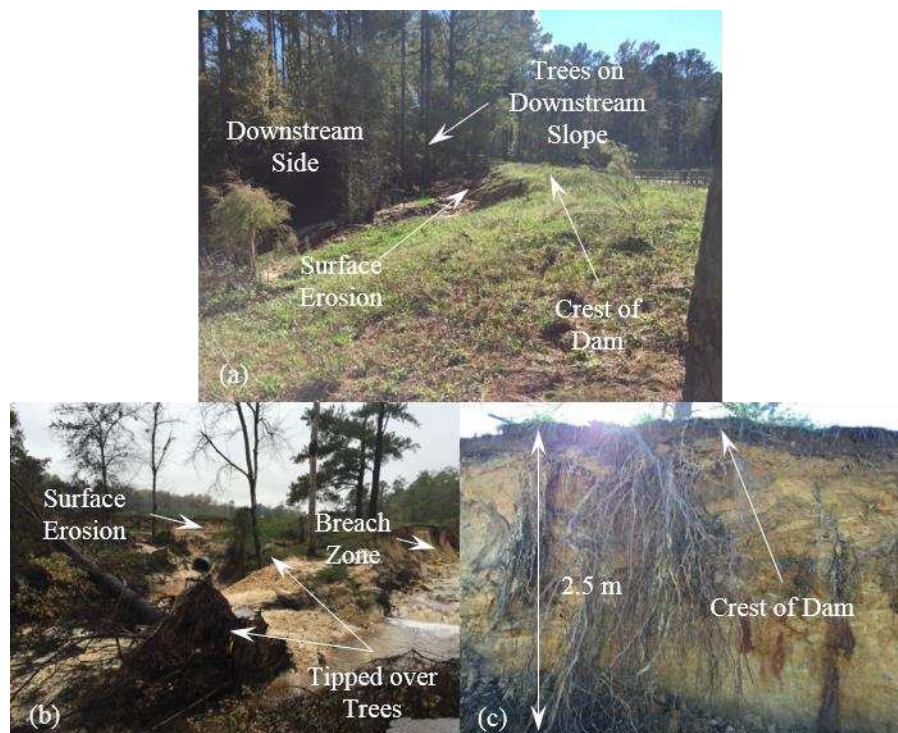
Vegetation was observed over the entire surface of the dam (see Figure 15). The upstream side-slope and crest of the dam are covered with grass and shrubs with heights less than 1 m. Several mature trees with heights from 15 to 18 m were observed on the crest and downstream side-slope of the dam (see Figures 15a and 15b). The roots of one of these trees were exposed by the dam breach, as shown in Figure 15c. The roots reach depths of nearly 2.5 m, penetrating through the upper half and into the lower half of the 4.3 m high dam. The SCDHEC inspection report from 2008 (SCDHEC 2016) also highlighted the need of removing vegetation to an acceptable grass cover. It is clear that the vegetation was not removed, as requested.

Figure 15. Vegetation on Dam B: (a) low grasses and small bushes on the dam crest, trees on downstream side slope (south view from crest), (b) tipped over trees near breach and zone of surface erosion (west view from downstream), and (c) presence of roots throughout the dam on the south breach wall (south view from breach).

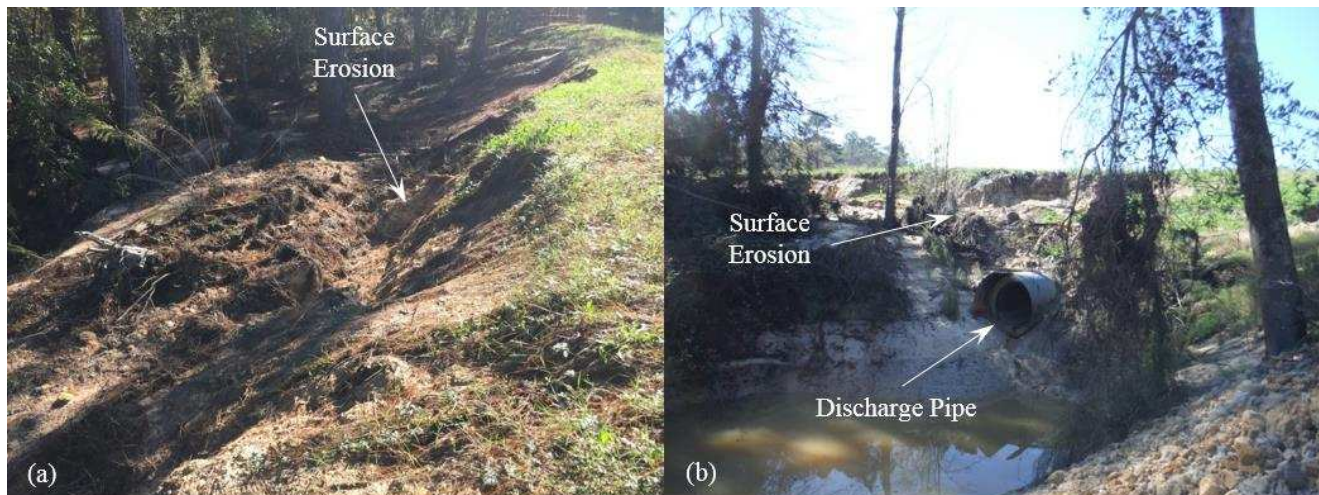
Figure 16. Surface erosion on downstream side slope of Dam B: a) south view from the crest of dam and b) west view from downstream.

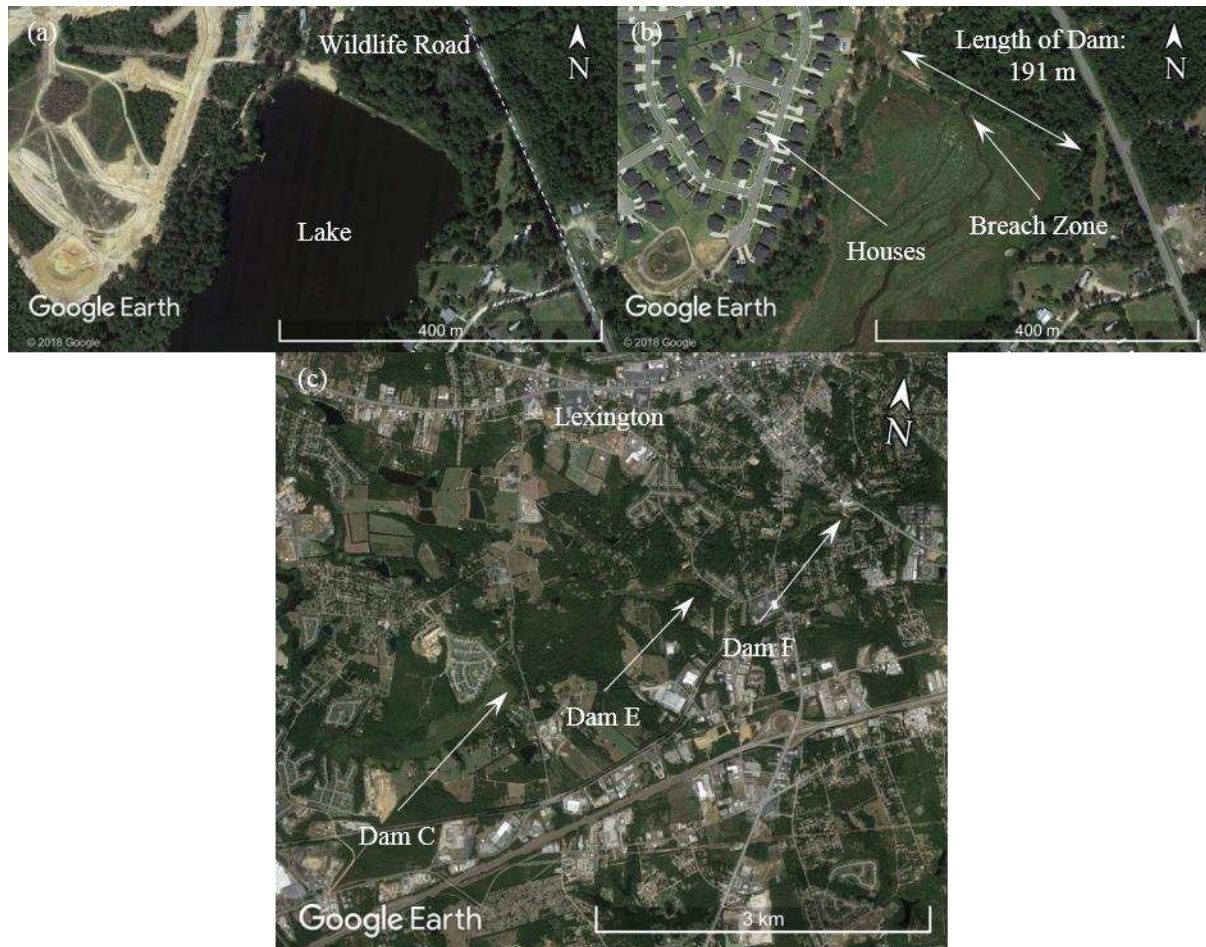
Figure 18. Dam C (a) before and (b) after failure, (c) locations of Dams E and F downstream of Dam C (Google Earth, accessed on April 8, 2018).

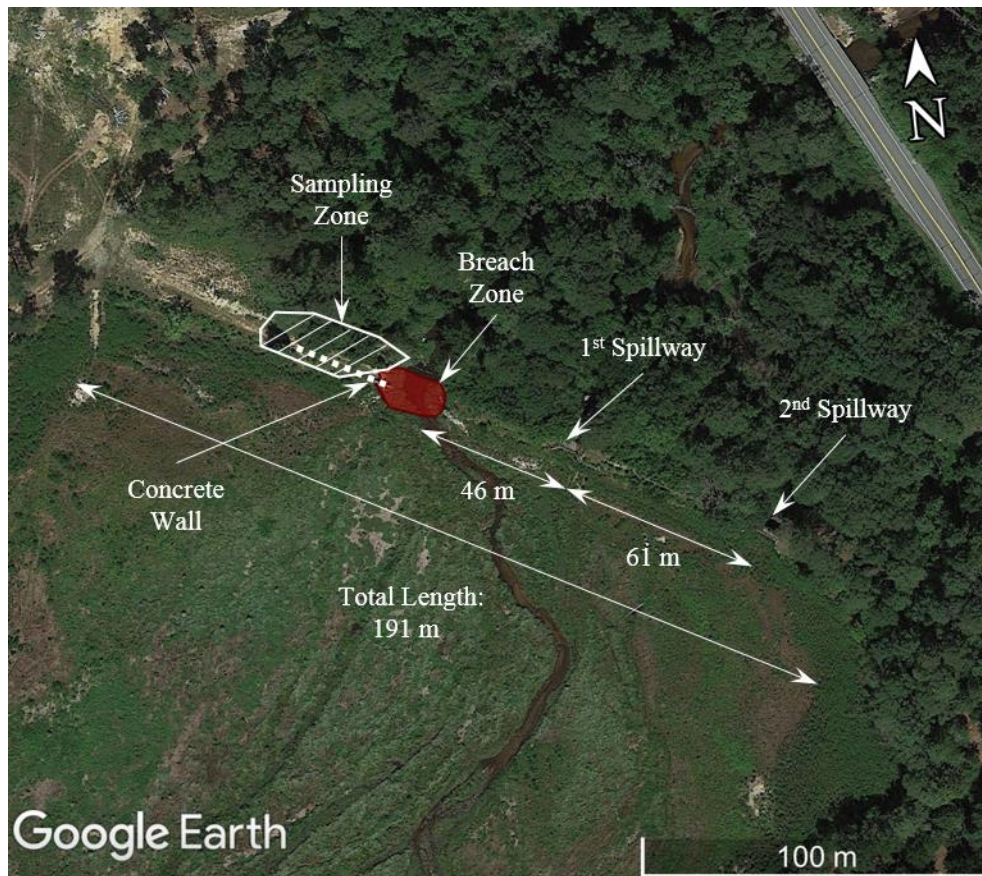
Two spillway systems were found at Dam C as shown in Figure 19. According to USACE (2016), the dam has a maximum discharge capacity of $30 \text{ m}^3/\text{s}$. One of the systems was observed in the middle of the dam (see Figures 20a) and is a spillway gate made of concrete with a length of approximately 9.5 m. The size of the opening in this spillway gate was nearly 2.5 m in width and 9.5 m in height. The spillway system includes a $10 \text{ m} \times 12 \text{ m} \times 8 \text{ m}$ (height x width x length) concrete structure located next to the gate (see Figure 20b). The purpose of this structure is unknown, but it was presumably used for power generation according to the dam owner. The second structure, a spillway gate made of concrete, wood and steel beams (see Figures 20c and 20d), and with a length of approximately 12 m, was found toward the east end of the dam. The opening of this spillway gate was nearly 10 m in length and 2 m in height. Both spillway gates appeared to be in good condition with no observed damage from the flood event. This is expected since the breach zone is 46 m away from the first spillway and 107 m away from the other (see Figure 19). It is unknown whether the spillways worked as primary or emergency drainage systems, or if they were functioning properly before the flood event.

Figure 19. Locations of the breach and the two spillways in Dam C (Google Earth, accessed on April 8, 2018).

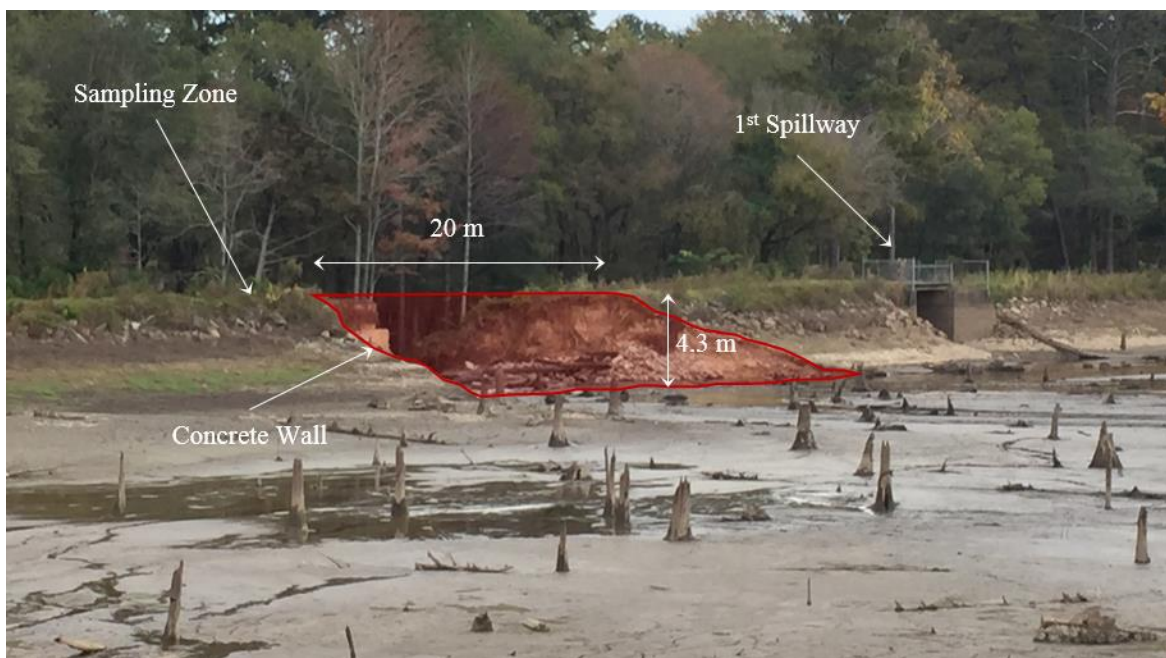
The dam was completely breached during the flood event as shown in Figure 22. The breach was located near the middle of the dam, 46 m northwest from the location of the first spillway gate (see Figure 19). The length of the breach was approximately 20 m of the total 191 m length of the dam, and nearly 900 m³ of soil were washed out. Eyewitnesses during the flood event indicated that overtopping did not occur. Subsequent field observations did not find evidence of surface erosion on the downstream side slope or near the spillways.

Figure 22. Picture of the breached section of Dam C (northeast view from subdivision). Drained pond in the foreground.

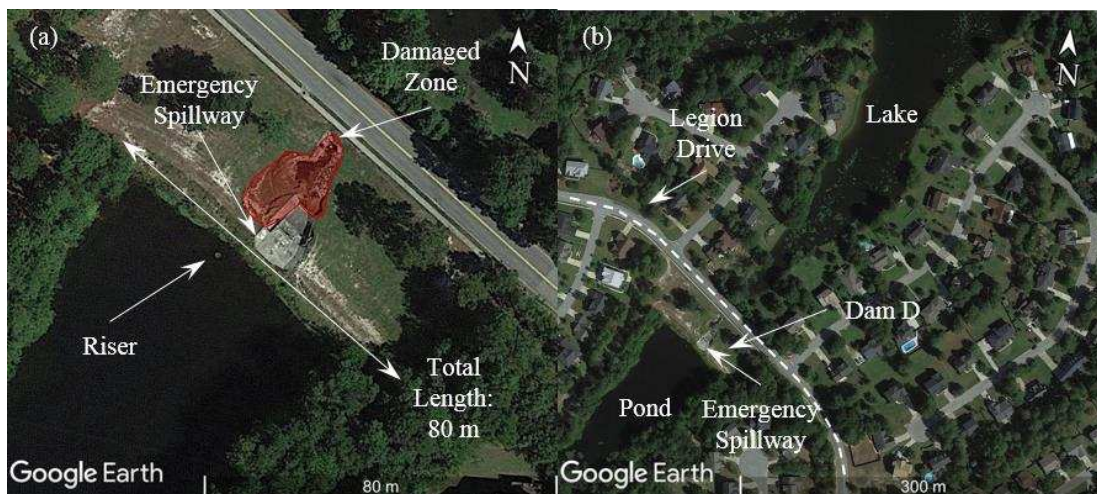
Figure 25. Aerial views of Dam D: a) geometry, draining structures, and damaged zone, and b) location relative to surrounding community (Google Earth, accessed on April 8, 2018).

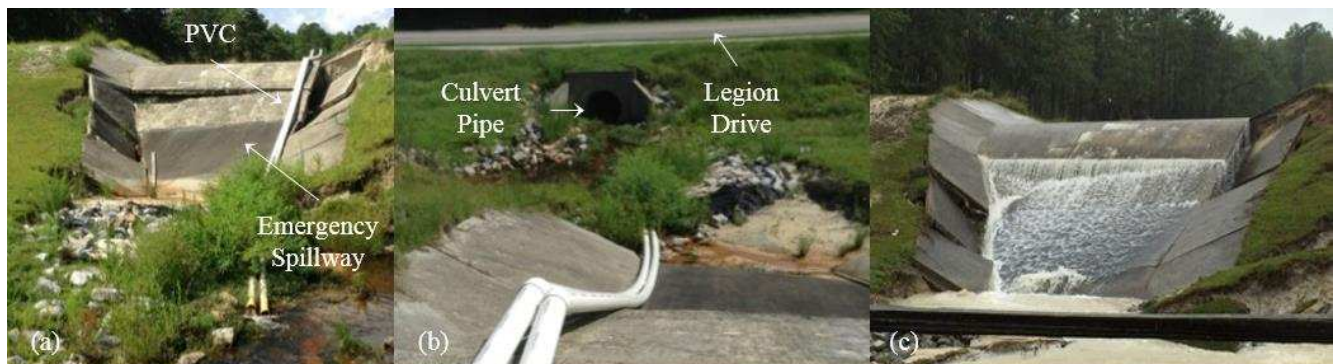
Figure 28. Emergency spillway and PVC drainage pipes at Dam D a) southwest view from downstream; (b) culvert pipe below the two-lane road (northeast view from the crest); and (c) failed concrete spillway during the heavy rain event (southwest view from downstream).

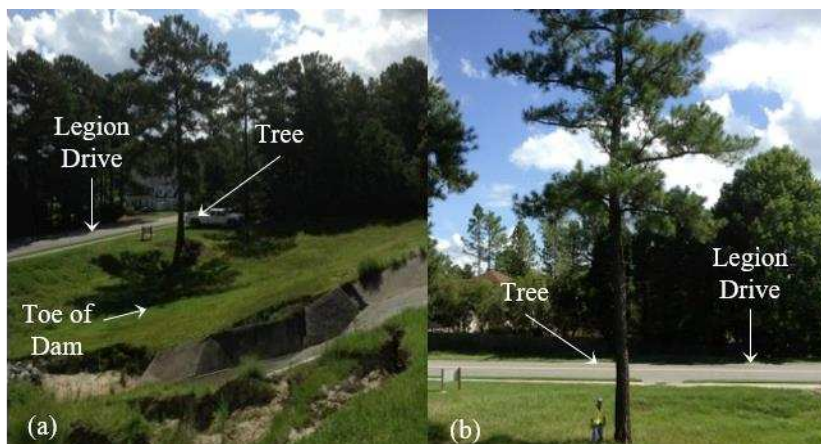
Figure 29. Vegetation on Dam D: a) east view from the crest showing short grasses and trees growing along the roadway near the downstream toe of the dam, and b) north east view from the crest showing a tree near the roadway on the southeast end of the dam.

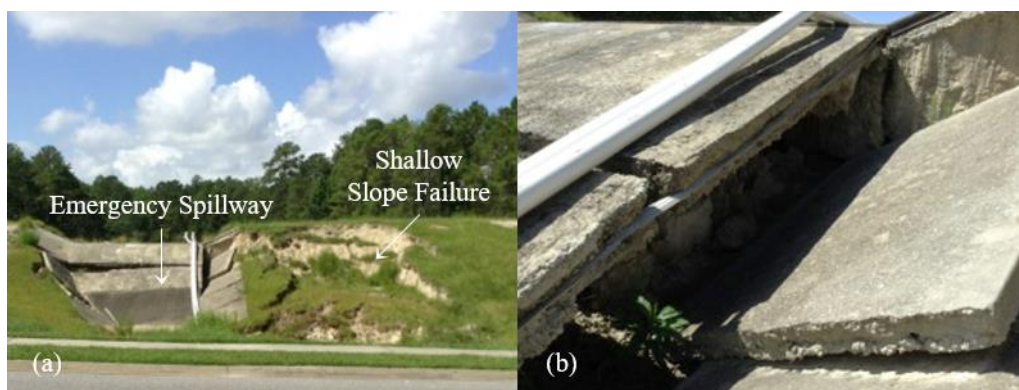
Dam D did not breach during the flood event but was severely damaged. A shallow slope failure, which was observed to be 15 m in length and 9 m in width, developed adjacent to the emergency spillway (see Figure 30a). The scarp of the slide indicates a vertical displacement of nearly 1 m. Right next to the slide, the concrete panels for the emergency spillway were detached and displaced from the side of the channel. Some cracks were observed in the concrete panels and there were voids between the panels and the soil beneath them. These voids (see Figure 30b) are evidence of erosion at the interface between the base of the concrete slabs and the supporting soil. While the specific mechanism(s) cannot be determined from the visual evidence, field observations and information provided from an eyewitness indicate that the crest of the dam was not overtopped. Thus, erosion was most likely caused by either surface water or subsurface water flow at sufficiently high velocity to undermine the soil support. The undermining and displacement of concrete panels may have contributed to the the shallow slope failure. Furthermore, a high volume of high velocity water flowing over the emergency spillway could have diverted onto the downstream side slope, enhancing the erosion in this area. Surface erosion was also observed near the toe of the downstream side slope where the primary and emergency spillway systems converge (see Figure 27b).

Figure 30. Failure of Dam D: (a) shallow slope failure in the downstream side slope and damage to the emergency spillway (southwest view from Legion Drive), and (b) close up view of voids under concrete slabs due to erosion below the slabs.
