Geotechnical Observations of Dams Failed During the 2015 Historic Flooding in South Carolina

ABSTRACT: *This paper presents a description of post-flood reconnaissance and geotechnical investigation of four earthen dams that were breached or damaged following an extreme flooding event in South Carolina in 2015. As a result of unprecedented rainfall and flooding that occurred during a five-day period at the beginning of October in 2015, a total of 51 earthen dams failed and nearly 200 were damaged. Many of these dams failed due to overtopping that led to a breach of the dam. Among the four dams investigated, full breach was observed at three dams; two of which were overtopped, and one was not. The fourth dam was not breached but was severely damaged. For each of these dams, the paper documents background information, pre-flood conditions, post-flood field observations and measurements, and laboratory testing results of collected soil samples. Impacts of vegetation on the dams and the effects of dam failure on critical infrastructure are also presented. The detailed descriptions and geotechnical investigations of the dam failures presented herein serve as case histories that can be u

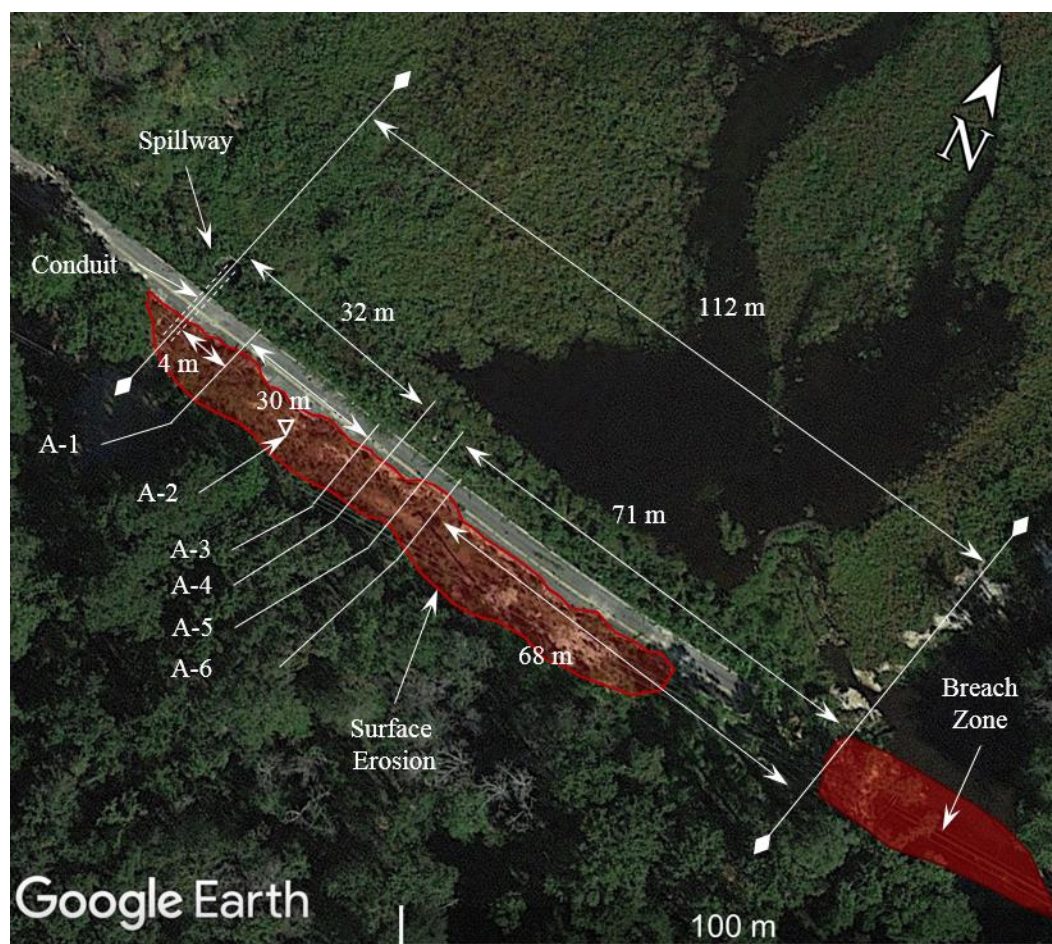
Figure 3. Location of spillway, surface erosion, breach, and sampling locations in Dam A (Google Earth, accessed on April 8, 2018).

The spillway structure of this dam is located on the west side of the dam and about 112 m from the breach zone, as shown in Figure 3. Sampling locations relative to the spillway and the breach zone are also presented in this figure. The spillway is a conduit made of a 1.2 m diameter concrete pipe, as shown in Figure 4a, with a maximum discharge capacity of approximately 17 m³/s (USACE 2016). The soil above the pipe on the downstream side was washed out, as shown in Figure 4b. It is unknown whether this structure worked as the primary spillway of the dam, or if an additional spillway structure existed before the breach.

Damage to this dam includes a complete breach and a large zone of surface erosion separate from the breach, as shown in Figure 3. The breach is located near to the east end of the dam. The breach extended approximately 50 m of the total 290 m length of the dam, and nearly 7,300 m³ of material, including soil and pavement, were washed out (see Figure 6). In the breach zone, several trees on the upstream side slope tipped over the road in the direction of water flow (see Figures 6 and 8), which provides some evidence of overtopping. In the surface erosion zone, the soil erosion along the downstream side slope extended over 60 m parallel to and 20 m perpendicular to the road, as shown in Figures 3, 5b and 7b. As shown in Figure 7a, part of the asphalt shoulder and roadway collapsed above the zone of surface erosion.

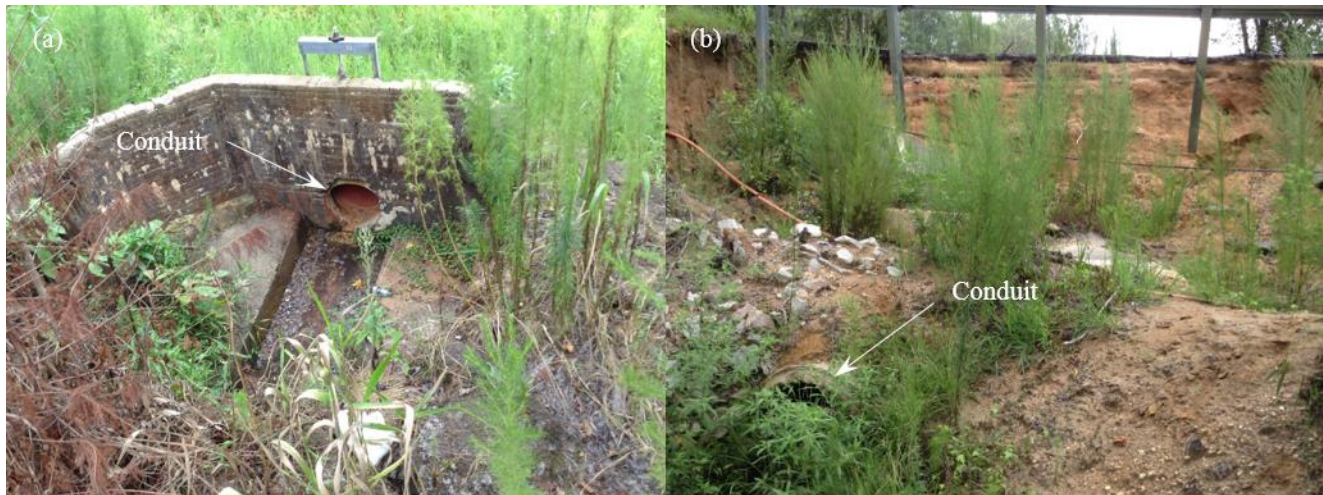
Figure 4. Spillway structure for Dam A: (a) conduit on upstream side (north view from SR-40-67), and (b) conduit and washed out soil above on downstream side (north view from downstream).

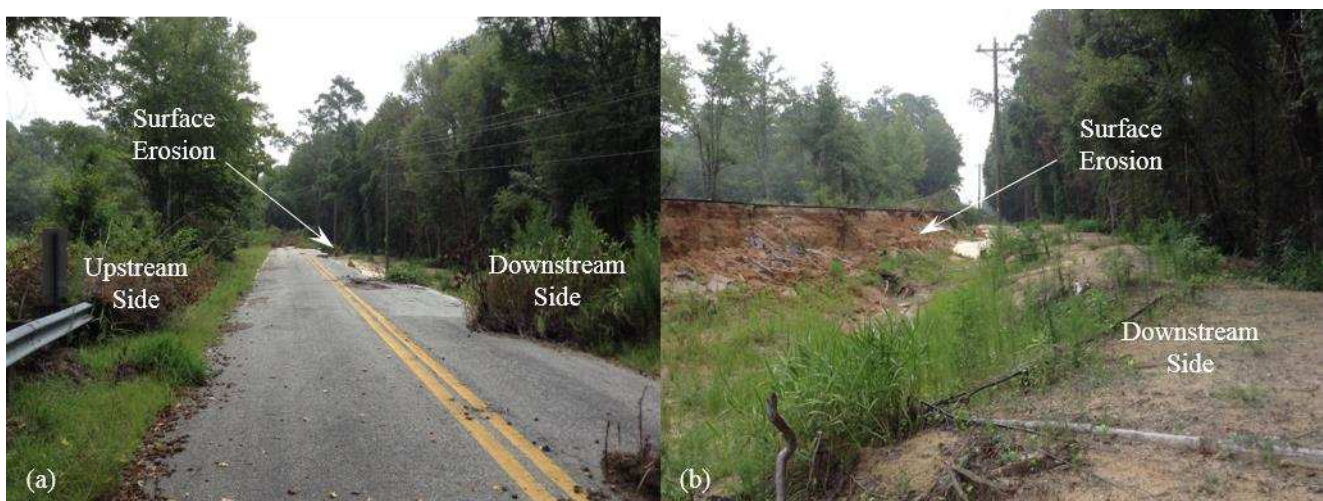
Vegetation was not present on the crest of Dam A where the road is located. However, there is vegetation on the edges of the crest adjacent to the road and on the upstream and downstream sides of the dam. Mature trees with heights of nearly 12 m were observed on the upstream side, parallel to the road and nearly 3 m away from the upstream shoulder (see Figure 5a). Trees on the downstream side have similar heights, but were found nearly 20 m away from the road (see Figure 5b). All of the mature trees appear to be part of the natural growth in the local ecosystem. It is unclear if the presence of vegetation influenced dam performance or contributed to its failure. In the area where soil was exposed on the downstream side slope (noted as surface erosion in Figure 5b), there were no trees present and no roots observed in the soil. Near the northeast section of the breach, several trees were found tipped over the road (see Figure 6), but no roots were observed in the soil.

Figure 5. Vegetation on Dam A: (a) vegetation upstream and downstream of the dam (east view from S-40-67), and (b) vegetation and surface erosion on the downstream side of the dam (east view from downstream).

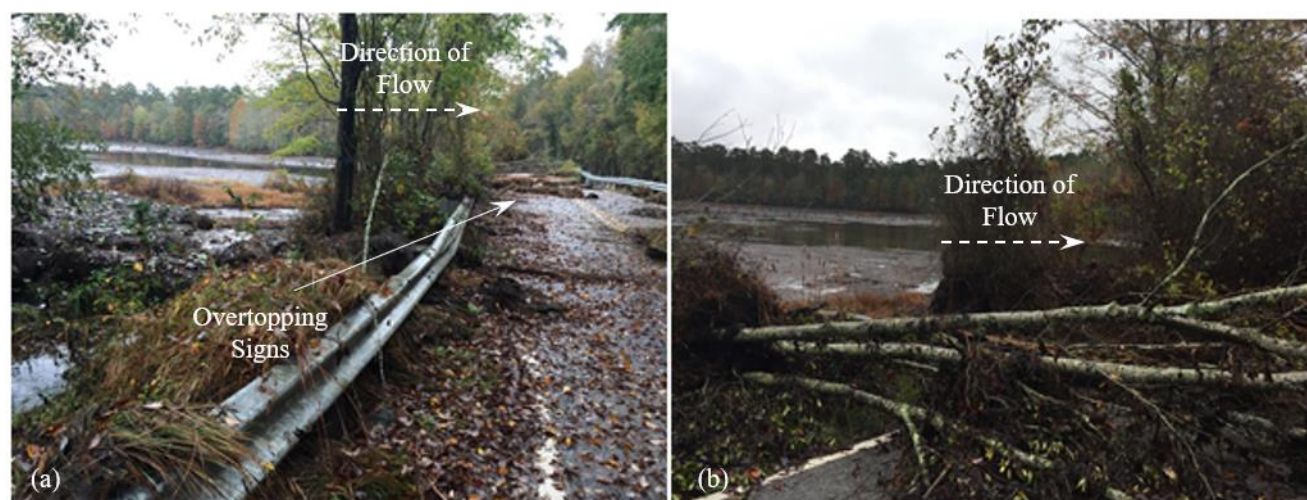
Figure 8. Evidence of overtopping during the flood for Dam A: (a) eroded vegetation and debris on the crest (east view from SR-40-67); and (b) fallen trees on the crest (north view from SR-40-67).

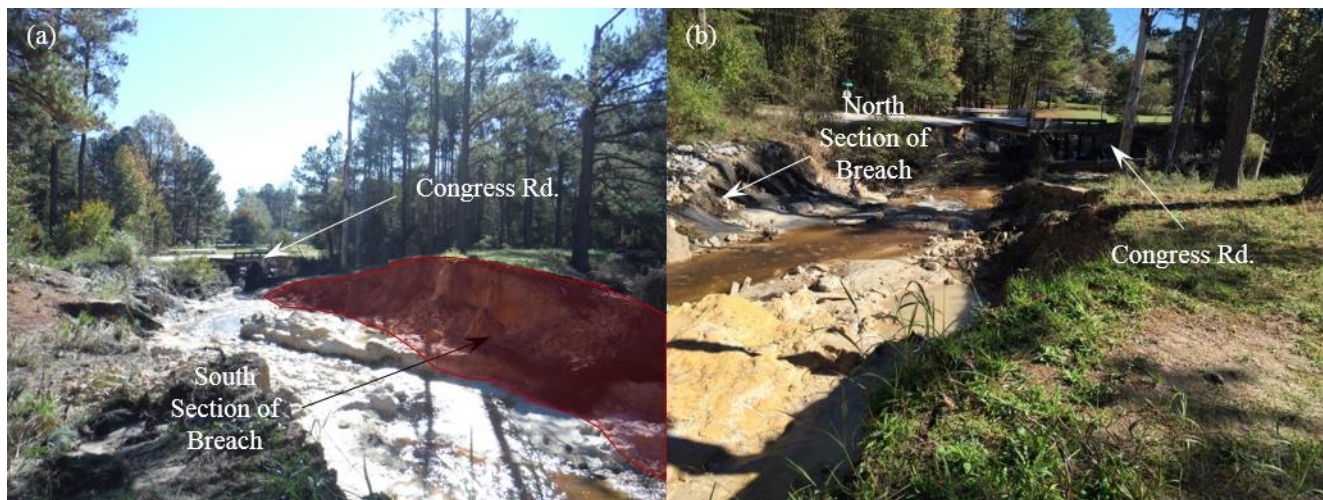
Figure 11. Breach section in Dam B: southeast views from (a) the north section of breach and (b) the south sections of the breach.

The dam was completely breached during the flood as shown in Figure 11. The location of the breach (see Figure 12) was close to the north end of the dam and close to the supposed original location of the second spillway riser pipe. The breach was approximately 15 m of the total 130 m length of the dam. Nearly 1,050 m³ of embankment material was washed out during the flood event. Surface erosion was observed along the downstream side slope extending along the entire length of the dam, as shown in Figure 16. Trees on the downstream side slope of the dam were partially or fully tipped over and some appeared to be displaced (Figure 15b). These observations might indicate overtopping of the dam.

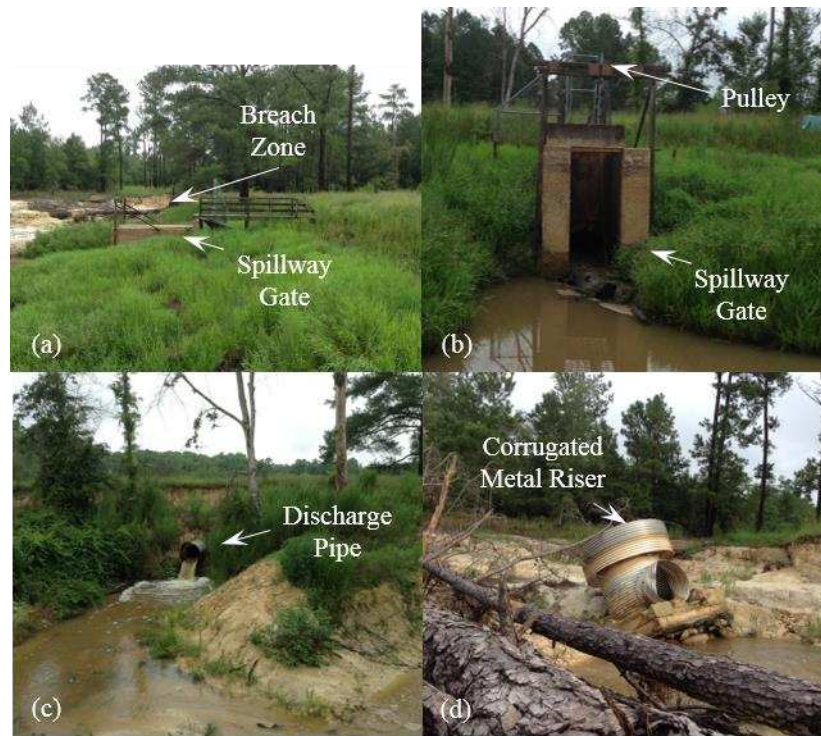
Two spillway systems were observed at Dam B, but it is unknown which worked as primary spillway before the breach. According to USACE (2016), the maximum discharge capacity of the dam was approximately $34 \text{ m}^3/\text{s}$. The first system was located on the west side of the dam, nearly 24 m from the breach zone (location marked in Figure 12). It is composed of a 1.3 m wide concrete inlet structure leading to a 1.2 m diameter concrete discharge pipe (see Figures 14a, 14b and 14c). A pulley lift system is attached to a metal frame surrounding the concrete. The structure appeared to be missing a sliding door that would have been raised and lowered with the pulley to manually control the lake water level. Water from the lake was observed draining through the pipe on the downstream side of the gate (see Figures 12 and 14c). The second spillway was found near the south section of the breach. It consisted of a corrugated-metal riser pipe supported by a concrete base. The dimensions of the conduit were not measured. As shown in Figure 14d, this structure appears to be damaged, displaced, and separated from a conduit that would have been used to drain water from the lake, presumably through or under the dam, towards a creek flowing below the Congress Road bridge (see Figure 12). According to an SCDHEC inspection report from 2008 (SCDHEC 2016), repair procedures were required in the corrugated-metal riser pipe as well as calculations assuring that the spillway met design flood requirements according to the hazard potential. It is unknown whether the spillway was repaired before the flood event.

Figure 14. Spillway structures in Dam B: (a) location (view along the crest looking north), (b) concrete spillway gate (east view from upstream), (c) discharge pipe downstream from gate (east view from downstream), and (d) failed riser (northwest view from breach).

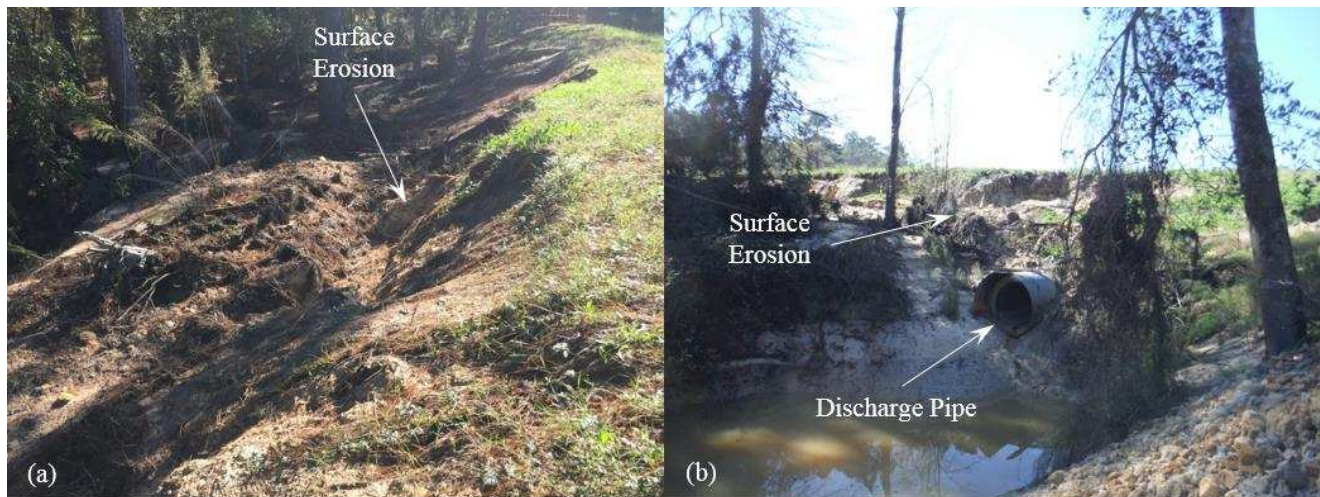
Figure 16. Surface erosion on downstream side slope of Dam B: a) south view from the crest of dam and b) west view from downstream.

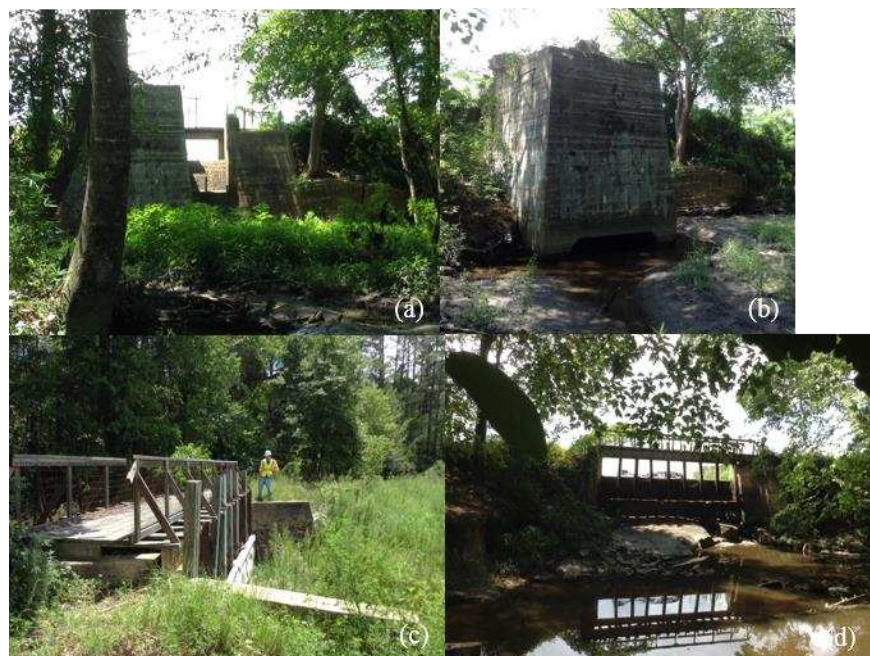
Two spillway systems were found at Dam C as shown in Figure 19. According to USACE (2016), the dam has a maximum discharge capacity of $30 \text{ m}^3/\text{s}$. One of the systems was observed in the middle of the dam (see Figures 20a) and is a spillway gate made of concrete with a length of approximately 9.5 m. The size of the opening in this spillway gate was nearly 2.5 m in width and 9.5 m in height. The spillway system includes a $10 \text{ m} \times 12 \text{ m} \times 8 \text{ m}$ (height \times width \times length) concrete structure located next to the gate (see Figure 20b). The purpose of this structure is unknown, but it was presumably used for power generation according to the dam owner. The second structure, a spillway gate made of concrete, wood and steel beams (see Figures 20c and 20d), and with a length of approximately 12 m, was found toward the east end of the dam. The opening of this spillway gate was nearly 10 m in length and 2 m in height. Both spillway gates appeared to be in good condition with no observed damage from the flood event. This is expected since the breach zone is 46 m away from the first spillway and 107 m away from the other (see Figure 19). It is unknown whether the spillways worked as primary or emergency drainage systems, or if they were functioning properly before the flood event.

Figure 20. Spillways in Dam C: (a) first spillway structure (southwest view from downstream), (b) close up of concrete gate in first spillway structure (southwest view from downstream), (c) second spillway structure near the southeast end of the dam (southeast view from crest), and (d) southeast view of second spillway structure from downstream.

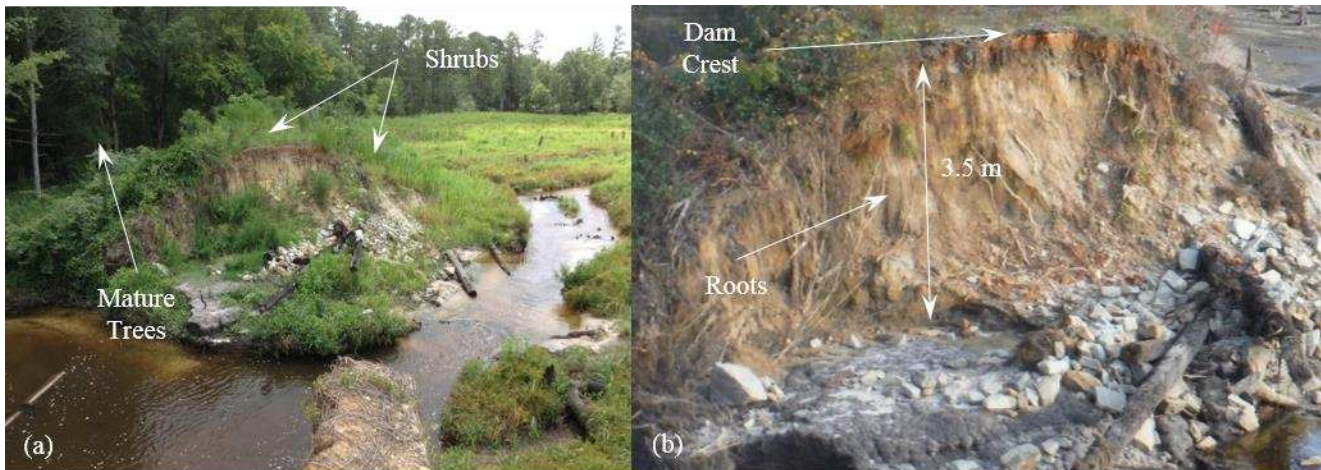
Grass and shrubs with heights up to 1 m were observed over the surface of Dam C (see Figure 21). Mature trees with heights of nearly 15 m were also observed in the area between the downstream toe of the dam and the road (see Figure 21a). Vegetation on the downstream side appears to be part of the natural ecosystem of the area (see Figure 20 and 21a). Roots growing through the dam were exposed in the breach zone (see Figure 21b), with depths of nearly 3.5 m penetrating into the 4 m height of the dam. According to a 2010 SCDHEC inspection report (SCDHEC 2016), vegetation on the downstream side should have been removed to allow inspection of the dam. An inspection report from 2014 indicates that vegetation was partially cleared from the dam, but the presence of trees on the downstream side should have been evaluated for seepage problems. The condition of the vegetation in the crest and side slopes of the dam, before and by the time of the flood event, is unknown.

Figure 21. Vegetation on Dam C: southeast views from crest of a) crest of dam with tall grasses and small shrubs (taken 10 months after breach), and b) exposed deep root structures at southeast breach wall (taken 1 month after breach).

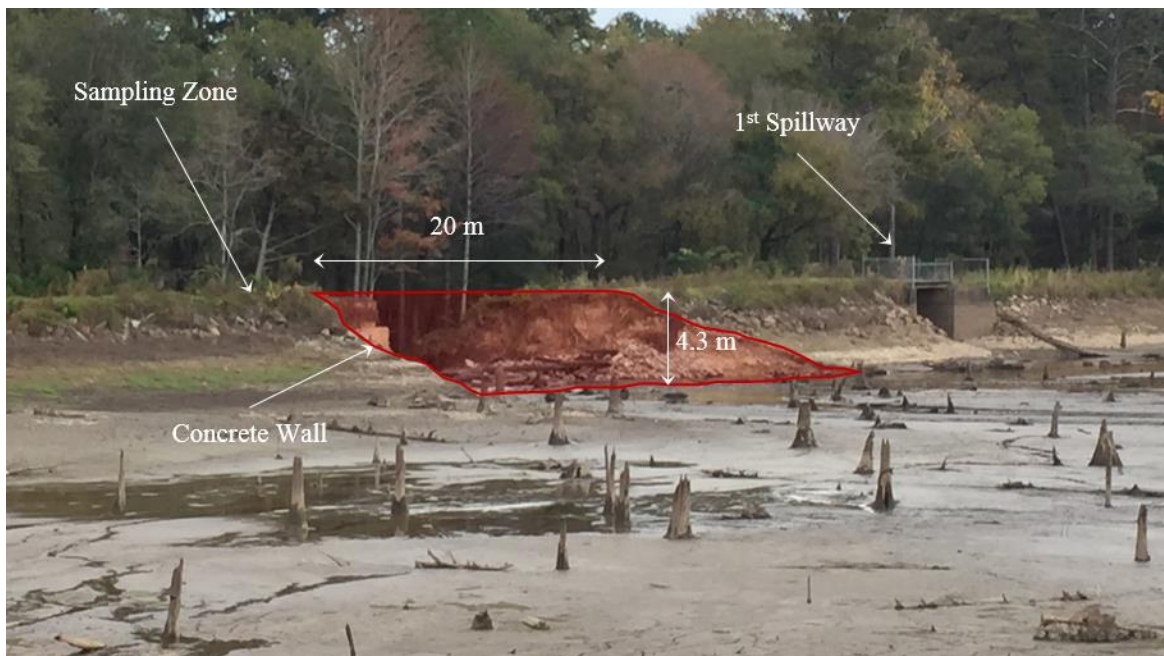
The dam was completely breached during the flood event as shown in Figure 22. The breach was located near the middle of the dam, 46 m northwest from the location of the first spillway gate (see Figure 19). The length of the breach was approximately 20 m of the total 191 m length of the dam, and nearly 900 m³ of soil were washed out. Eyewitnesses during the flood event indicated that overtopping did not occur. Subsequent field observations did not find evidence of surface erosion on the downstream side slope or near the spillways.

Figure 22. Picture of the breached section of Dam C (northeast view from subdivision). Drained pond in the foreground.

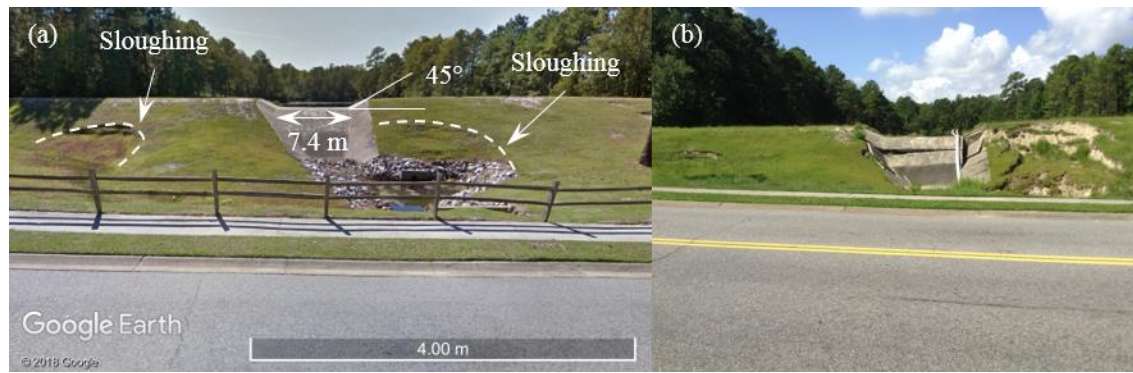
Figure 26. Southwest views of downstream side of Dam D, from Legion Drive: (a) before (Google Earth accessed on January 27, 2016) and (b) after 2015 flood event.

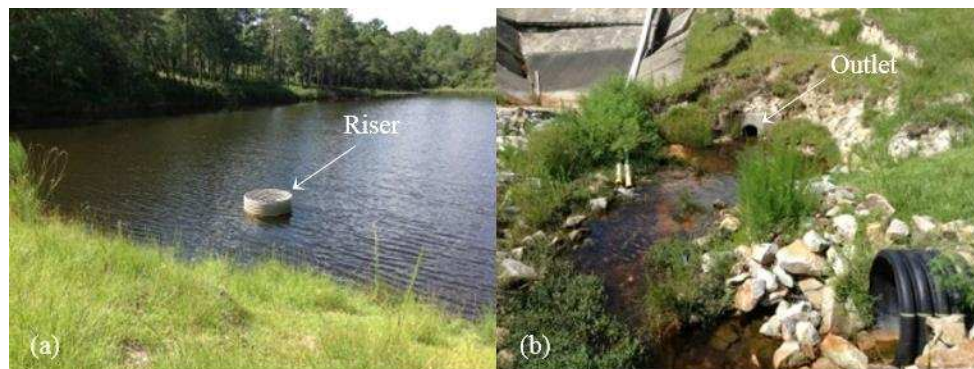
Two spillway systems were found at Dam D. The primary spillway is composed of a corrugated-metal riser used as an inlet (see Figure 27a), and a conduit made of a 0.6 m diameter concrete pipe used as an outlet (Figure 27b). The inlet is located nearly 10 m west of the crest of the dam, while the outlet is located at the toe of the downstream side slope. The second spillway is an emergency (overflow) spillway made of a trapezoidal-shaped concrete channel located in the middle of the dam (see Figure 28). The channel is 7.4 m in length at the base and has side slopes of nearly 45° (see Figure 26). From the photograph in Figure 26a (taken in October 2014), the concrete spillway appears to have been in good condition prior to the heavy rainfall event. After the event, two additional 10 cm diameter PVC pipes were installed on the emergency spillway to lower the water level in the pond (Figure 28a and 28b). All discharge water is directed toward a 1.5 m concrete culvert pipe located below Legion Drive that drains to the lake located downstream (see Figure 25b and 28b).

Figure 27. Primary spillway in Dam D: a) riser structure (southwest view from crest); and b) outlet pipe (southwest view from downstream).

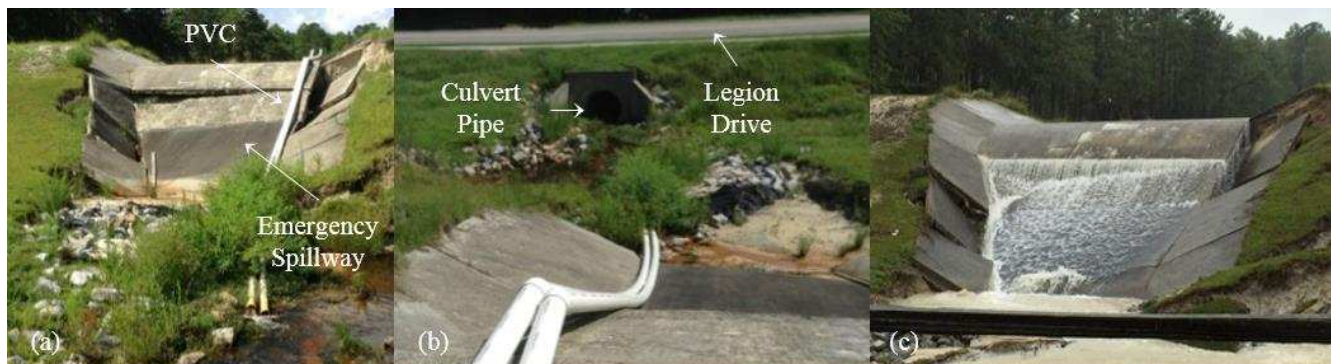
Figure 28. Emergency spillway and PVC drainage pipes at Dam D a) southwest view from downstream; (b) culvert pipe below the two-lane road (northeast view from the crest); and (c) failed concrete spillway during the heavy rain event (southwest view from downstream).

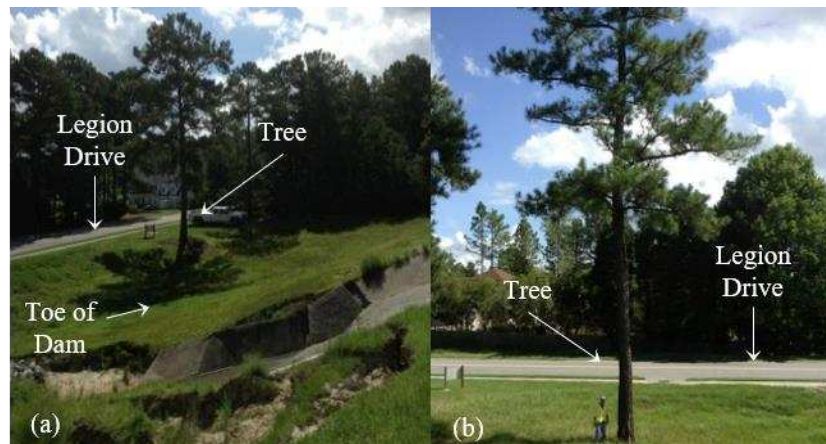
Figure 29. Vegetation on Dam D: a) east view from the crest showing short grasses and trees growing along the roadway near the downstream toe of the dam, and b) north east view from the crest showing a tree near the roadway on the southeast end of the dam.

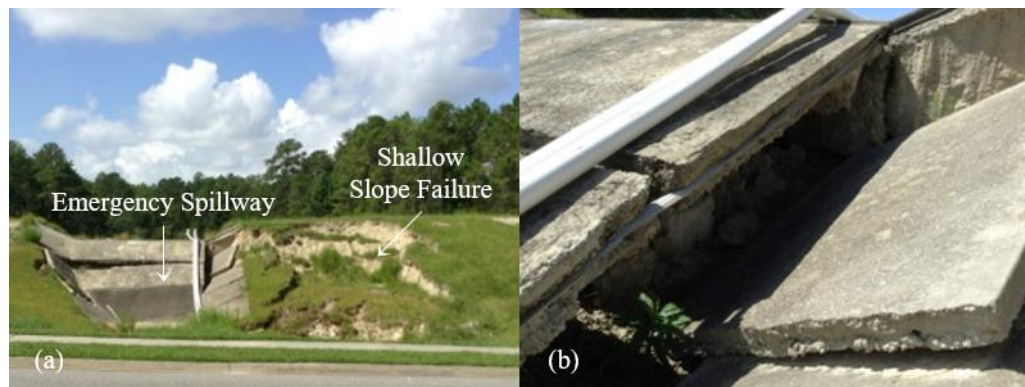
Dam D did not breach during the flood event but was severely damaged. A shallow slope failure, which was observed to be 15 m in length and 9 m in width, developed adjacent to the emergency spillway (see Figure 30a). The scarp of the slide indicates a vertical displacement of nearly 1 m. Right next to the slide, the concrete panels for the emergency spillway were detached and displaced from the side of the channel. Some cracks were observed in the concrete panels and there were voids between the panels and the soil beneath them. These voids (see Figure 30b) are evidence of erosion at the interface between the base of the concrete slabs and the supporting soil. While the specific mechanism(s) cannot be determined from the visual evidence, field observations and information provided from an eyewitness indicate that the crest of the dam was not overtopped. Thus, erosion was most likely caused by either surface water or subsurface water flow at sufficiently high velocity to undermine the soil support. The undermining and displacement of concrete panels may have contributed to the the shallow slope failure. Furthermore, a high volume of high velocity water flowing over the emergency spillway could have diverted onto the downstream side slope, enhancing the erosion in this area. Surface erosion was also observed near the toe of the downstream side slope where the primary and emergency spillway systems converge (see Figure 27b).

Figure 30. Failure of Dam D: (a) shallow slope failure in the downstream side slope and damage to the emergency spillway (southwest view from Legion Drive), and (b) close up view of voids under concrete slabs due to erosion below the slabs.
