Geotechnical Observations of Dams Failed During the 2015 Historic Flooding in South Carolina

ABSTRACT: *This paper presents a description of post-flood reconnaissance and geotechnical investigation of four earthen dams that were breached or damaged following an extreme flooding event in South Carolina in 2015. As a result of unprecedented rainfall and flooding that occurred during a five-day period at the beginning of October in 2015, a total of 51 earthen dams failed and nearly 200 were damaged. Many of these dams failed due to overtopping that led to a breach of the dam. Among the four dams investigated, full breach was observed at three dams; two of which were overtopped, and one was not. The fourth dam was not breached but was severely damaged. For each of these dams, the paper documents background information, pre-flood conditions, post-flood field observations and measurements, and laboratory testing results of collected soil samples. Impacts of vegetation on the dams and the effects of dam failure on critical infrastructure are also presented. The detailed descriptions and geotechnical investigations of the dam failures presented herein serve as case histories that can be u

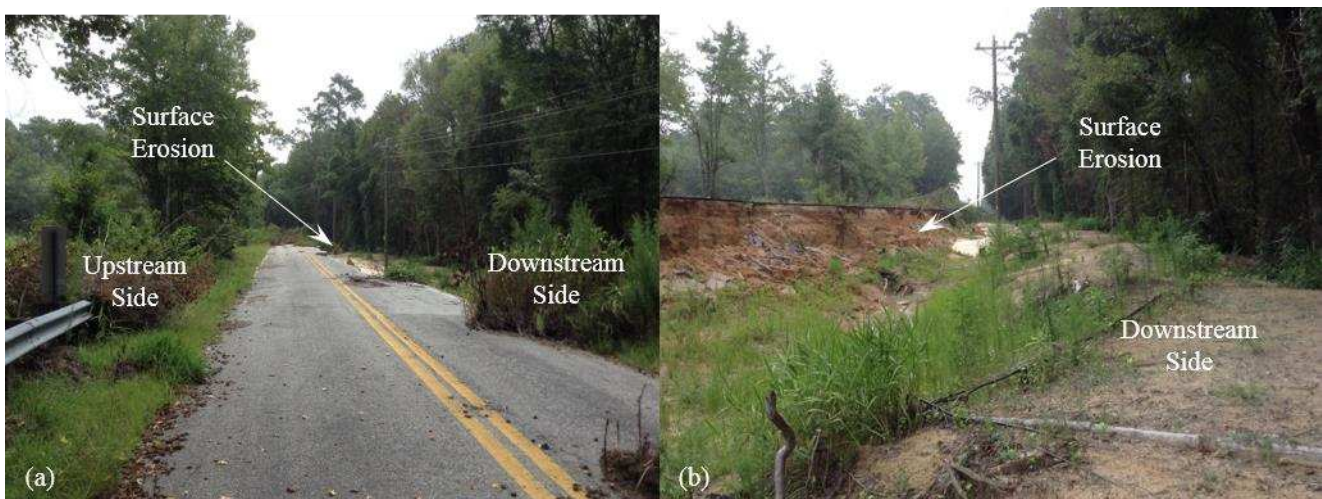
Vegetation was not present on the crest of Dam A where the road is located. However, there is vegetation on the edges of the crest adjacent to the road and on the upstream and downstream sides of the dam. Mature trees with heights of nearly 12 m were observed on the upstream side, parallel to the road and nearly 3 m away from the upstream shoulder (see Figure 5a). Trees on the downstream side have similar heights, but were found nearly 20 m away from the road (see Figure 5b). All of the mature trees appear to be part of the natural growth in the local ecosystem. It is unclear if the presence of vegetation influenced dam performance or contributed to its failure. In the area where soil was exposed on the downstream side slope (noted as surface erosion in Figure 5b), there were no trees present and no roots observed in the soil. Near the northeast section of the breach, several trees were found tipped over the road (see Figure 6), but no roots were observed in the soil.

Figure 5. Vegetation on Dam A: (a) vegetation upstream and downstream of the dam (east view from S-40-67), and (b) vegetation and surface erosion on the downstream side of the dam (east view from downstream).

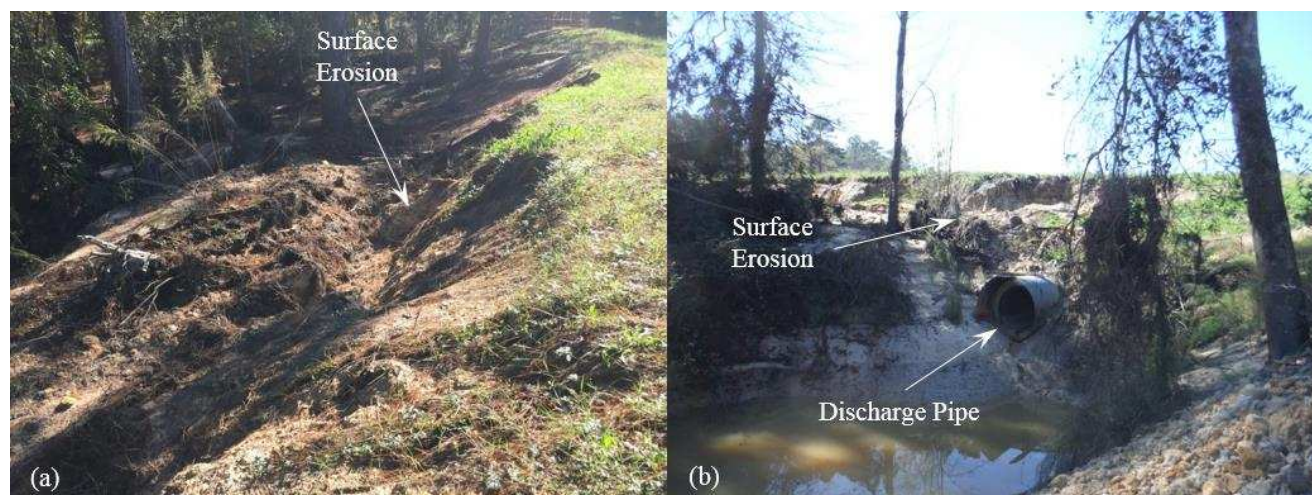
Figure 16. Surface erosion on downstream side slope of Dam B: a) south view from the crest of dam and b) west view from downstream.

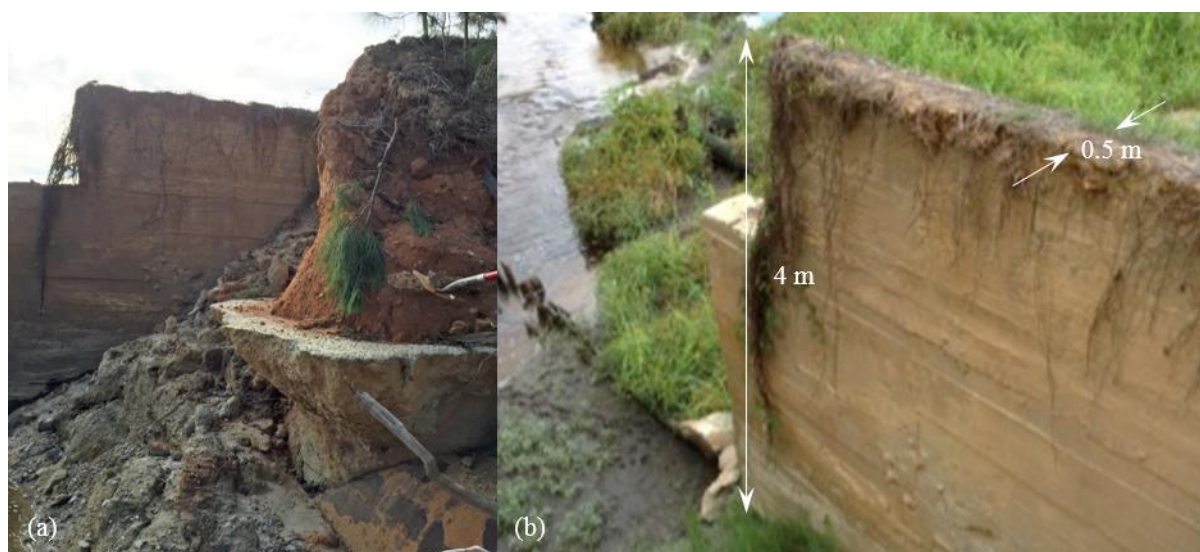
A concrete wall about 4 m high and 0.5 m thick (see Figure 23) was observed at the location of the breach (see Figures 19 and 22). The wall appears to run parallel to the dam crest, within the upstream side slope, but does not extend the entire length of the dam. The purpose of this structure, the actual dimensions, and whether the wall was built before or during the construction of the dam, are unknown. As shown in Figure 23, soil near the wall was washed away during the flood event. According to a SCDHEC inspection report from 2014 (SCDHEC 2016), part of the wall protruded from the dam and had an attached fence that was used as a fishing fence. This fence was no longer attached to the wall at the time of the reconnaissance. The inspection report also highlighted several signs of deterioration in the dam including cracks in the spillway structures

and animal burrows. It is possible that internal erosion near the concrete wall initiated the breach of the dam. Cracks in the wall or gaps between the wall and the surrounding soil due to animal activity may result in concentrated flow initiating internal erosion (Bonelli 2013).

Figure 23. Concrete wall in the upstream section of Dam C, next to the breach zone: a) southwest view from downstream, and b) southeast view from crest of dam.
