Geotechnical Observations of Dams Failed During the 2015 Historic Flooding in South Carolina

ABSTRACT: *This paper presents a description of post-flood reconnaissance and geotechnical investigation of four earthen dams that were breached or damaged following an extreme flooding event in South Carolina in 2015. As a result of unprecedented rainfall and flooding that occurred during a five-day period at the beginning of October in 2015, a total of 51 earthen dams failed and nearly 200 were damaged. Many of these dams failed due to overtopping that led to a breach of the dam. Among the four dams investigated, full breach was observed at three dams; two of which were overtopped, and one was not. The fourth dam was not breached but was severely damaged. For each of these dams, the paper documents background information, pre-flood conditions, post-flood field observations and measurements, and laboratory testing results of collected soil samples. Impacts of vegetation on the dams and the effects of dam failure on critical infrastructure are also presented. The detailed descriptions and geotechnical investigations of the dam failures presented herein serve as case histories that can be u

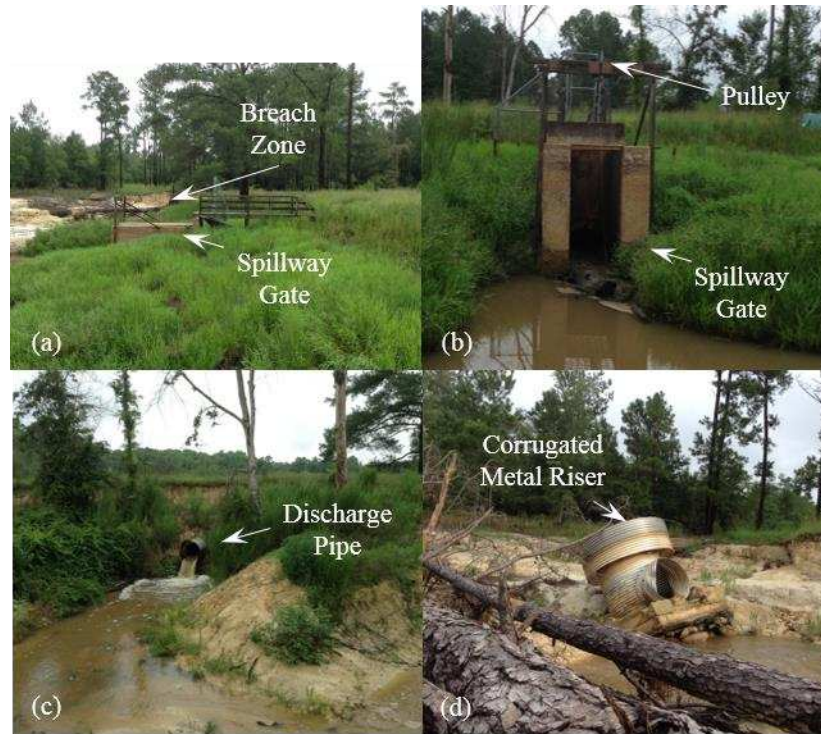
Two spillway systems were observed at Dam B, but it is unknown which worked as primary spillway before the breach. According to USACE (2016), the maximum discharge capacity of the dam was approximately $34 \text{ m}^3/\text{s}$. The first system was located on the west side of the dam, nearly 24 m from the breach zone (location marked in Figure 12). It is composed of a 1.3 m wide concrete inlet structure leading to a 1.2 m diameter concrete discharge pipe (see Figures 14a, 14b and 14c). A pulley lift system is attached to a metal frame surrounding the concrete. The structure appeared to be missing a sliding door that would have been raised and lowered with the pulley to manually control the lake water level. Water from the lake was observed draining through the pipe on the downstream side of the gate (see Figures 12 and 14c). The second spillway was found near the south section of the breach. It consisted of a corrugated-metal riser pipe supported by a concrete base. The dimensions of the conduit were not measured. As shown in Figure 14d, this structure appears to be damaged, displaced, and separated from a conduit that would have been used to drain water from the lake, presumably through or under the dam, towards a creek flowing below the Congress Road bridge (see Figure 12). According to an SCDHEC inspection report from 2008 (SCDHEC 2016), repair procedures were required in the corrugated-metal riser pipe as well as calculations assuring that the spillway met design flood requirements according to the hazard potential. It is unknown whether the spillway was repaired before the flood event.

Figure 14. Spillway structures in Dam B: (a) location (view along the crest looking north), (b) concrete spillway gate (east view from upstream), (c) discharge pipe downstream from gate (east view from downstream), and (d) failed riser (northwest view from breach).

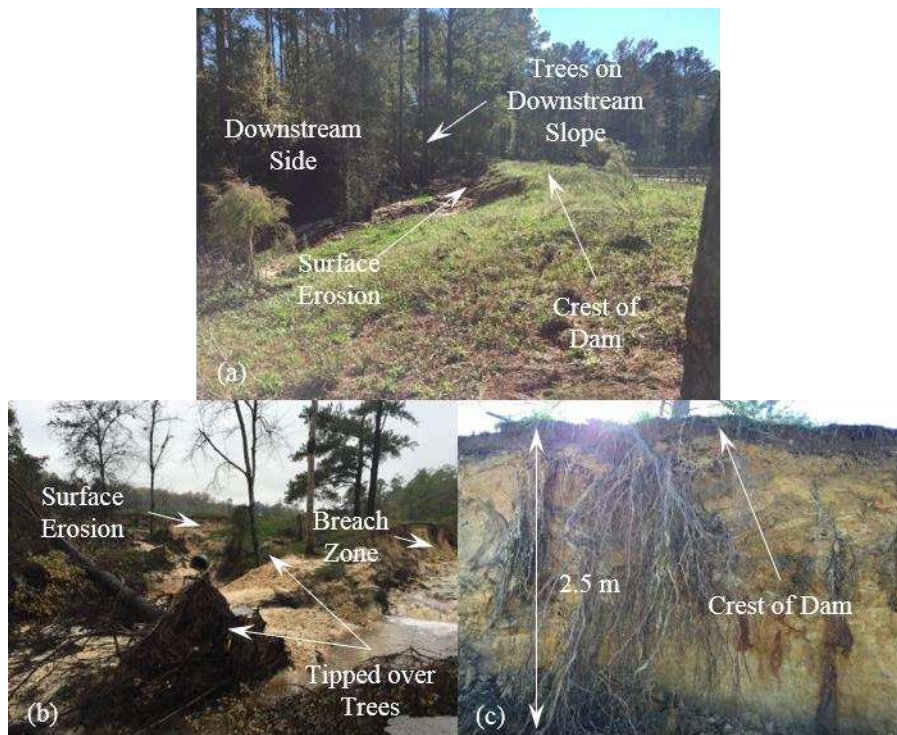
Vegetation was observed over the entire surface of the dam (see Figure 15). The upstream side-slope and crest of the dam are covered with grass and shrubs with heights less than 1 m. Several mature trees with heights from 15 to 18 m were observed on the crest and downstream side-slope of the dam (see Figures 15a and 15b). The roots of one of these trees were exposed by the dam breach, as shown in Figure 15c. The roots reach depths of nearly 2.5 m, penetrating through the upper half and into the lower half of the 4.3 m high dam. The SCDHEC inspection report from 2008 (SCDHEC 2016) also highlighted the need of removing vegetation to an acceptable grass cover. It is clear that the vegetation was not removed, as requested.

Figure 15. Vegetation on Dam B: (a) low grasses and small bushes on the dam crest, trees on downstream side slope (south view from crest), (b) tipped over trees near breach and zone of surface erosion (west view from downstream), and (c) presence of roots throughout the dam on the south breach wall (south view from breach).
