## Geotechnical Observations of Dams Failed During the 2015 Historic Flooding in South Carolina

**ABSTRACT:** *This paper presents a description of post-flood reconnaissance and geotechnical investigation of four earthen dams that were breached or damaged following an extreme flooding event in South Carolina in 2015. As a result of unprecedented rainfall and flooding that occurred during a five-day period at the beginning of October in 2015, a total of 51 earthen dams failed and nearly 200 were damaged. Many of these dams failed due to overtopping that led to a breach of the dam. Among the four dams investigated, full breach was observed at three dams; two of which were overtopped, and one was not. The fourth dam was not breached but was severely damaged. For each of these dams, the paper documents background information, pre-flood conditions, post-flood field observations and measurements, and laboratory testing results of collected soil samples. Impacts of vegetation on the dams and the effects of dam failure on critical infrastructure are also presented. The detailed descriptions and geotechnical investigations of the dam failures presented herein serve as case histories that c

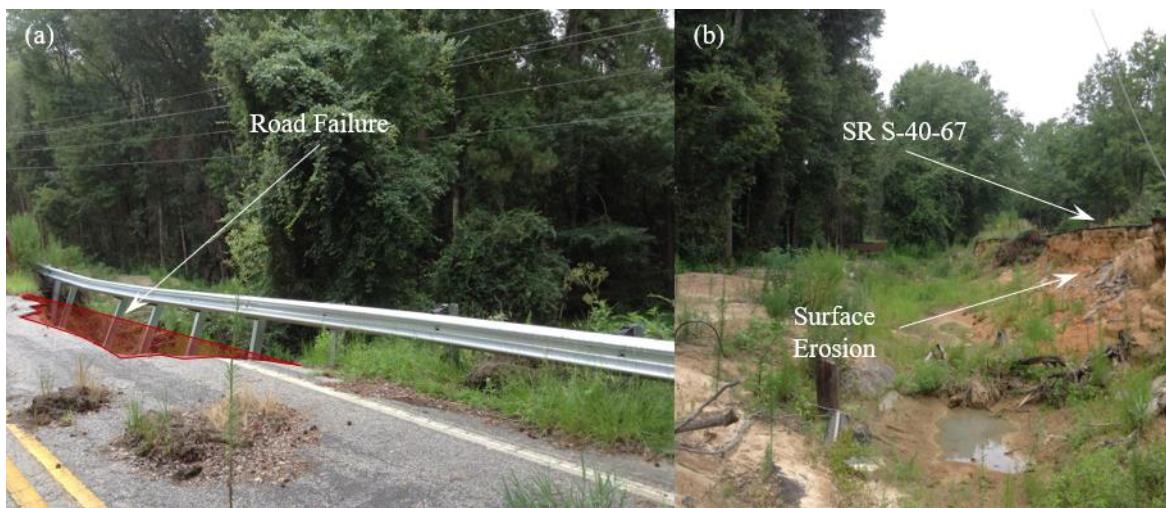
Figure 7. Failure of Dam A: (a) road failure of State Road S-40-67 (southeast view from S-40-67), and (b) surface erosion due to overtopping (west view from downstream).
