Geotechnical Observations of Dams Failed During the 2015 Historic Flooding in South Carolina

Inthuorn Sasanakul, Assistant Professor, Civil and Environmental Engineering, University of South Carolina, Columbia, SC, United States; email: sasanaku@cec.sc.edu

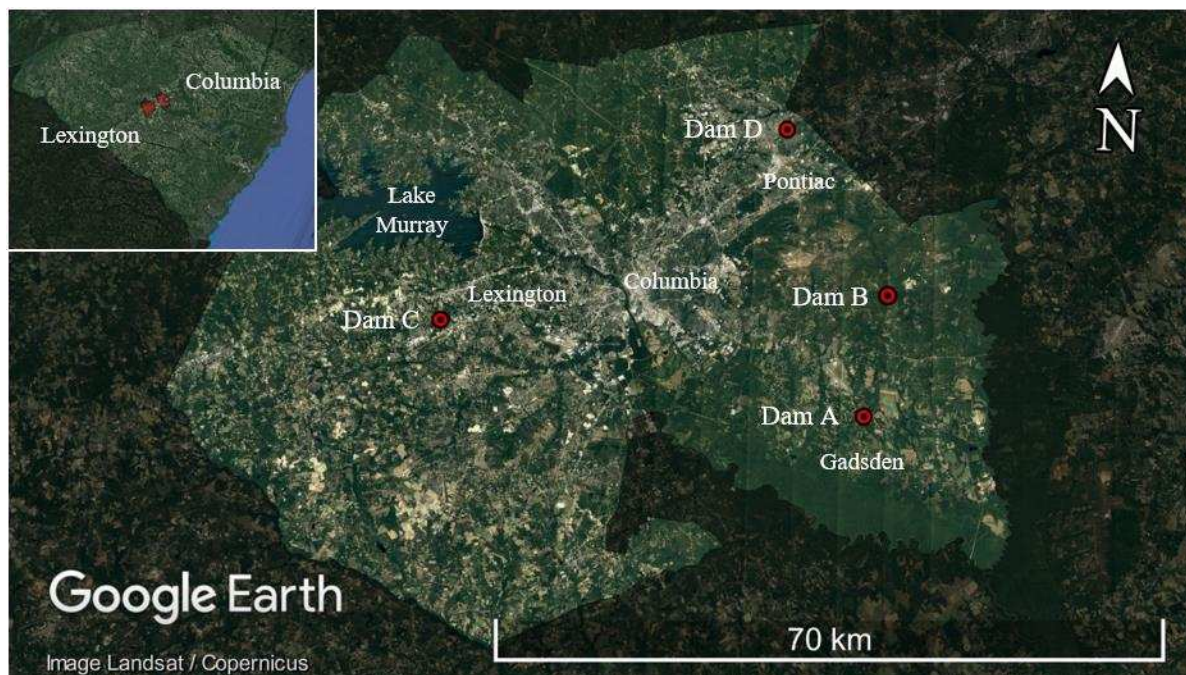
Figure 1. Map showing the locations of the four dam sites in South Carolina (Google Earth, accessed on April 7, 2018).

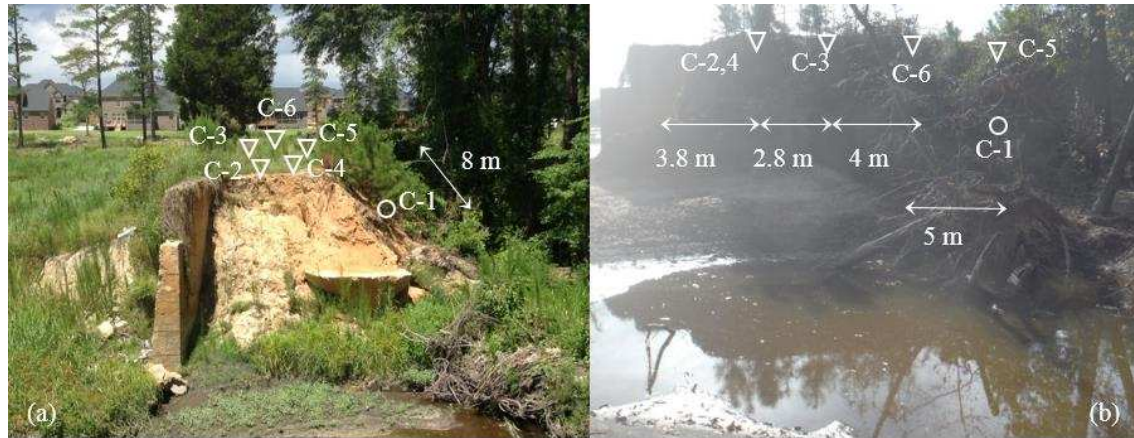
Figure 24. Sampling locations for Dam C: a) northwest view from southeast section of breach, and b) southwest view from downstream (∇ : vertical sample, \circ : horizontal sample).
