Geotechnical Effects of Hurricane Harvey in the Houston, Beaumont, and Port Arthur Areas

ABSTRACT: *The Geotechnical Extreme Events Reconnaissance (GEER) Association deployed multiple teams of engineers from academia and practicing firms to the coast of Texas in late August and early September 2017 following Hurricane Harvey. This report summarizes the observations and data from the GEER team that focused primarily on the inland effects of Hurricane Harvey in the Houston area with some observations in the Port Arthur / Beaumont area east of Houston. Rain, not storm surge or wind, caused the observed damage in Houston, Beaumont, and Port Arthur by overwhelming stormwater management facilities and creating high flows and flooding in and near area waterways. The major Houston-area flood structures, Addicks and Barker Dams, performed well from a geotechnical perspective. Observed damages included shallow slides along levees, severe erosion along riverways, isolated road and culvert erosion and uplift, and area-wide flood effects in low and poorly drained neighborhoods.*

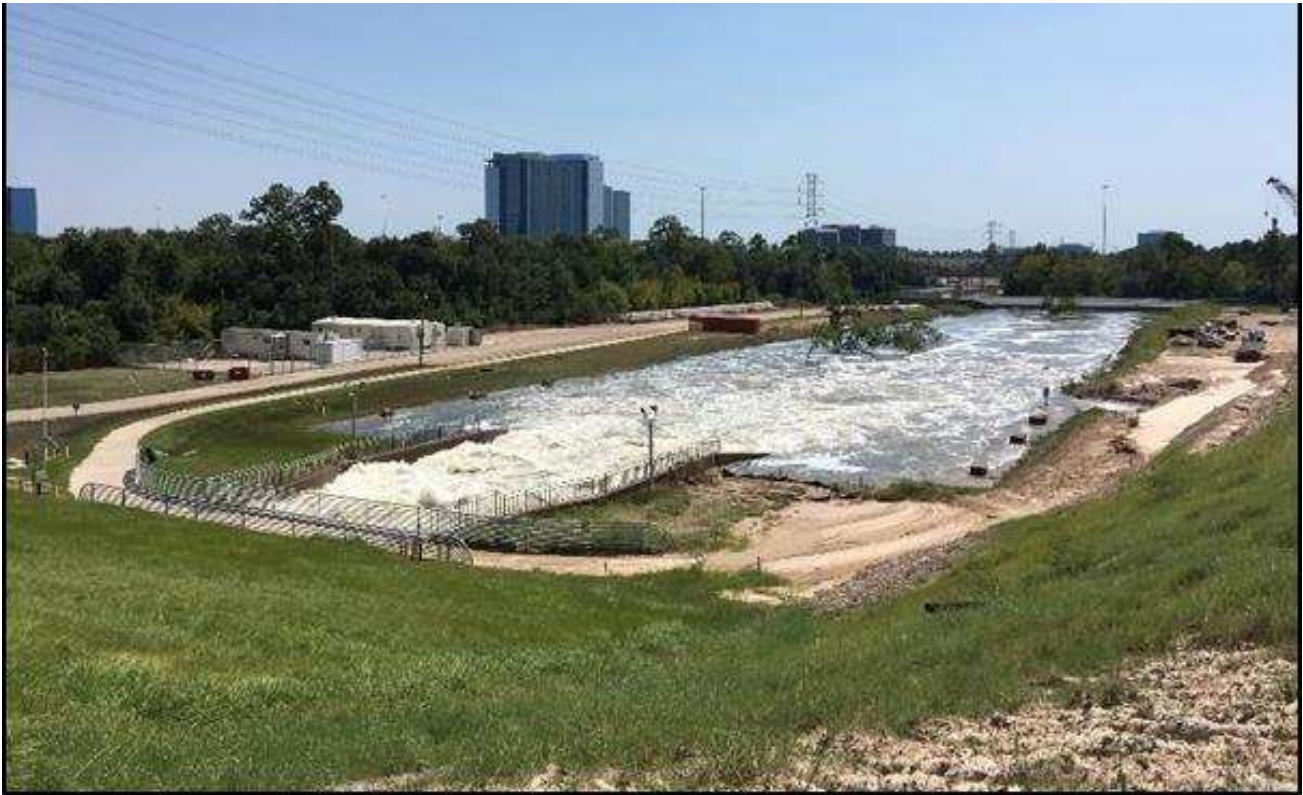
Although hydrologic/hydraulic performance of the dams was outside of our purpose and primary expertise, it appeared that Addicks and Barker Dams fulfilled their mission of reducing the impact of flooding for a significant part of the Houston area, specifically along Buffalo Bayou downstream of the dams, including the central business district. During the heaviest rainfall, around 86-89 cm (34-35 inches) of rainfall was recorded in the watershed. Peak reservoir levels occurred on about August 30, 2017 at 33.3 m (109.1 ft) and 31.0 m (101.6 ft) in the Addicks and Barker reservoirs, respectively. The highest elevations of the crest for these two dams are 34.1m (121 ft) and 34.1 m (112 ft), respectively, which provided freeboards of approximately 3.4 m (11 ft) (Addicks) and 3.0 m (10 ft) (Barker) at the peak reservoir levels. The peak reservoir water level in Addicks slightly exceeded the level of the ground at the north end of Addicks north auxiliary spillway (details below). The USACE opened the Addicks outflow gates on August 28, 2017 to reduce risks associated with higher water levels. These outflows peaked around August 30, 2017 at about 200 cubic meters/second (m^3/s) (7,000 cubic ft per second [cfs]) for Addicks and 180 m^3/s (6,300 cfs) for Barker. The USACE noted that Addicks and Barker Dams reduced peak flows in Buffalo Bayou by more than 3,540 m^3/s (125,000 cfs) during the April 2016 flooding, a smaller event than Hurricane Harvey. The April 2016 event, also known as the Tax Day Flood, resulted from about 43 cm (17 inches) of rain, which accumulated over just 12 hours and caused the previous record pools for the dams. During the time of our visit on September 9, 2017, the gates of the dams were opened to allow flows of 170 m^3/s (6,000 cfs) (Addicks) and 110 m^3/s (4,000 cfs) (Barker) for a total flow into the Buffalo Bayou of 280 m^3/s (10,000 cfs) (see Figs. 5 and 6). The USACE gradually reduced outflows from these levels to a total of 110 m^3/s (4,000 cfs) on September 17, 2017.

Figure 5. Addicks outlet releasing $\sim 170 \text{ m}^3/\text{s}$ ($\sim 6000 \text{ cfs}$) (September 9, 2017, 29.79026° N , 95.62378° W).

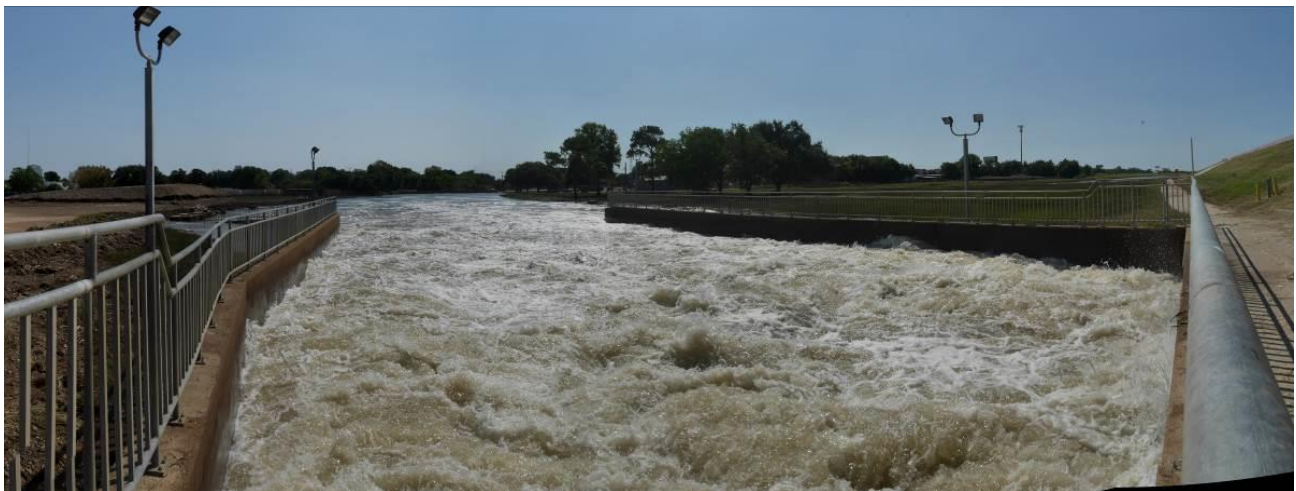
Figure 6. Barker outlet releasing $\sim 110 \text{ m}^3/\text{s}$ ($\sim 4000 \text{ cfs}$) (September 9, 2017, 29.76977° N , 95.64629° W).

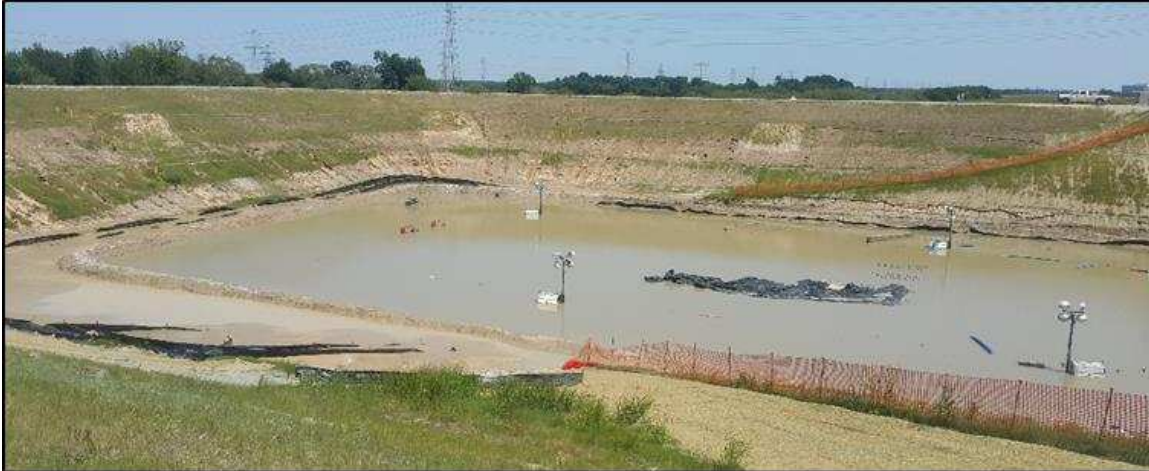
The USACE had contracted to construct new outlet structures and cutoff walls at each dam. This construction was in progress at the time of Hurricane Harvey and was suspended until the consequences of and recovery from the flooding could be assessed. At the time of the hurricane, cofferdams were in place and parts of the cutoff walls had been constructed. The cofferdams performed suitably in keeping the water in the reservoir from flooding the construction zone; however, the high backwater from the channel to Buffalo Bayou flooded the Addicks construction zone (see Fig. 7), and rainwater and underseepage pooled in the Barker cofferdammed area.

Figure 7. Interior of Addicks construction cofferdam for new outlet structure, flooded from Buffalo Bayou backwater; note erosion channels on slopes (September 9, 2017, 29.79063° N, 95.62586° W).

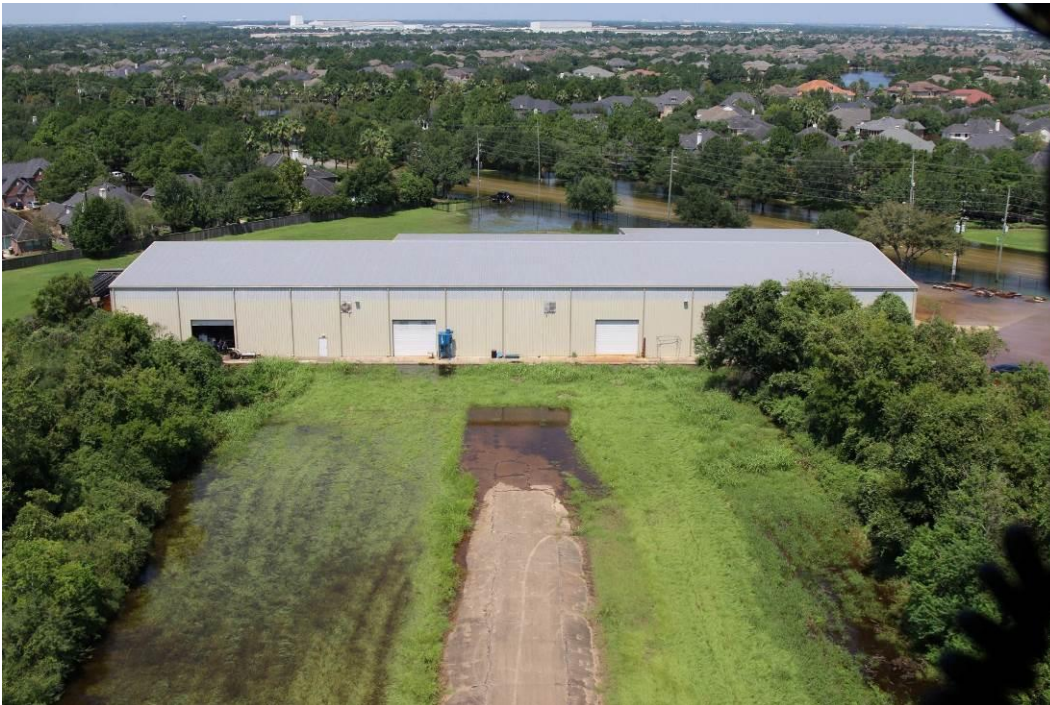
High water in the Addicks Reservoir (~33.3 m [~El. 109.1 ft]) exceeded the elevation of the level ground at the end of the north auxiliary spillway RCC (~El. 108), resulting in small outflows (~6 m³/s [~200 cfs]) that began on August 29, 2017. Figure 8 shows this area on September 7, 2017 when some small spillage was still taking place. These outflows were within the design intent of the dam and the auxiliary spillway, and should not be described as dam overtopping. Overtopping implies that the water levels have risen above the main dam, which is typically a serious condition that can lead to rapid erosion of the dam and a dam failure.

Figure 8. North end of Addicks auxiliary spillway (September 3, 2017, 29.84977° N, 95.58904° W, photo by USACE).
