Geotechnical Effects of Hurricane Harvey in the Houston, Beaumont, and Port Arthur Areas

ABSTRACT: *The Geotechnical Extreme Events Reconnaissance (GEER) Association deployed multiple teams of engineers from academia and practicing firms to the coast of Texas in late August and early September 2017 following Hurricane Harvey. This report summarizes the observations and data from the GEER team that focused primarily on the inland effects of Hurricane Harvey in the Houston area with some observations in the Port Arthur / Beaumont area east of Houston. Rain, not storm surge or wind, caused the observed damage in Houston, Beaumont, and Port Arthur by overwhelming stormwater management facilities and creating high flows and flooding in and near area waterways. The major Houston-area flood structures, Addicks and Barker Dams, performed well from a geotechnical perspective. Observed damages included shallow slides along levees, severe erosion along riverways, isolated road and culvert erosion and uplift, and area-wide flood effects in low and poorly drained neighborhoods.*

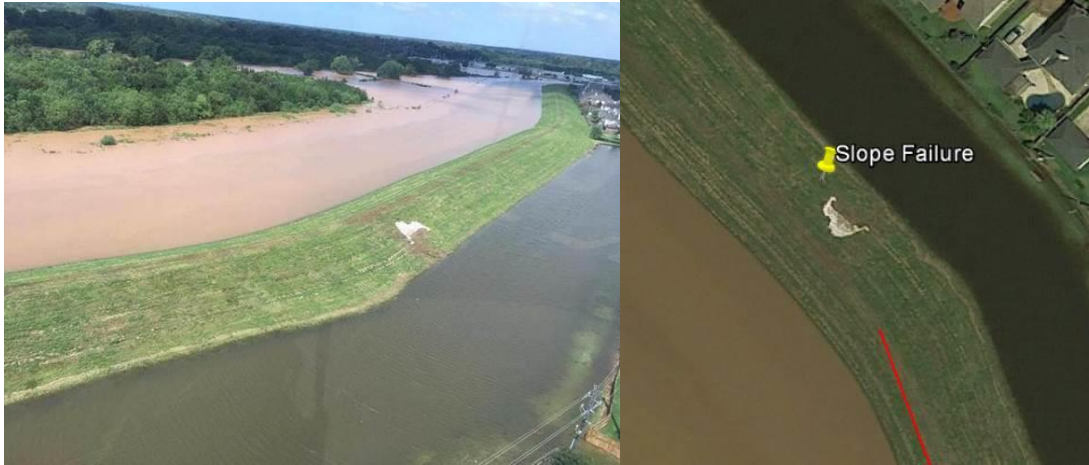
Overall, we understand that the Brazos River LID levees performed well, with no major failures, breaches, or overtopping. One incident of a surficial slide on the protected slope of a Sienna Plantation LID levee was reported and photographed by others as shown in Fig. 14 (see Location 2 on Fig. 13). The GEER team visited the First Colony LID 2 (see Location 3 on Fig. 13) and two of the drainage ditches that serve the LIDs (see Locations 4 and 5 on Fig. 13). Despite the good levee performance, flooding occurred within several LIDs due to the issues with storm water removal from the protected side behind the levees to the river side. Some LIDs were even completely cut off due to water surrounding the entirety of the LID.

Figure 14. Aerial photo (right) and Google Earth (left), August 30, 2017, 29.491844° N, 95.541017° W.

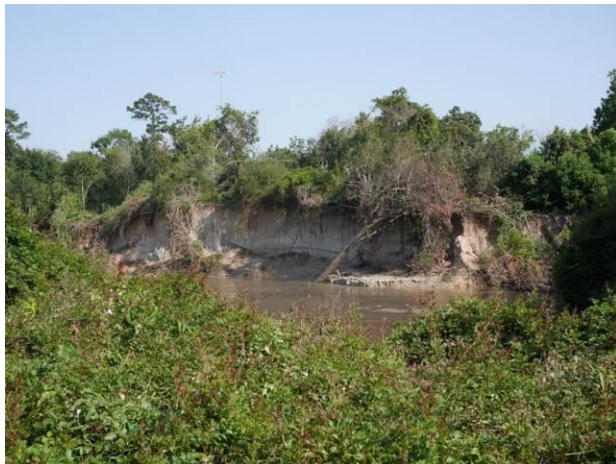
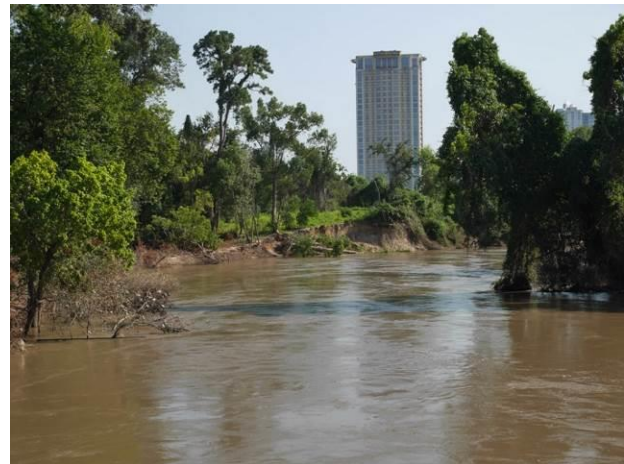
Figure 26. Buffalo Bayous slope failures (September 9, 2017, 29.76318° N, 95.45945° W).

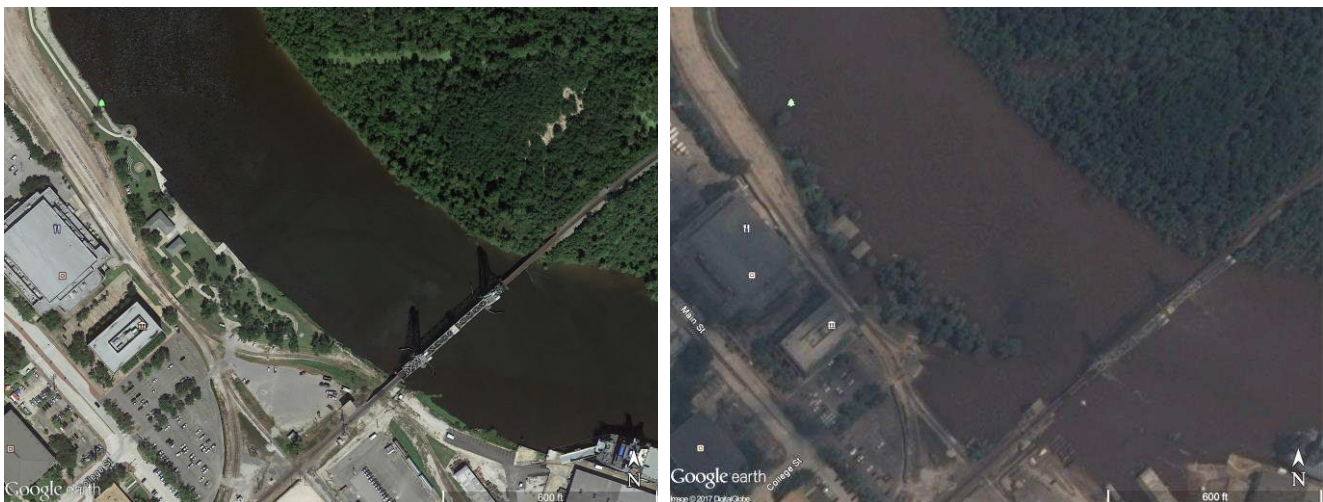
In Beaumont, the team observed significant erosion scour along the Neches River in the downtown area. Riverfront Park, behind City Hall and located on an outside bend of the river, was severely affected with the loss of shoreline and undercutting of many park features. Fig. 1 shows the location of Beaumont within the study area. Fig. 27 shows the location of Riverfront Park along the Neches River. Fig. 28 shows aerial / satellite images from Google Earth of Riverfront Park taken before the Harvey flooding (January 2015) and during the Harvey flooding (September 2015), respectively.

Figure 28. Aerial images of Beaumont Riverfront Park, January 2015 (left) and September 3, 2017 (right) (Google Earth).

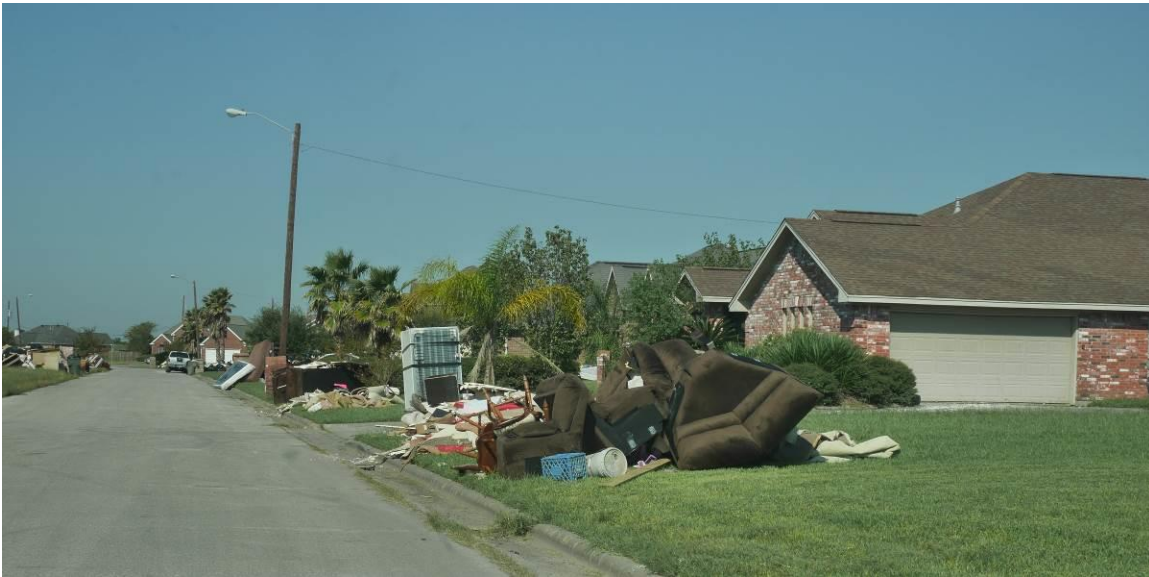
Figure 46. Residential flood damage debris, Port Arthur.
