Geotechnical Effects of Hurricane Harvey in the Houston, Beaumont, and Port Arthur Areas

ABSTRACT: *The Geotechnical Extreme Events Reconnaissance (GEER) Association deployed multiple teams of engineers from academia and practicing firms to the coast of Texas in late August and early September 2017 following Hurricane Harvey. This report summarizes the observations and data from the GEER team that focused primarily on the inland effects of Hurricane Harvey in the Houston area with some observations in the Port Arthur / Beaumont area east of Houston. Rain, not storm surge or wind, caused the observed damage in Houston, Beaumont, and Port Arthur by overwhelming stormwater management facilities and creating high flows and flooding in and near area waterways. The major Houston-area flood structures, Addicks and Barker Dams, performed well from a geotechnical perspective. Observed damages included shallow slides along levees, severe erosion along riverways, isolated road and culvert erosion and uplift, and area-wide flood effects in low and poorly drained neighborhoods.*

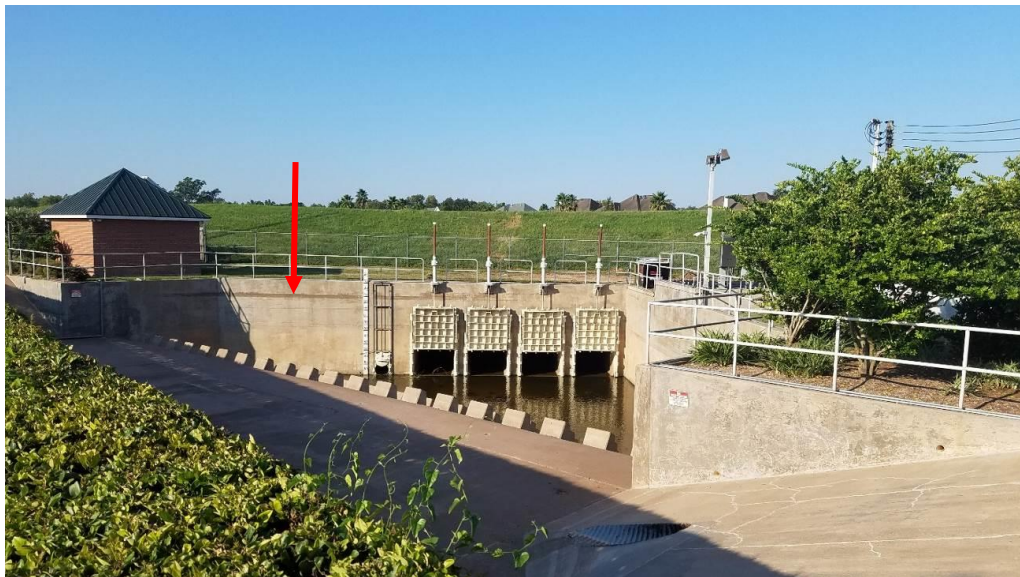
Figure 15. FCLID2 drainage outfall / pumping station basin, showing four 1.4 m (60 inch) flood gates, high water line at ~19.8 m (65 ft) gauge height, levee in background (September 10, 2017, 29.55509° N, 95.61779° W).
