Geotechnical Effects of Hurricane Harvey in the Houston, Beaumont, and Port Arthur Areas

ABSTRACT: *The Geotechnical Extreme Events Reconnaissance (GEER) Association deployed multiple teams of engineers from academia and practicing firms to the coast of Texas in late August and early September 2017 following Hurricane Harvey. This report summarizes the observations and data from the GEER team that focused primarily on the inland effects of Hurricane Harvey in the Houston area with some observations in the Port Arthur / Beaumont area east of Houston. Rain, not storm surge or wind, caused the observed damage in Houston, Beaumont, and Port Arthur by overwhelming stormwater management facilities and creating high flows and flooding in and near area waterways. The major Houston-area flood structures, Addicks and Barker Dams, performed well from a geotechnical perspective. Observed damages included shallow slides along levees, severe erosion along riverways, isolated road and culvert erosion and uplift, and area-wide flood effects in low and poorly drained neighborhoods.*

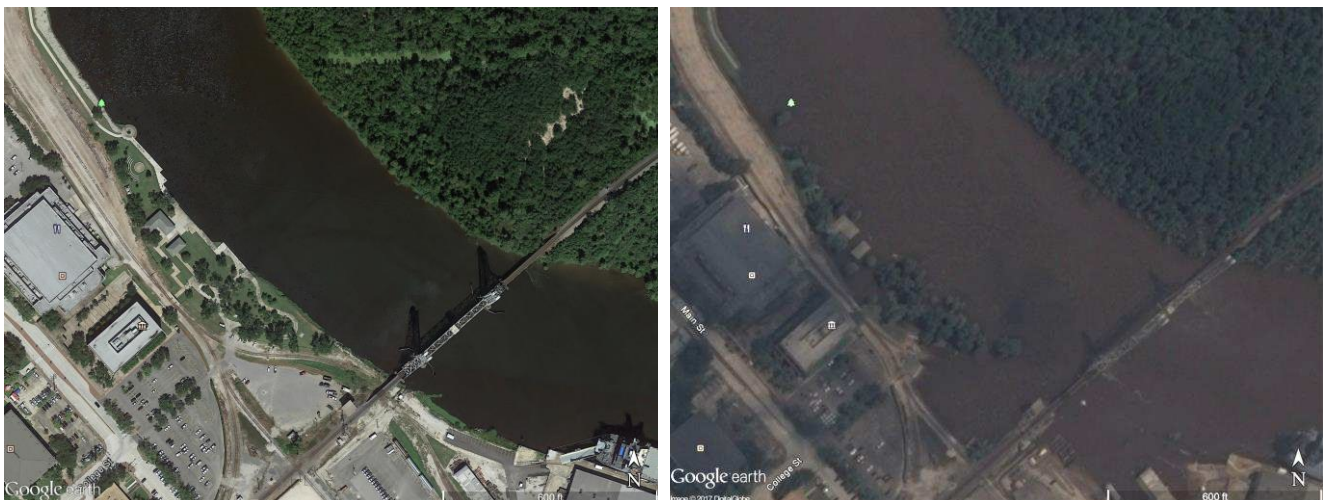
In Beaumont, the team observed significant erosion scour along the Neches River in the downtown area. Riverfront Park, behind City Hall and located on an outside bend of the river, was severely affected with the loss of shoreline and undercutting of many park features. Fig. 1 shows the location of Beaumont within the study area. Fig. 27 shows the location of Riverfront Park along the Neches River. Fig. 28 shows aerial / satellite images from Google Earth of Riverfront Park taken before the Harvey flooding (January 2015) and during the Harvey flooding (September 2015), respectively.

Figure 28. Aerial images of Beaumont Riverfront Park, January 2015 (left) and September 3, 2017 (right) (Google Earth).
