Geotechnical Extreme Event Site Reconnaissance in Puerto Rico After The Passage of Hurricane Maria

ABSTRACT: *The National Weather Service classified Hurricane Maria as a strong Category 4 Hurricane on the Saffir-Simpson hurricane wind scale at the time of its landfall in Yabucoa, Puerto Rico, U.S.A., on September 20, 2017. The immediate aftermath of Hurricane Maria was a devastated island with at least 64 people killed, severe infrastructure loss, a devastated electric power grid, and numerous geotechnical failures related to the intense rainfall and strong winds associated to this extreme event. This paper will summarize the event timeline and the geotechnical consequences of Maria's path across Puerto Rico. The impacts of Hurricane Maria on infrastructure and geomorphology are documented through the data and observations of the engineers and geologists that comprised the Geotechnical Extreme Events Reconnaissance (GEER) team. The main reconnaissance mission took place between October 25 and November 6, 2017, followed by a second field component involving terrestrial LiDAR surveys and UAV photogrammetry performed January 8 to 11, 2018.*

Reference: Silva-Tulla F., and Pando M. A

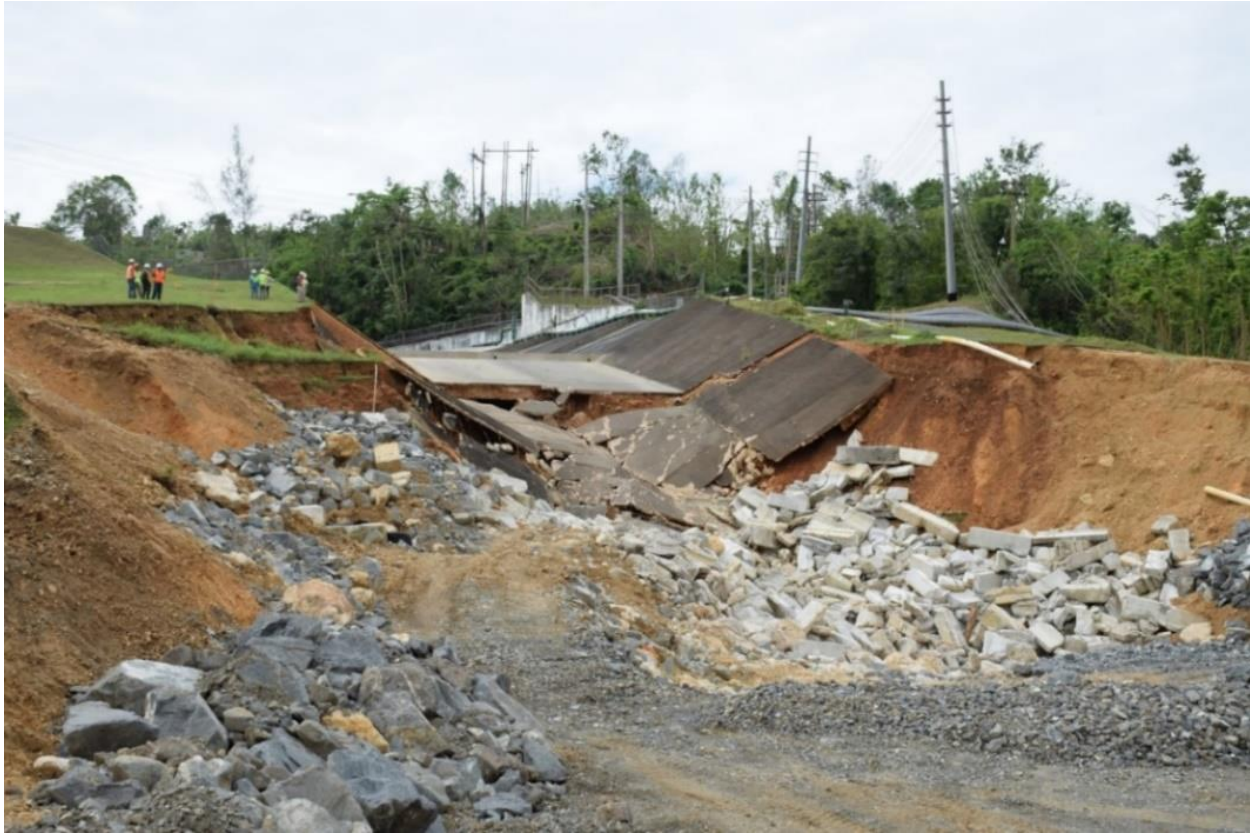
During Hurricane Maria, scour severely damaged the spillway and siphon at Guajataca Dam, as shown in Figure 10. The siphon, replaced by pumps after the damage from the hurricane, supplied raw water for the Aqueduct and Sewer Authority pump located near the reservoir. Concerns about the dam's stability prompted emergency remedial measures and the evacuation of about 70,000 residents located downstream of the dam. The maximum reservoir elevation that resulted from Hurricane Maria remains unknown.

Figure 10. Damaged condition of Guajataca Dam spillway (Silva-Tulla et al., 2018).

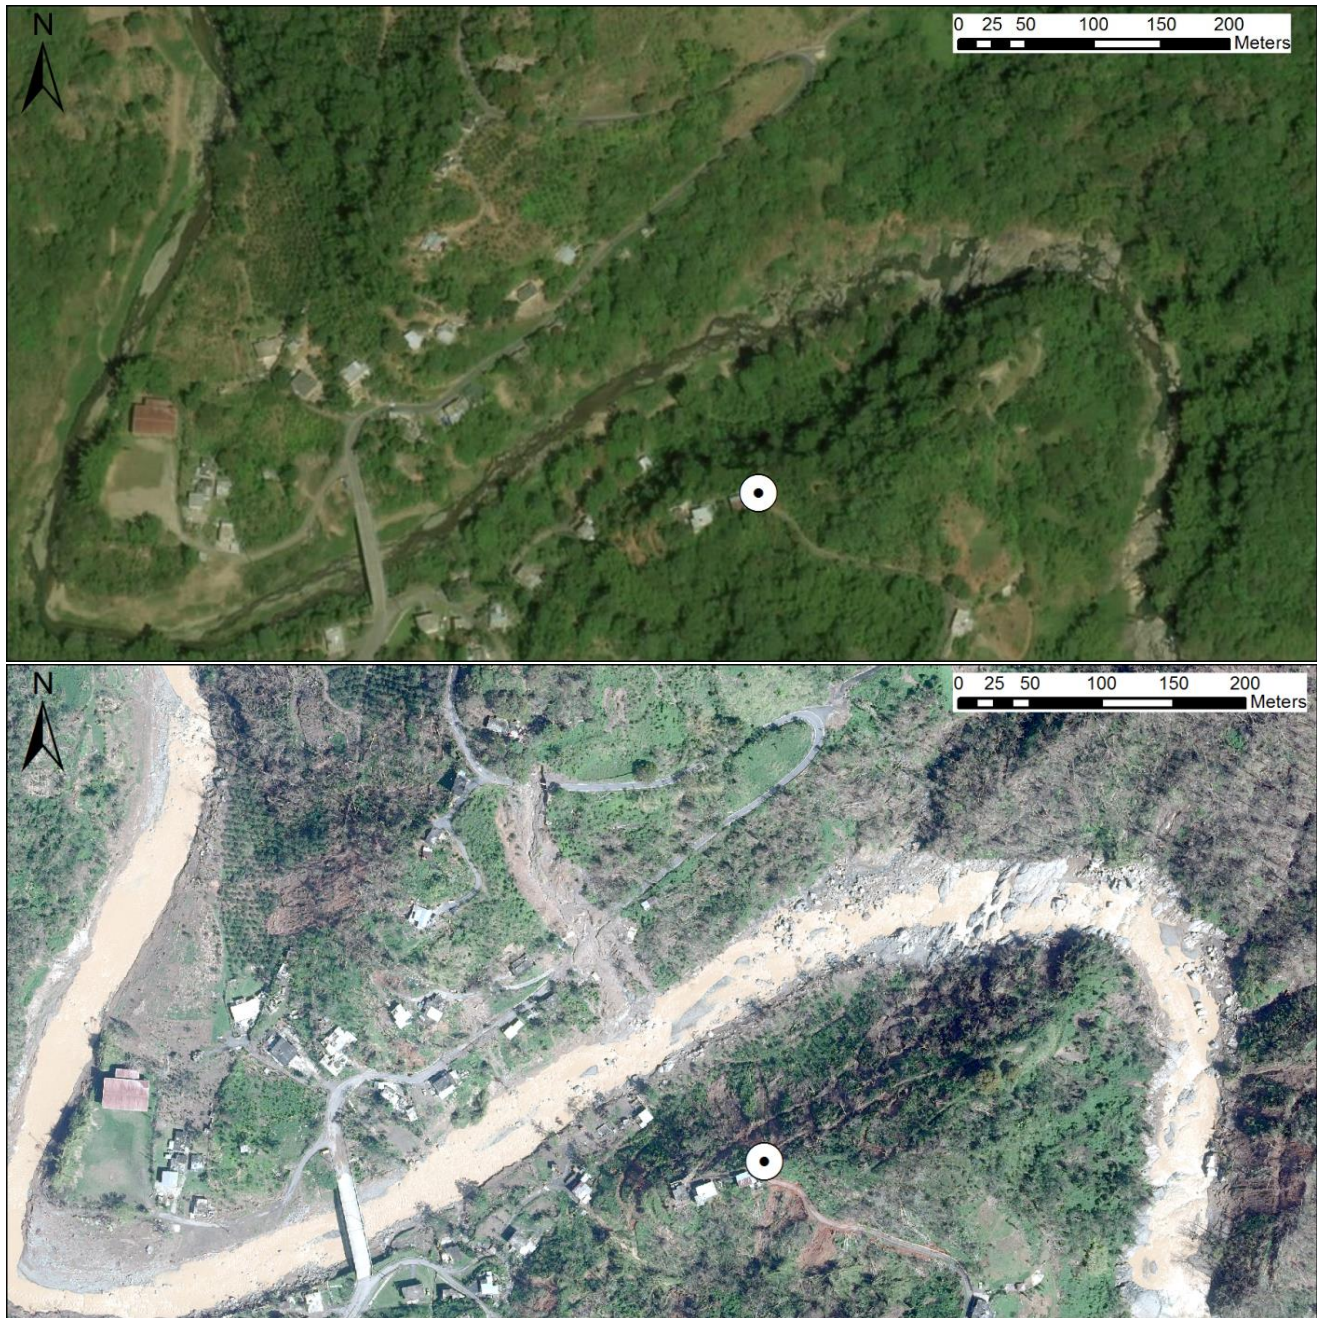
Note: Upper image taken before Hurricane Maria. Lower photo captured by FEMA on October 12, 2017. The white circle with black center dot indicates the location of the TLS Lidar performed in January 2018.

Figure 17. Aerial photos of debris flow site on PR-4131 in central Lares along the Rio Blanco (Silva-Tulla et al., 2018).

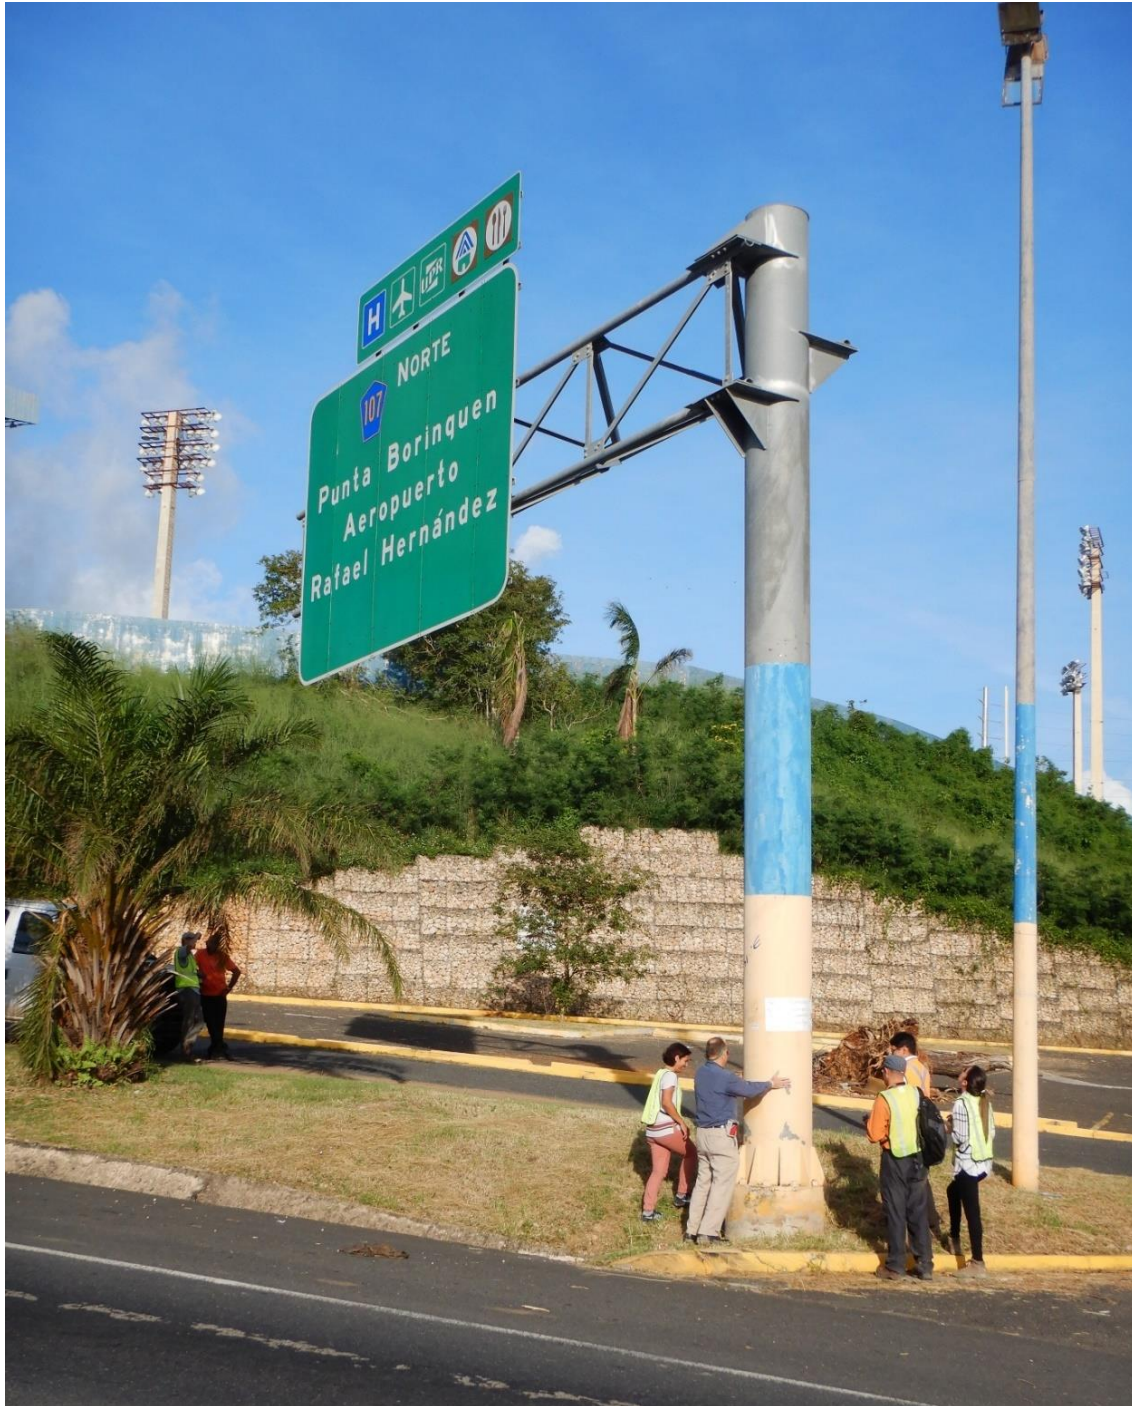
Foundation failures observed by the team included lighting towers, electrical transmission poles, and many road sign failures. Some of the road signs simply rotated about the axis of their circular drilled shaft foundation, while others also experienced bearing capacity failures. Although some electrical transmission poles failed from bearing capacity failures, the large number of reinforced concrete poles that had snapped at mid-height provided graphic evidence of the storm power. Figure 24 shows a representative torsional foundation failure of a highway sign structure.

Figure 24. Photo of cantilevered sign foundation failure (GEER Mission Site F2; Silva-Tulla et al. 2018).
