# Geotechnical Extreme Event Site Reconnaissance in Puerto Rico After The Passage of Hurricane Maria

**Francisco Silva-Tulla**, Consulting Civil Engineer, GeoEngineering and Environment, Lexington, Massachusetts, U.S.A.; email: [silva@alum.mit.edu](mailto:silva@alum.mit.edu)

**Miguel A. Pando**, Associate Professor, Department of Civil, Architectural, and Environmental Engineering, Drexel University, Philadelphia, PA, 19104, U.S.A.; email: [miguel.a.pando@drexel.edu](mailto:miguel.a.pando@drexel.edu)

Submitted: 7 November 2018; Published: 2 July 2020

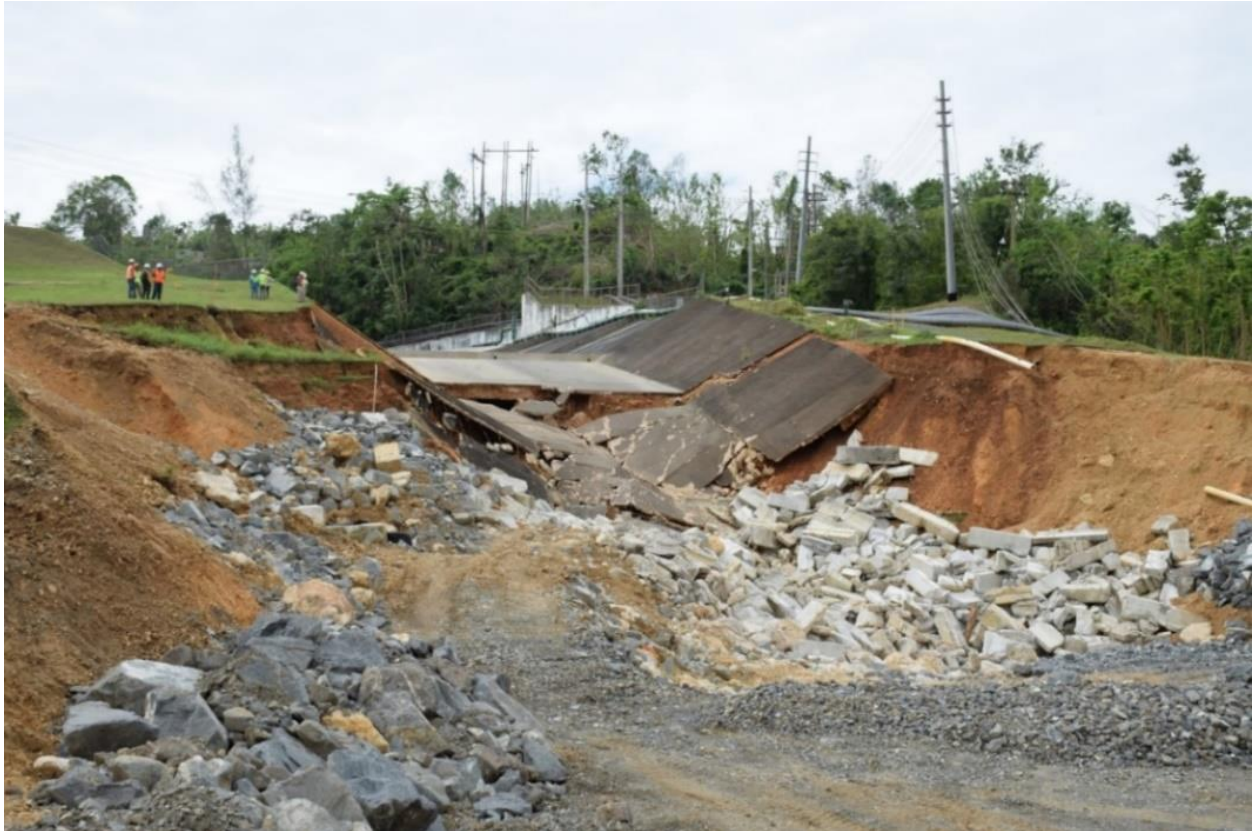
During Hurricane Maria, scour severely damaged the spillway and siphon at Guajataca Dam, as shown in Figure 10. The siphon, replaced by pumps after the damage from the hurricane, supplied raw water for the Aqueduct and Sewer Authority pump located near the reservoir. Concerns about the dam's stability prompted emergency remedial measures and the evacuation of about 70,000 residents located downstream of the dam. The maximum reservoir elevation that resulted from Hurricane Maria remains unknown.

*Figure 10. Damaged condition of Guajataca Dam spillway (Silva-Tulla et al., 2018).*

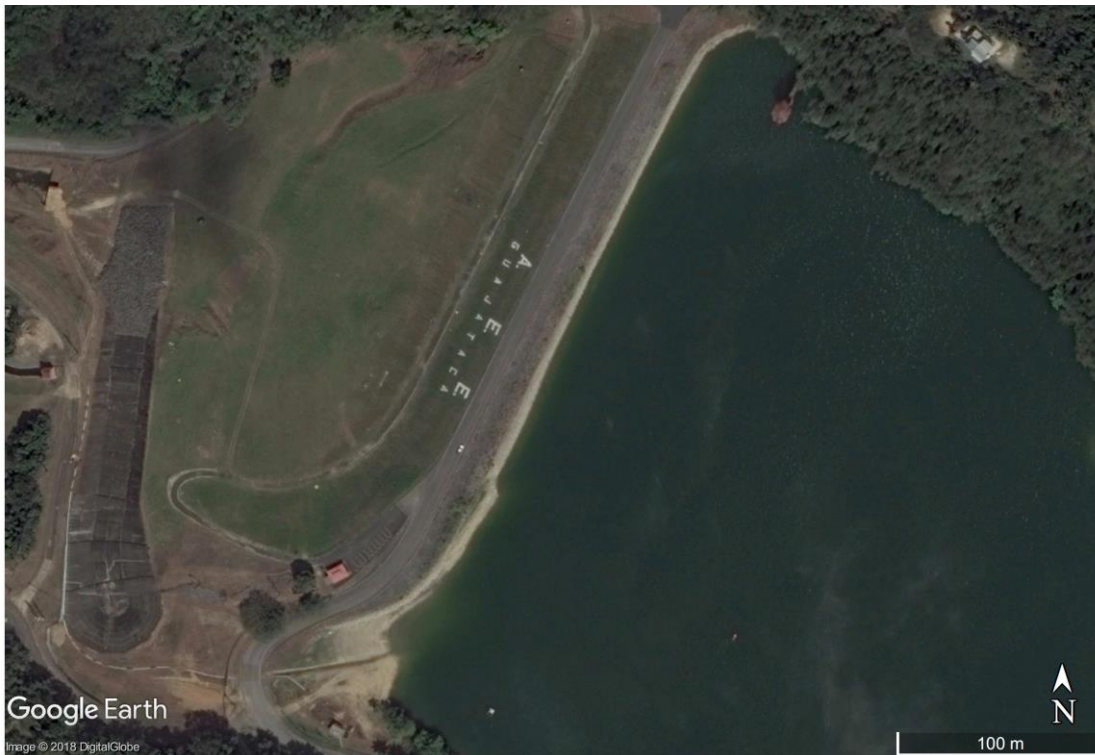
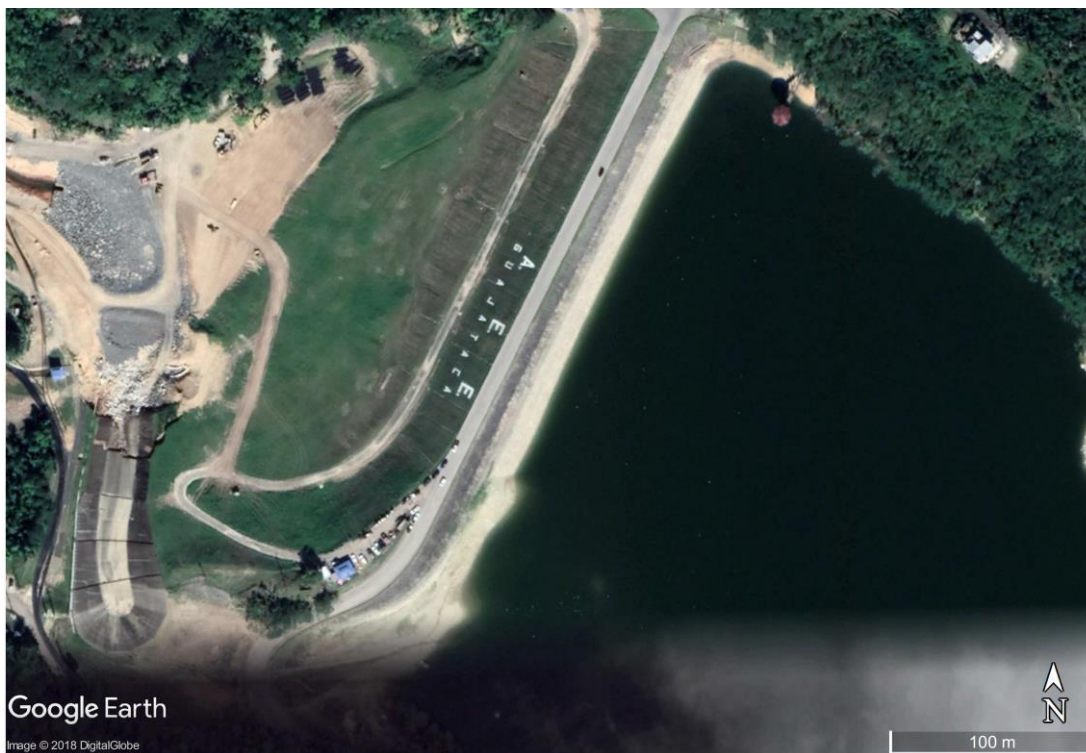
The Google Earth aerial image shown in Figure 11(a) shows the spillway, apparently in good condition in March 2017. In contrast, a Google Earth image from November 2017, shown in Figure 11(b), illustrates significant damage after Hurricane Maria. Figure 11(b) shows that about 100 m (300 ft) of spillway was completely destroyed (roughly 40 m of concrete and 60 m of riprap), and that an additional 25 m of concrete spillway was significantly undermined and displaced. A siphon located under the spillway was also destroyed. Aerial photographs taken during the aftermath of Hurricane Maria show water spilling out of the upstream side of the siphon (on the north side of the spillway), indicating that the siphon was operational during Hurricane Maria. Scour depths below the spillway could not be measured since the area had already been partly filled, but photographs and witness accounts indicate that extensive scour occurred.

Figure 11. Comparison of the Guajataca Dam condition between March and November 2017.

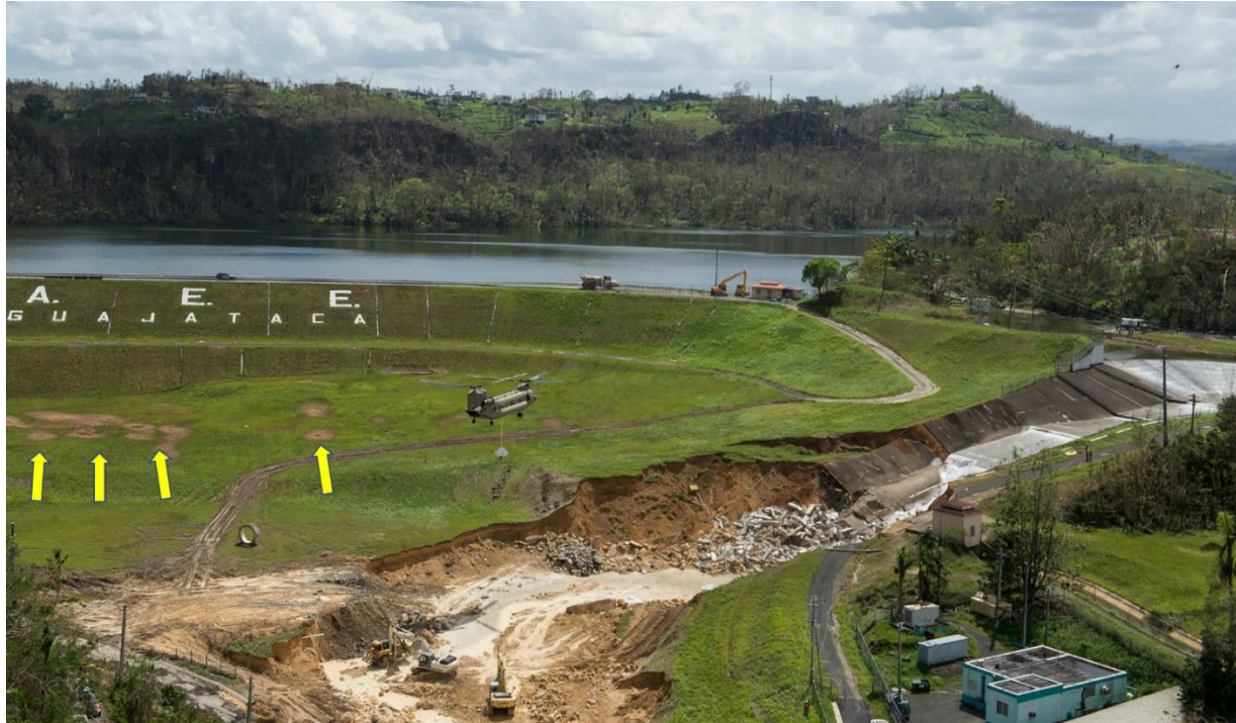
What appear to be sand boils along the toe of the earth dam suggest that its foundation materials were also subject to soil transport during Hurricane Maria (Figure 12). The seepage path and source of the eroded materials remain unknown, and considerable uncertainty exists about the origin and nature of the features shown in Figure 12. The GEER team observed water, soil, and other debris in the capped piezometer protective pipes consistent with a recent spike in groundwater pressures. During their visit, the team noted a large void approximately 0.3 m in diameter, located 10 m downstream of the toe and directly downstream of the “A” of the AEE sign on the downstream slope. Excavations, structures, poles, or posts were not reported or visible in aerial photographs near the location of the reported cavity. It seems possible that the void was either created or exacerbated by underseepage resulting from high hydraulic head during Hurricane Maria (Silva-Tulla et al., 2018).

*Note: Yellow arrows show location of apparent sand boils downstream of the dam toe.*

*Figure 12. Apparent sand boils downstream of the dam toe (photograph from the Pennsylvania National Guard; figure adapted from Silva-Tulla et al., 2018).*

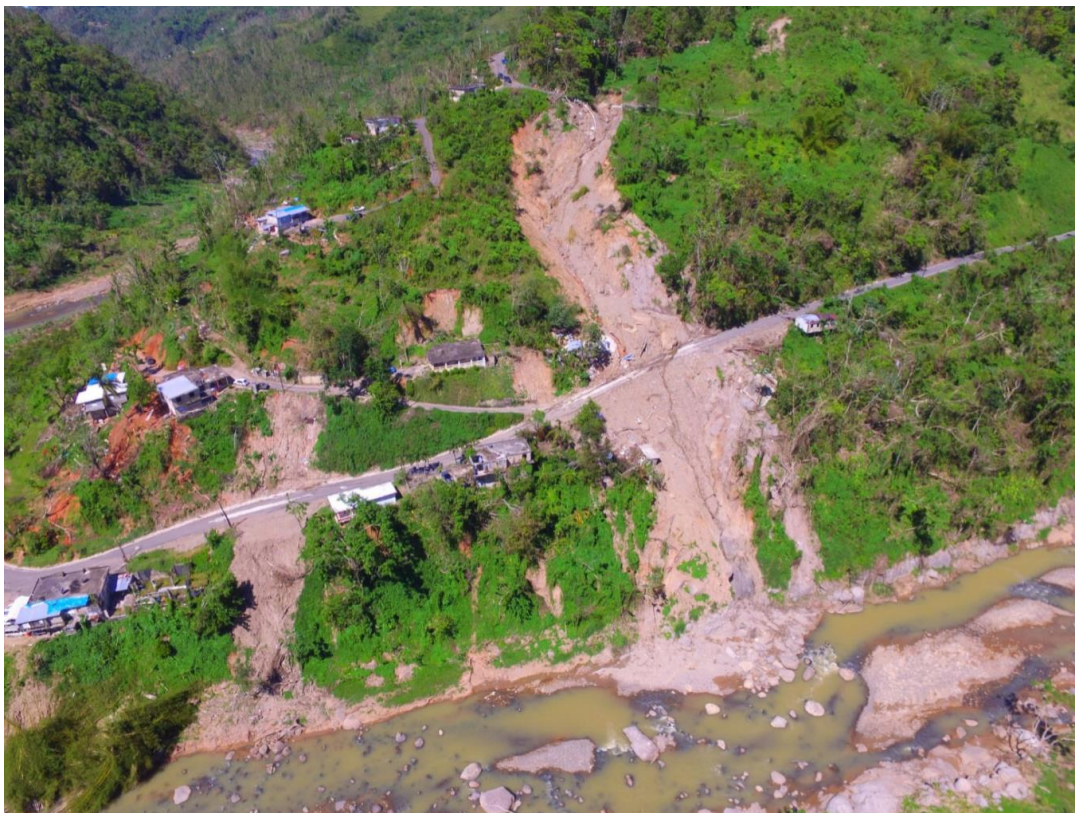
The majority of the slides shown in Figure 14 consisted of shallow debris flows. Figure 16 shows a site, visited by the GEER team, which was affected by some debris flows; this site is located along Puerto Rico State Road 4131 (PR-4131) near the Rio Blanco River in the municipality of Lares. The largest debris flow shown destroyed three homes along the lower road alignment (Silva-Tulla et al., 2018). Luckily, the inhabitants of those homes were not present at the time of the landslide. The debris flow initiated just above the highest road cut on a switchback along PR-4131. The upper area is the primary zone of volume loss, while the lower portion of the road was only covered by debris. The hillslope material slid directly into the river below, which carried much of the small- to medium-sized sediment downstream. Figure 17 shows aerial imagery of the landslide before and after Hurricane Maria.

Figure 16. Photo of debris flow above the Rio Blanco River along PR-4131 in Municipality of Lares (photo taken using UAV at location: Lat. +18.250348° Lon. -66.884155°, looking toward the North).

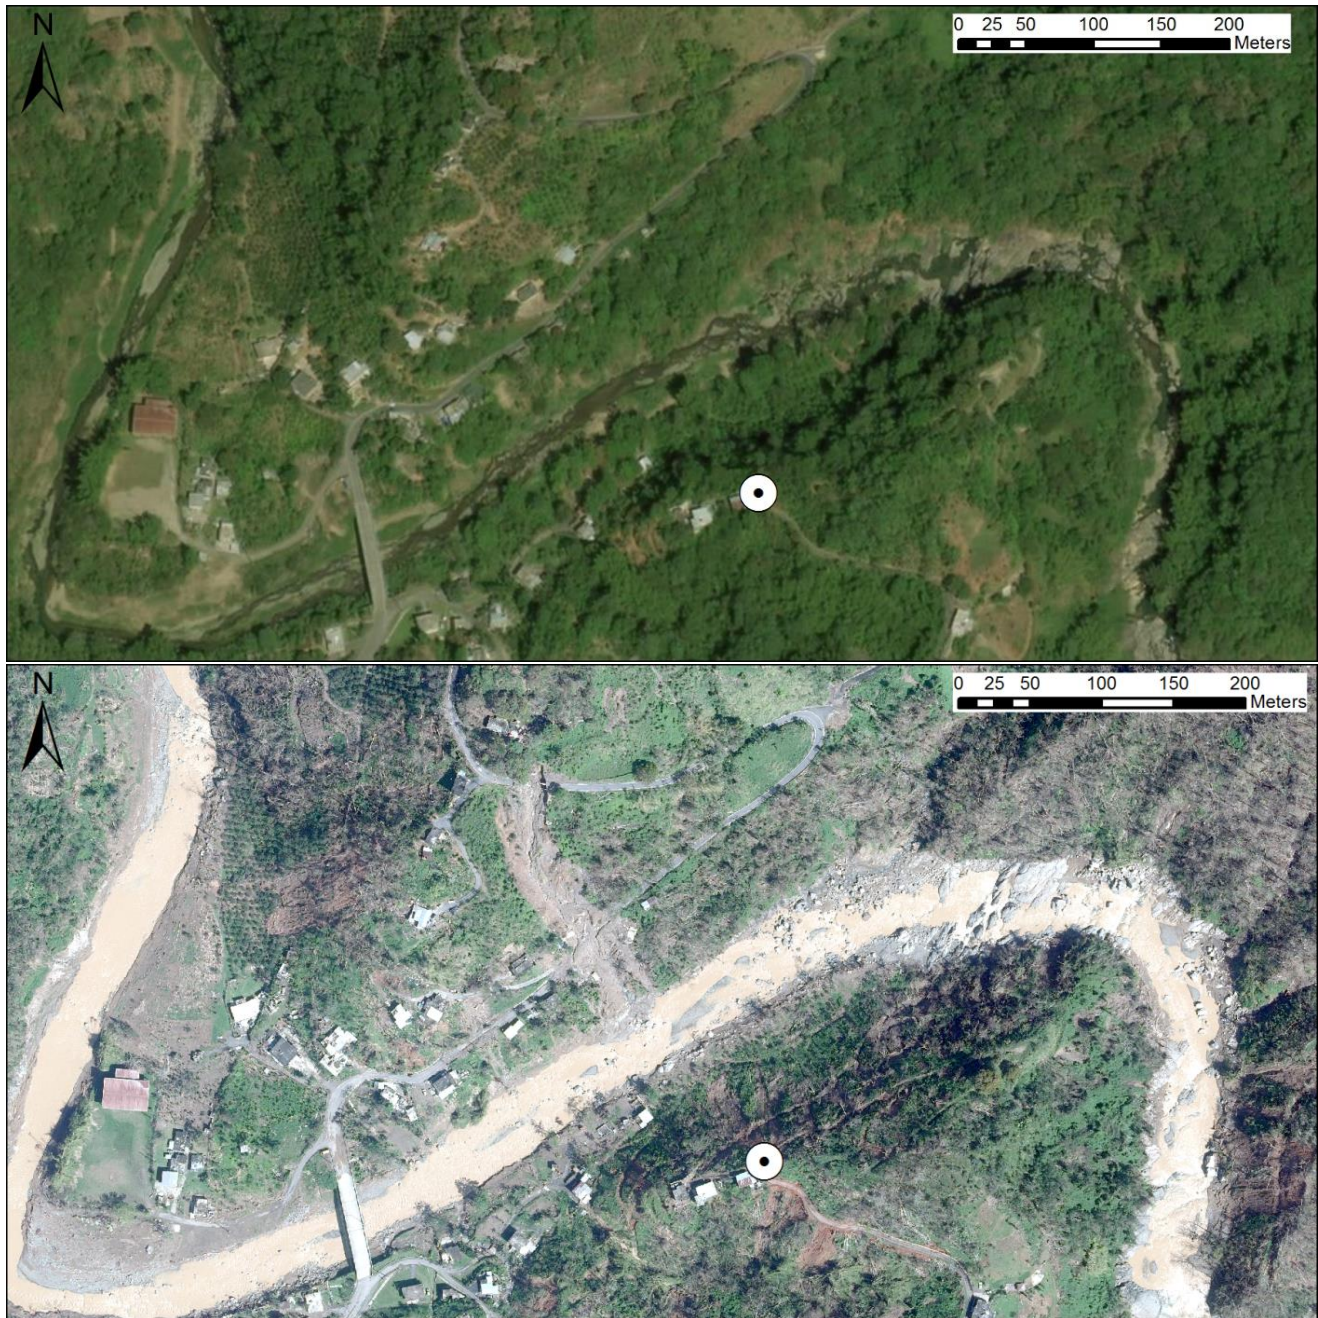
*Figure 17. Aerial photos of debris flow site on PR-4131 in central Lares along the Rio Blanco (Silva-Tulla et al., 2018).*

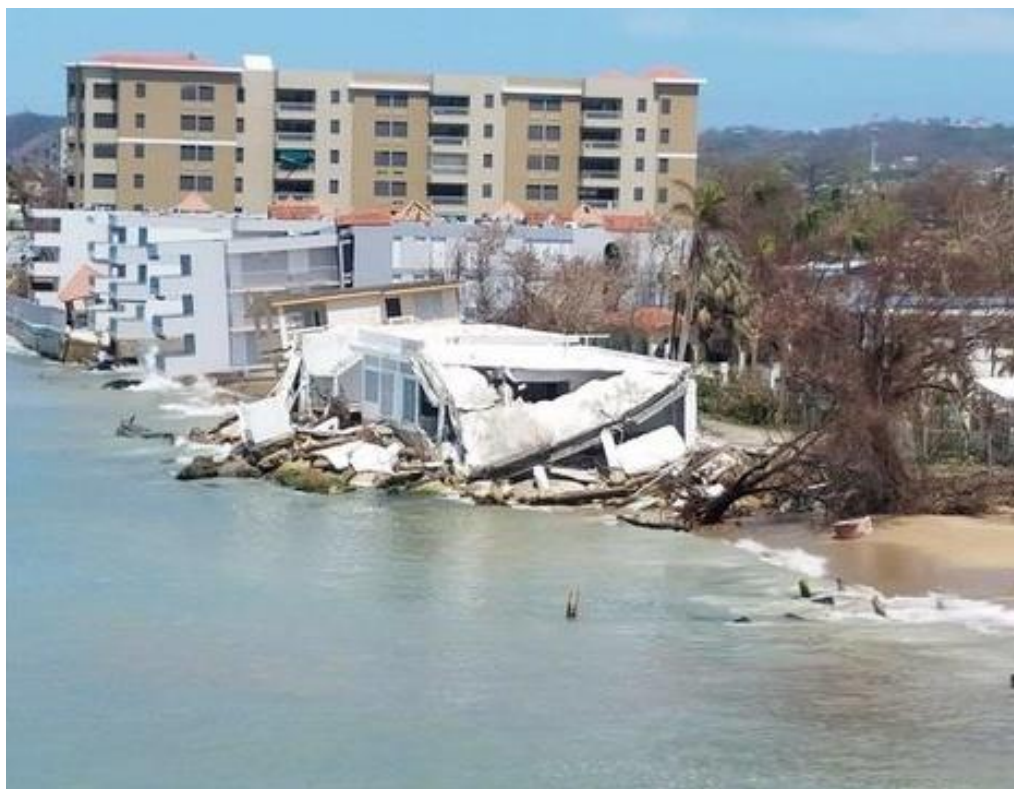
After Hurricane Maria, several buildings in the area of Site CE3 suffered severe damage, as shown in Figure 20. This figure shows extensive damage from waves or scour at the three-story Rincón Ocean Club I building, which was supported on shallow footings, and at the common areas of the terrace and swimming pool. A large volume of soil eroded from the front of the buildings and from beneath the swimming pool. Footings and beams supporting the terrace were exposed and sheared off from the building foundation. Part of Building A collapsed into the ocean and what remained standing was severely cracked. The Victoria Del Mar Condominium, the tallest building in this area and located to the north of Rincón Ocean Club I, also suffered extensive damage due to coastal scour. The terrace and swimming pool area of this condominium collapsed thanks to the storm.

The beachfront in the Córcega Beach area suffered extensive coastal scour. The approximately 6 to 9 m (20 to 30 ft) of beachfront shown in the pre-storm photo (Figure 19) was drastically reduced at the time of the site reconnaissance. The GEER Team did not observe sand washout deposits or shoreline erosion protection measures during the field reconnaissance of Site CE3. Unfortunately, there were no storm tide sensors available near Rincón to help assess tidal levels or the magnitude of wave action during this hurricane. However, NOAA (2017) reported highest water levels of 0.3 to 0.6 m (1 to 2 ft) above maximum higher high water (MHHW) for the northwest coastline of PR, where MHHW is defined as the average daily highest tide. This is consistent with a high-water elevation mark data recorded at USGS Stations (Silva-Tulla et al, 2018).

*Figure 20. Oceanfront damage in Córcega Beach area (Site CE3; Silva-Tulla et al., 2018).*

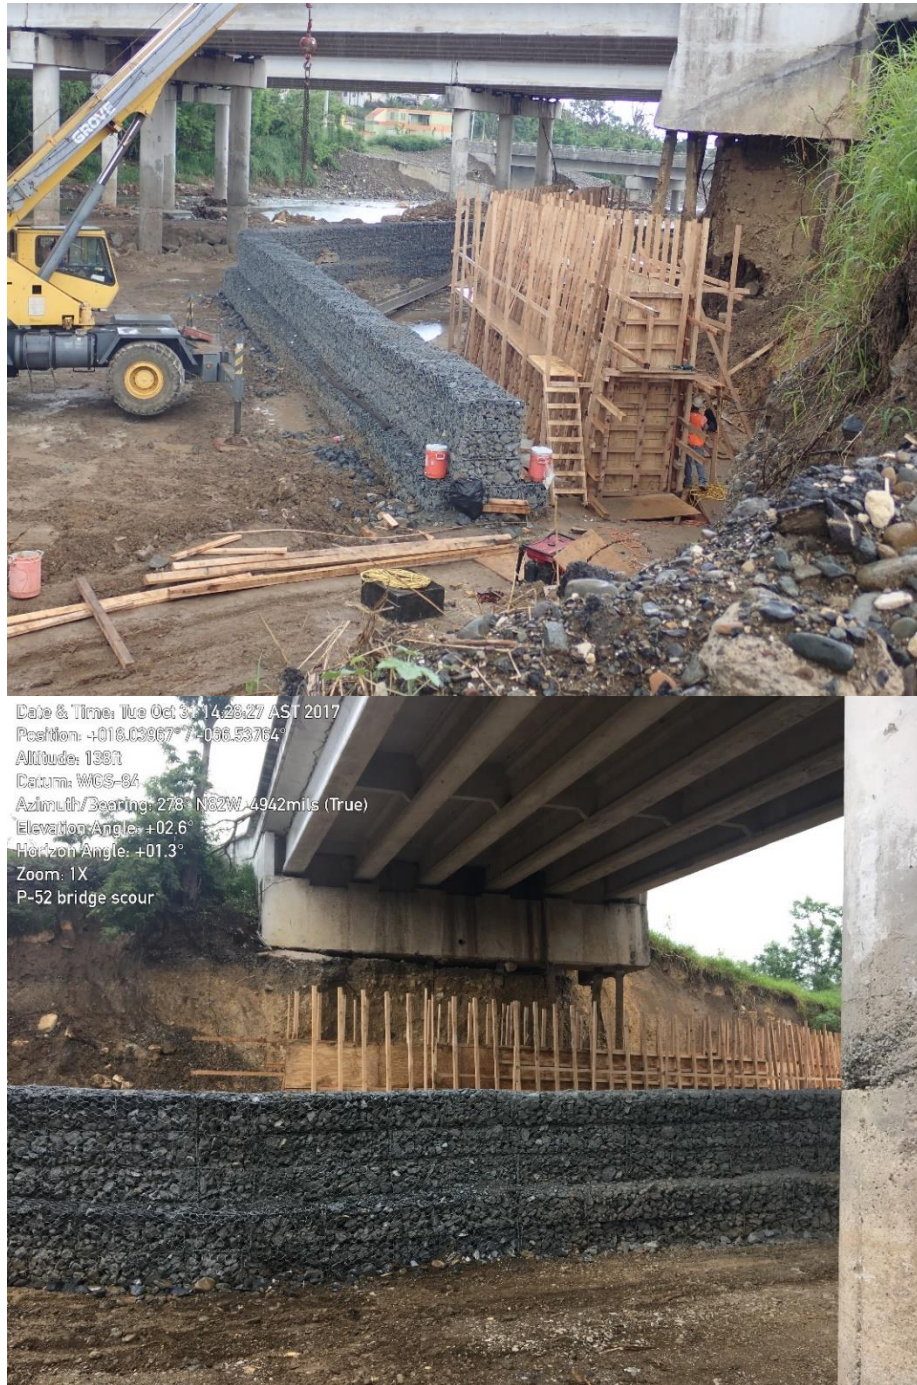
On October 31, 2017, the GEER team observed scour and erosion near the piers and abutments of Highway 52 bridges over the Inabón River at site RE1, just east of the city of Ponce, PR. Figure 21 shows select photos taken during the site visit. The photos show exposed abutment H-piles and ongoing emergency work, including the erection of formwork for abutment repairs and a temporary protective gabion wall. The gabion wall should protect the abutment and reinforced concrete shield under construction in front of the original exposed piles.

Figure 21: Photos of west abutment of westbound Highway 52 Bridge over the Inabón River (October 31, 2017; Silva-Tulla et al., 2018).

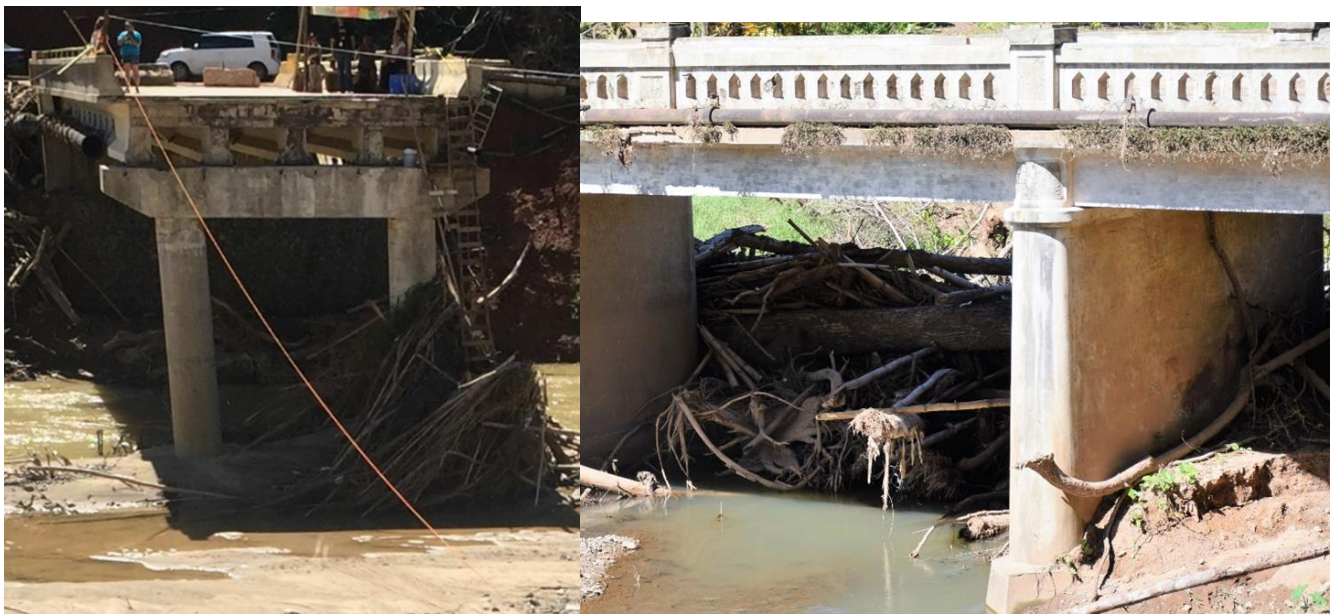
The GEER team visited several bridge sites and observed damage related to the large hydrodynamic forces from the increased volume and flow speeds associated with Hurricane Maria floods. Figure 22 shows photos from two bridge sites visited by the GEER team; these provide an idea of the magnitude of debris accumulation and the associated large hydrodynamic forces.

(Lat: +18.301439°, Lon: -66.698319°, 11/02/17)  
a) PR-123 bridge failure (“Los Olvidados”)

(Lat: +18.28683°, Lon: -67.10610°, 11/03/17)  
b) Debris blocked at bridge

Figure 22. Images showing debris accumulation and damage at bridges during Hurricane Maria (Silva-Tulla et al., 2018).

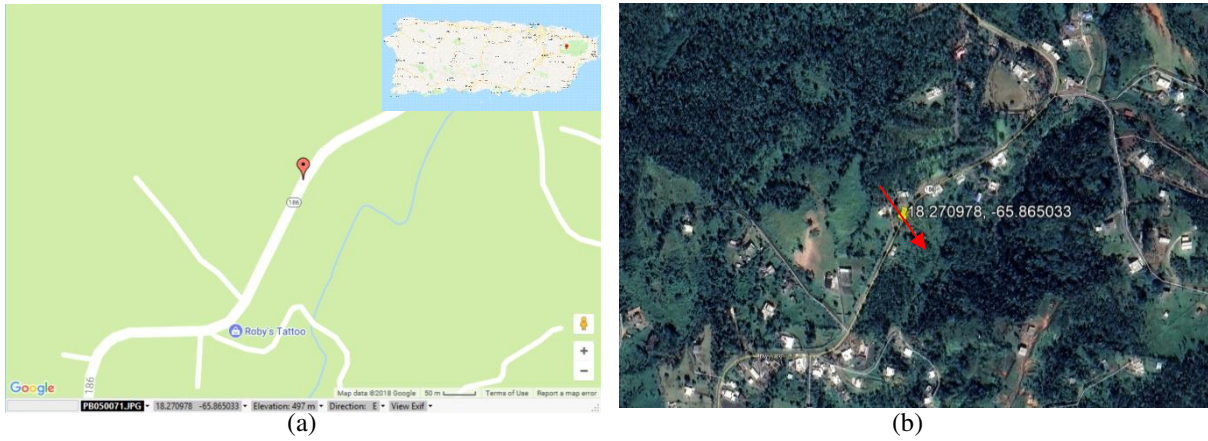
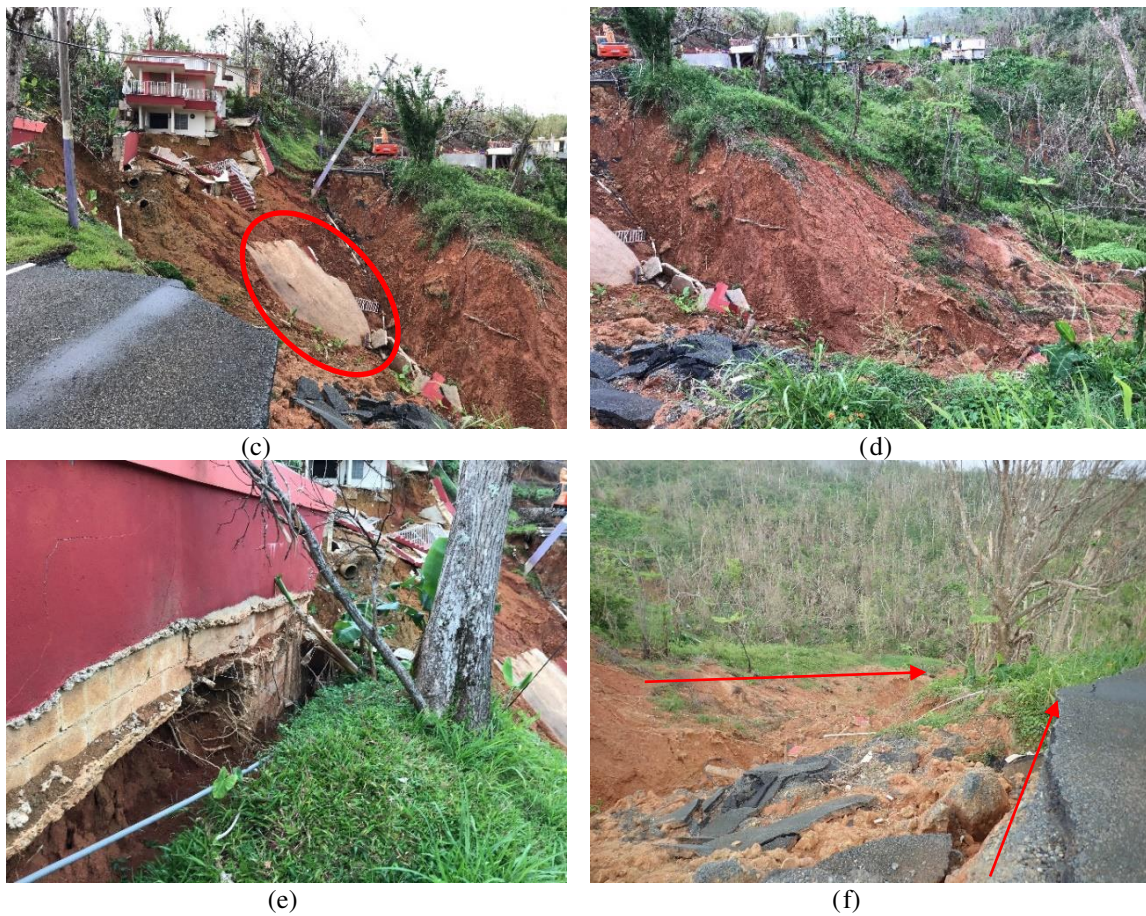
Figure 23(a) shows the location of a road failure on the northeast side of the island near the west boundary of the El Yunque National Rain Forest, along road PR-186. The failure affected the full width of PR-186 and the entrance driveway of a residence on the west side of the road (upslope side). The arrow shown in Figure 23(b) points toward the slope failure direction (southeast). Figure 23(c) shows the upper portion of the failure that resulted in a complete cut-off of PR-186. Figure 23(c)

shows a portion of the concrete pavement driveway of a residence to the left of the image (residence not shown); the final position of the piece of concrete driveway is shown inside the red oval. Additional exemplifying photos are shown in Figures 23 (d), (e), and (f). The arrows in Figure 23(f) point toward the slope failure direction (southeast).

Figure 23. Road failure affecting PR-186 (GEER mission Site 7; Silva-Tulla et al., 2018).

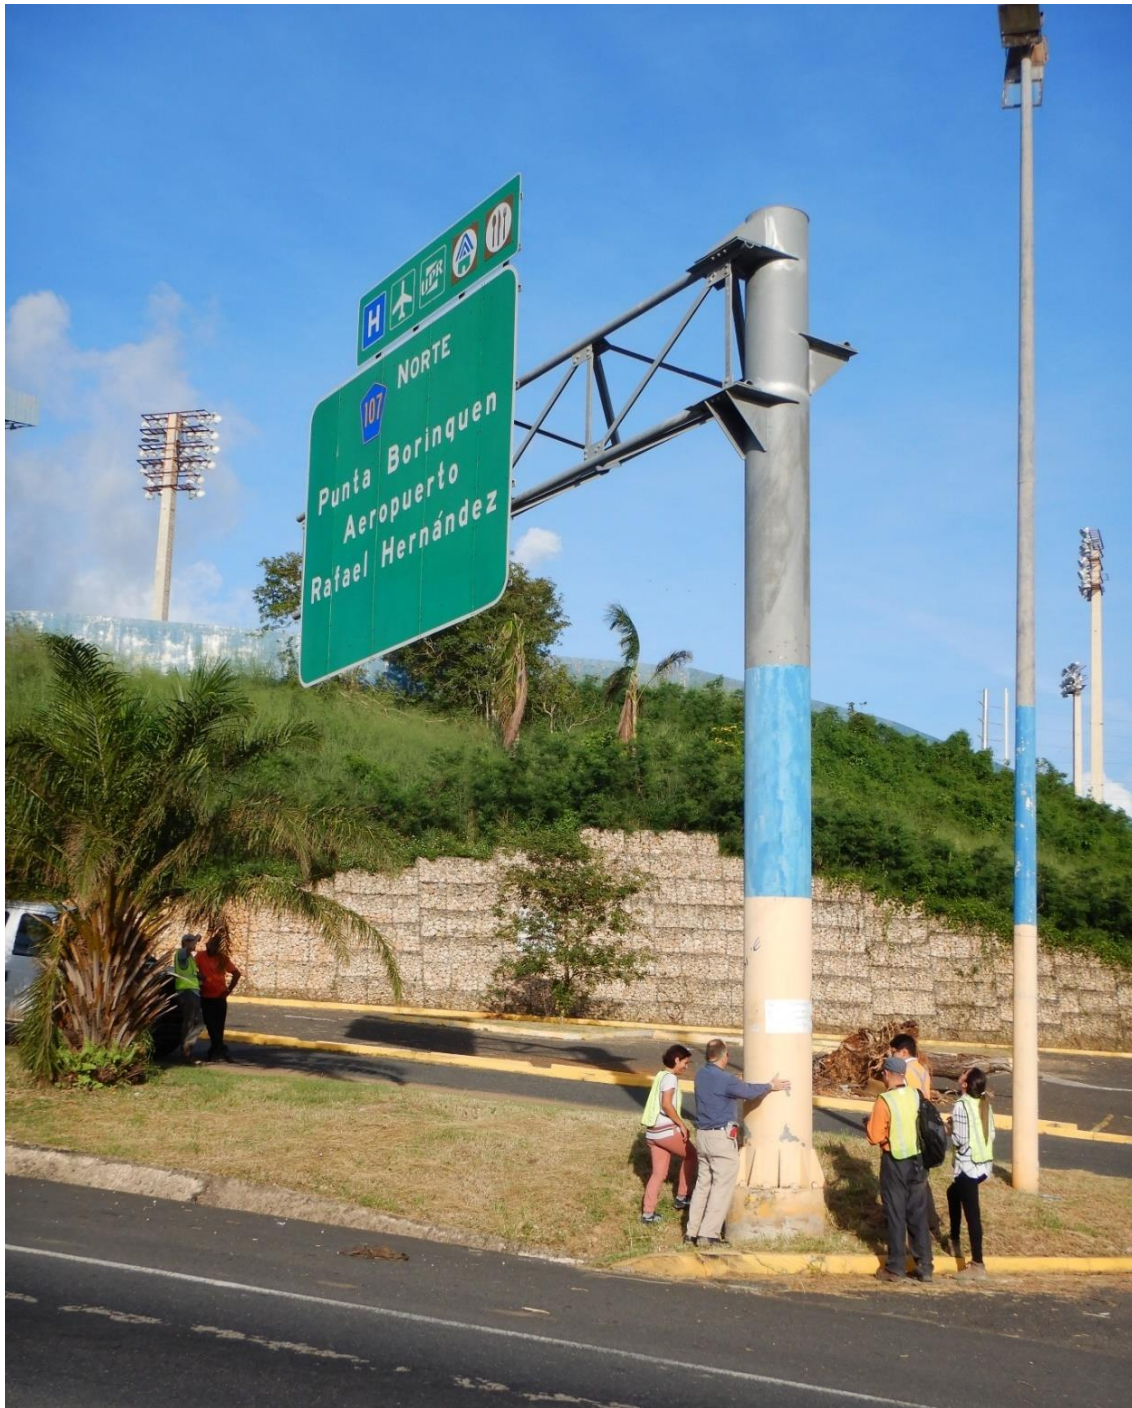
Foundation failures observed by the team included lighting towers, electrical transmission poles, and many road sign failures. Some of the road signs simply rotated about the axis of their circular drilled shaft foundation, while others also experienced bearing capacity failures. Although some electrical transmission poles failed from bearing capacity failures, the large number of reinforced concrete poles that had snapped at mid-height provided graphic evidence of the storm power. Figure 24 shows a representative torsional foundation failure of a highway sign structure.

Figure 24. Photo of cantilevered sign foundation failure (GEER Mission Site F2; Silva-Tulla et al. 2018).
