Geotechnical Extreme Event Site Reconnaissance in Puerto Rico After The Passage of Hurricane Maria

Reference: Silva-Tulla F., and Pando M. A. (2020). Geotechnical Extreme Event Site Reconnaissance in Puerto Rico after the Passage of Hurricane Maria. International Journal of Geoengineering Case Histories, Volume 5, Issue 4, pp. 1-25, doi: 10.4417/IJGCH-05-04-01

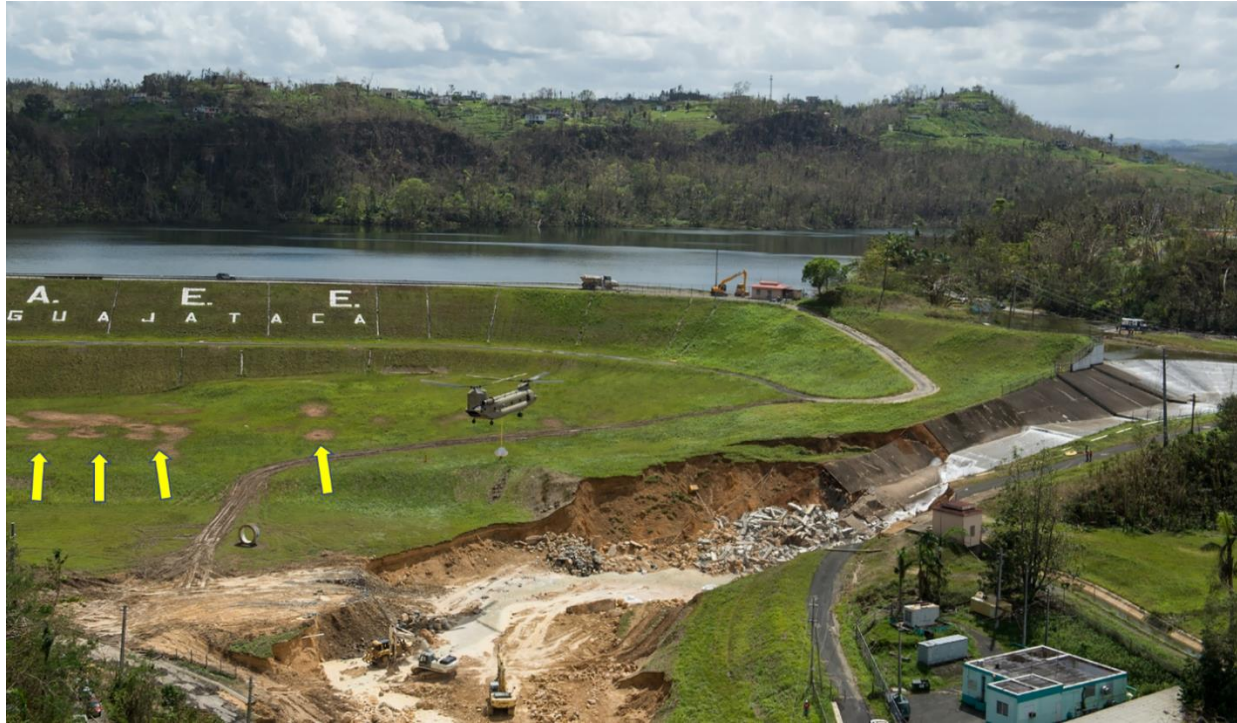
What appear to be sand boils along the toe of the earth dam suggest that its foundation materials were also subject to soil transport during Hurricane Maria (Figure 12). The seepage path and source of the eroded materials remain unknown, and considerable uncertainty exists about the origin and nature of the features shown in Figure 12. The GEER team observed water, soil, and other debris in the capped piezometer protective pipes consistent with a recent spike in groundwater pressures. During their visit, the team noted a large void approximately 0.3 m in diameter, located 10 m downstream of the toe and directly downstream of the “A” of the AEE sign on the downstream slope. Excavations, structures, poles, or posts were not reported or visible in aerial photographs near the location of the reported cavity. It seems possible that the void was either created or exacerbated by underseepage resulting from high hydraulic head during Hurricane Maria (Silva-Tulla et al., 2018).

Note: Yellow arrows show location of apparent sand boils downstream of the dam toe.

Figure 12. Apparent sand boils downstream of the dam toe (photograph from the Pennsylvania National Guard; figure adapted from Silva-Tulla et al., 2018).
