Geotechnical Extreme Event Site Reconnaissance in Puerto Rico After The Passage of Hurricane Maria

ABSTRACT: *The National Weather Service classified Hurricane Maria as a strong Category 4 Hurricane on the Saffir-Simpson hurricane wind scale at the time of its landfall in Yabucoa, Puerto Rico, U.S.A., on September 20, 2017. The immediate aftermath of Hurricane Maria was a devastated island with at least 64 people killed, severe infrastructure loss, a devastated electric power grid, and numerous geotechnical failures related to the intense rainfall and strong winds associated to this extreme event. This paper will summarize the event timeline and the geotechnical consequences of Maria's path across Puerto Rico. The impacts of Hurricane Maria on infrastructure and geomorphology are documented through the data and observations of the engineers and geologists that comprised the Geotechnical Extreme Events Reconnaissance (GEER) team. The main reconnaissance mission took place between October 25 and November 6, 2017, followed by a second field component involving terrestrial LiDAR surveys and UAV photogrammetry performed January 8 to 11, 2018.*

Reference: Silva-Tulla F., and Pando M. A

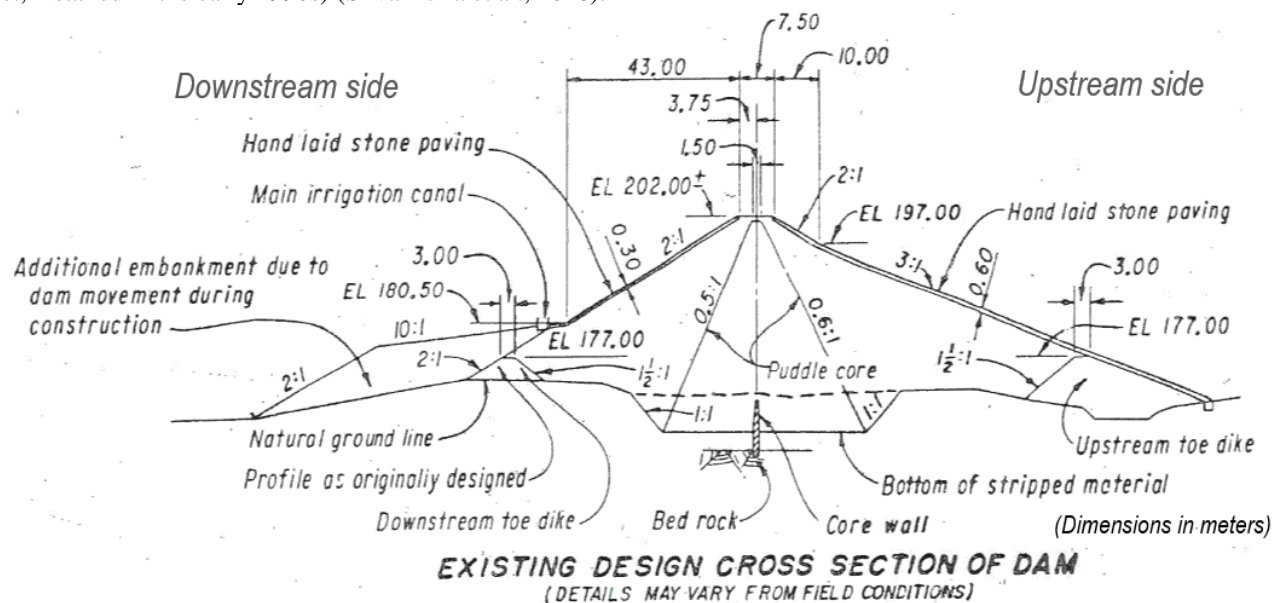
Figure 9 shows the cross section of Guajataca Dam, as reported by USBR (2002). Available records suggest that a large part of the dam consists of hydraulic fill, but its internal geometry and composition remain unclear. For example, the center of the dam is reported as a “puddle core”, but the USBR (2002) report suggests that the hydraulic fill process left the coarsest fill materials near the dam faces and the finest in the core area. The same report indicates that fill placement was changed to “dry” roller compaction in 1927 to address field observations of dam instability. Instability during the initial construction of the dam was reported in February 1927 as cracks, slippage, and other signs of movement, including bulging and settlement of the cofferdams. Reportedly, many locations showed movements on both the dam and the downstream natural ground; maximum movements included a 0.96 m (3.2 ft) downstream horizontal displacement and 1.44 m (4.7 ft) of vertical settlement.

Figure 9 shows the remedial berm constructed on the downstream side of the dam early in 1927 after the reservoir was drained, implemented to stabilize the ongoing sliding in the downstream direction. USBR (2002) also indicates that stabilization measures included the installation of numerous drain holes and replacing the fill placement technique to “dry” roller compaction. As construction of the dam proceeded, new movements of up to 35 cm (14 in) were reported on the upstream face and a heel was installed (location unknown). The USBR (2002) report indicates that in November 1927, as the dam was nearing completion, movements reported as “creep-type” were still observed. To enhance stability, fill was placed at the toe of the dam. The USBR (2002) report indicates that crest movements were measured during the years following the original dam’s completion. Movement varied from about 35 cm/yr (13.2 in/yr) between 1927 and 1929 to about 1 cm/yr (0.4 in/yr) between 1942 and 1951. In 1954, about 2,000 m³ of fill were added to the crest area to restore its original elevation.

Figure 9. Cross-section of Guajataca Dam from the 1920s (date of drawing is unknown; USBR, 2002).

In 1971, the USBR was requested to evaluate the dam; in 1977, it recommended various remedial measures, including rebuilding the crest and replacing part of the spillway. During an excavation near the toe of the spillway in 1981, movement of the spillway occurred. The excavation revealed a plastic layer with slickensides, and a subsequent investigation resulted in landslides being mapped under the spillway and dam. To increase the stability, the USBR recommended limiting the elevation of the downstream face berm (Figure 9) and filling or buttressing the river channel area. The work included the placement of a 2.44 m (8 ft) diameter pipeline, completed in 1984, to carry outlet flows.
