Geotechnical Extreme Event Site Reconnaissance in Puerto Rico After The Passage of Hurricane Maria

Reference: Silva-Tulla F., and Pando M. A. (2020). Geotechnical Extreme Event Site Reconnaissance in Puerto Rico after the Passage of Hurricane Maria. International Journal of Geoengineering Case Histories, Volume 5, Issue 4, pp. 1-25, doi: 10.4417/IJGCH-05-04-01

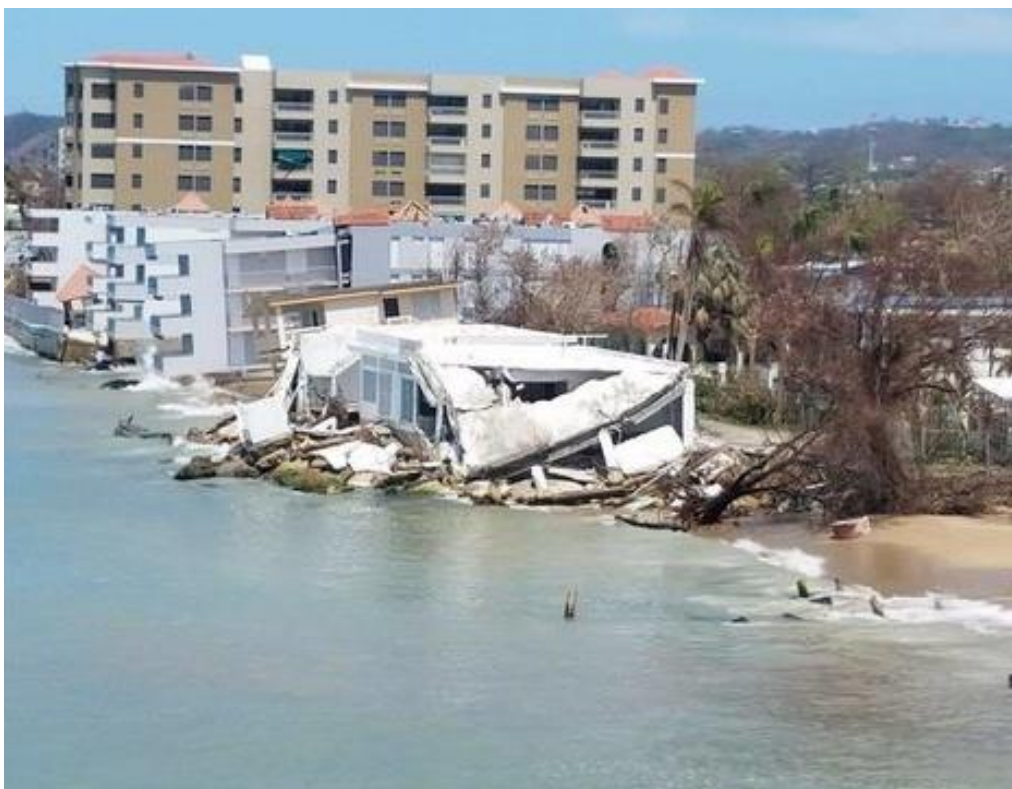
After Hurricane Maria, several buildings in the area of Site CE3 suffered severe damage, as shown in Figure 20. This figure shows extensive damage from waves or scour at the three-story Rincón Ocean Club I building, which was supported on shallow footings, and at the common areas of the terrace and swimming pool. A large volume of soil eroded from the front of the buildings and from beneath the swimming pool. Footings and beams supporting the terrace were exposed and sheared off from the building foundation. Part of Building A collapsed into the ocean and what remained standing was severely cracked. The Victoria Del Mar Condominium, the tallest building in this area and located to the north of Rincón Ocean Club I, also suffered extensive damage due to coastal scour. The terrace and swimming pool area of this condominium collapsed thanks to the storm.

The beachfront in the Córcega Beach area suffered extensive coastal scour. The approximately 6 to 9 m (20 to 30 ft) of beachfront shown in the pre-storm photo (Figure 19) was drastically reduced at the time of the site reconnaissance. The GEER Team did not observe sand washout deposits or shoreline erosion protection measures during the field reconnaissance of Site CE3. Unfortunately, there were no storm tide sensors available near Rincón to help assess tidal levels or the magnitude of wave action during this hurricane. However, NOAA (2017) reported highest water levels of 0.3 to 0.6 m (1 to 2 ft) above maximum higher high water (MHHW) for the northwest coastline of PR, where MHHW is defined as the average daily highest tide. This is consistent with a high-water elevation mark data recorded at USGS Stations (Silva-Tulla et al, 2018).

Figure 20. Oceanfront damage in Córcega Beach area (Site CE3; Silva-Tulla et al., 2018).
