# Hurricane Irma: Consequences of Intense Rainfall and Storm Surge from a Tropical Storm in North and Central Florida

**ABSTRACT:** Hurricane Irma affected the Florida peninsula from September 9-11, 2017, with high winds, rainfall, and storm surge. Although the storm made landfall on the west coast of Florida, impacts of the rainfall and storm surge affected central and northeast Florida. A GEER team mobilized on September 23, 2017, spent three days documenting sinkhole damage in central Florida, coastal scour and erosion along the northeast coast of Florida, and infrastructure damage in northeast Florida. Numerous sites with geotechnical damage were documented but this case history focuses specifically on sinkhole damage in The Villages, erosion and scour at Vilano Beach, failure of a concrete cover earth dam at Hampton Lake, and bridge embankment damage on US-17 over the Trout River. The most notable challenges to reconnaissance were the widespread and varied nature of the damages from Hurricane Irma and the rapid repair of damaged infrastructure that required the team to work closely with local, state, and federal officials to obtain documentation of the damage prior to repair.

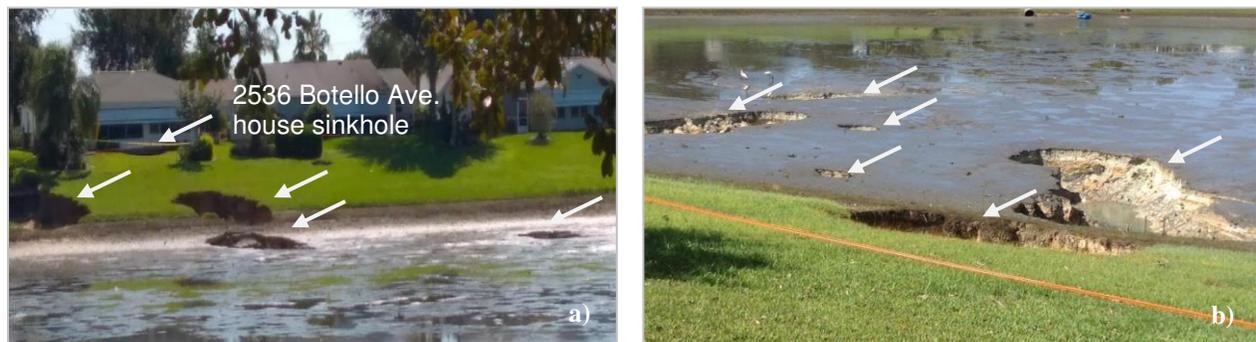
Residents graciously provided the GEER team with an account of the sinkhole events and photographs taken prior to the GEER team's arrival. On September 11, the water level in the pond was above the inlet pipes. On September 12, the water level decreased to approximately the midpoint of the inlet pipes. By the morning of September 13, the pond was empty. Digital photographs from residents show five sinkholes in the retention pond basin and two sinkholes on the bank behind the house at 2536 Botello Avenue (Figure 5). During the site visit 14 days following Hurricane Irma on September 25, repair of

Figure 5. Sinkholes on the bank of and within the retention pond between Alhambra Way and Botello Avenue at  $28^{\circ}57'11.92''N$  latitude and  $81^{\circ}59'31.49''W$  longitude (Images courtesy of Sheila Huffman Dailey, Dan Snyder, and Barbara Beveridge; from Hudyma et al., 2017).

the sinkholes within the basin and along the bank was being completed. Repair was performed using a Caterpillar D4 bulldozer to end dump granular fill near the holes, infill them, and then compact the fill with the machine's weight. The dimensions of the sinkholes themselves could not be estimated from either the pre-repair photos or the repairs.

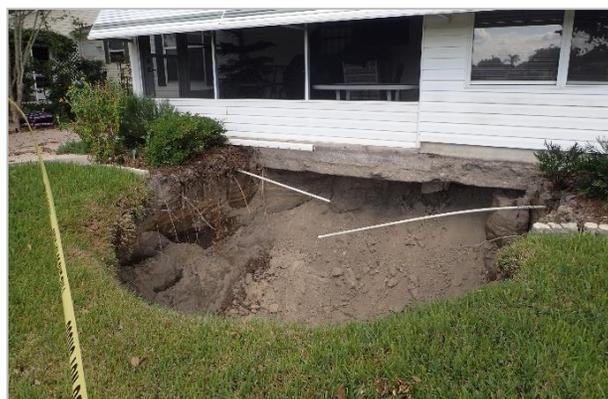
Sinkholes near the residential structures were easier to quantify during the site visit. The sinkhole that formed beneath the edge of the slab-on-grade foundation at 2536 Botello Avenue (Figure 6) was roughly elliptical in shape, approximately 4.0 m by 4.5 m (13 by 15 ft), with a depth of 2.5 m (8 ft), and exposed a small diameter, shallowly buried irrigation pipe that was unsupported over the hole. A repaired sinkhole with unknown dimensions was found at the edge of the road at 2532 Botello Avenue (Figure 7). There, the asphalt pavement showed no indication of distress, and it is unknown if the sinkhole extended under the road. The GEER team visited two other locations in The Villages where sinkholes formed, affecting retention ponds and a golf course irrigation infrastructure, and causing two houses to be classified as unsafe for occupancy by the local building official. The team heard anecdotal reports of dozens of other sinkholes that formed in The Villages, but were unable to visit them. Ruiter (2018) reports more than 400 sinkholes formed in north and central Florida as a result of Hurricane Irma.

Figure 6. Sinkhole undercutting a foundation at 2536 Botello Road at  $28^{\circ}57'11.67''N$  latitude and  $81^{\circ}59'30.05''W$  longitude (Hudyma et al., 2017).

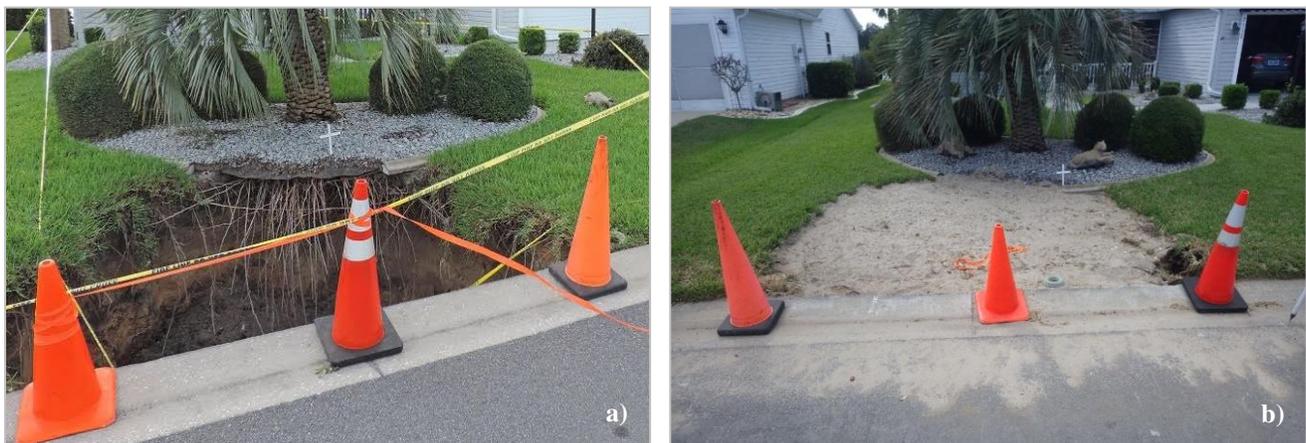
Figure 7. Sinkhole at 2532 Botello Avenue at 28°57'10.60"N latitude and 81°59'30.50"W longitude: a) prior to repair (Villages News 2017), b) following repair (Hudyma et al., 2017).

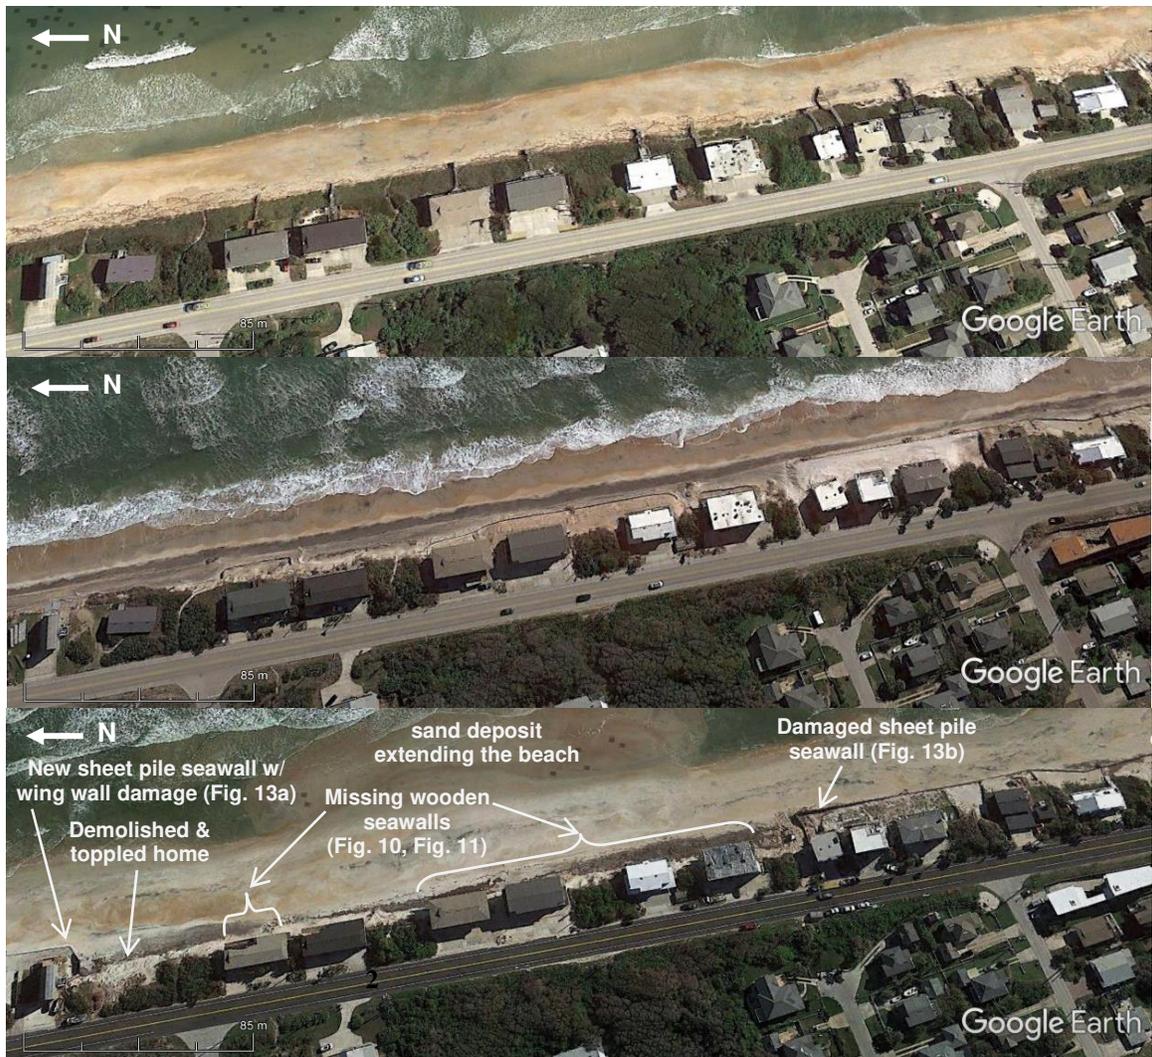
Vilano Beach has been experiencing consistent dune erosion during major storm events since 1994. Figure 9 illustrates how significantly and quickly the seemingly stable dune system changed because of extreme storms. The majority of erosion occurred after 2015 from both Hurricane Matthew (October 16, 2016) and Hurricane Irma (September 11, 2017). Figure 9c is annotated to show Hurricane Irma damage identified by the GEER team. To prevent erosion, seawalls of varying types were installed to protect residences from destructive wave action. The walls ranged from simply constructed walls to more complex walls with anchors. Many of the more complex systems were vinyl sheet pile walls anchored by either helical or dead man anchors connected to either pressure-treated wooden wales 100 mm (4 in) square in cross-section or cylindrical wooden piles secured at the front of the sheet piles. Several residences with more complex seawalls still experienced some damage and scour. The unprotected areas adjacent to seawalls were at greater risk of erosion and scour as the wave energy was directed around the seawalls and focused on the unprotected beach, dunes, and structures. Several residential structures with limited or no seawalls had their timber pile foundations exposed. In one extreme case, a residence supported by shallow foundations was completely undermined and toppled onto the beach.

Figure 9: Changes to the Vilano Beach coastline from 4020 to 3880 Coastal Highway, St. Augustine, Florida, at  $29^{\circ}56'49.30''N$  latitude and  $81^{\circ}18'9.37''W$  longitude dated: (a) November 2015, with few seawalls present; (b) March 2017, with seawalls installed following 2016 Hurricane Matthew, and; (c) October 2018, following damage from 2017 Hurricane Irma (Google Earth, 2018).

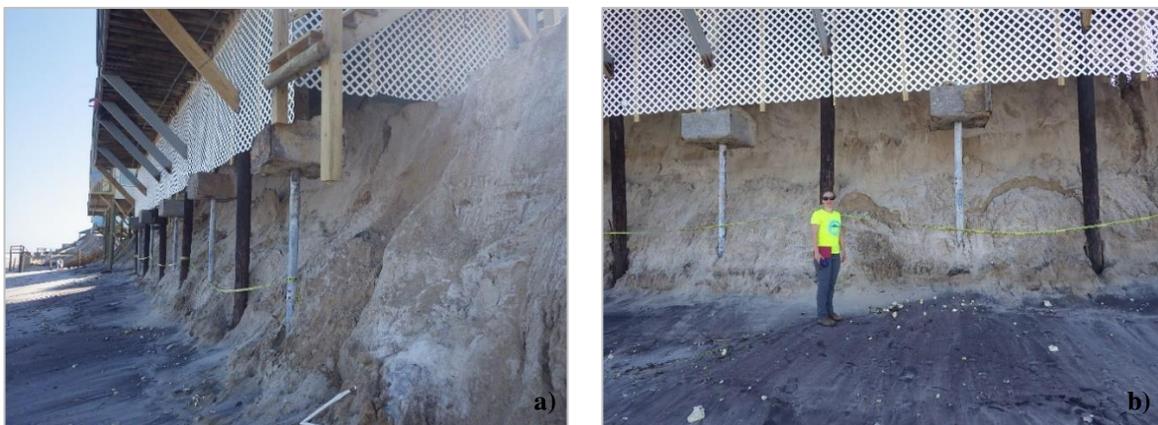
Figure 10 provides an example of damage to a residence that had been constructed on the dunes and protected by a wooden seawall of unknown design installed a distance away from the structure on the beach. The residence and its balcony are supported by alternating deeply embedded pressure-treated timber piles and pressure-treated lumber columns supported by concrete footings, presumably at the previous ground level, and micropiles. This structure experienced substantial erosion, where foundation elements became exposed over more than 10 m (~30 ft) height and both the footprint of the balcony area and structure itself were undercut. The seawall was itself destroyed (see Figure 9c). Minor slope failures were evident on the remaining dune face (Figure 10b). Drying and loss of capillary suction in the sand during the heat of the day made the exposed slopes more prone to sloughing and put the structures at greater risk of being undermined.

Figure 10: Erosion undercutting both the timber pile supports and micropile supported concrete footings for a beach house with continued slope failures in drying sand at  $29^{\circ}56'47.00''N$  latitude and  $81^{\circ}18'8.10''W$  longitude after Hurricane Irma.

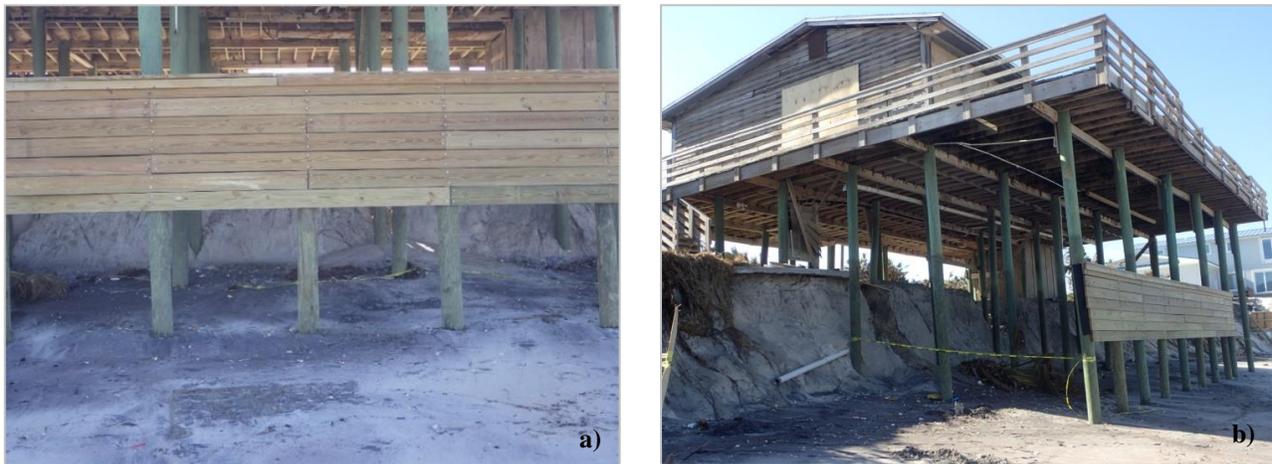
Figure 11 shows a wooden seawall left partially intact after Hurricane Irma. The seawall was constructed from pressure-treated lumber approximately 50 mm by 150 mm (2 in. by 6 in.) in cross-section nailed to pressure-treated timber piles supporting upper levels of the residence. The lumber was either not embedded or minimally embedded into the soil. The wall itself remained intact and undamaged, likely because it was attached to the piles. While the wall may have been initially effective at preventing erosion, soil was eroded from beneath and around the sides of the wall, undercutting three rows of timber piles. Notice also the underside of the elevated structure. The GEER team was uncertain how developed the ground floor of this structure was; however, there was evidence that walls and utilities were eliminated by wind and wave activity.

Figure 11. (a) Shallowly embedded timber seawall at approximately  $29^{\circ}56'49.30''\text{N}$  latitude and  $81^{\circ}18'9.37''\text{W}$  longitude, showing significant erosion (about 2 m or 6.6 ft) below a residential structure; and (b) subsequent beach erosion and removal of the first story walls by wind and water.

Timber pile and wooden lagging did not fare well in the extreme conditions brought on by Hurricane Irma (Figures 11 and 13). Lagging for these barriers may not have extended deep enough into the beach and retained soil was subject to basal erosion, leaving wooden walls unsupported and subject to even greater wave loading. Additionally, the impact of waves carrying entrained debris and sand likely amplified the rate of damage for these timber walls. Nearly all the wooden face

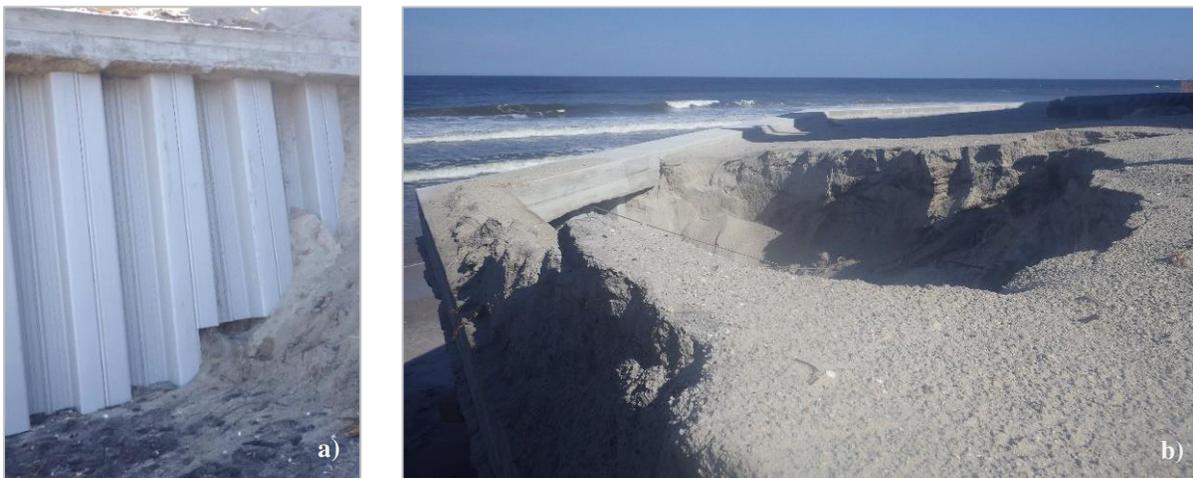
Figure 12: Sheet pile retaining wall failure from undercutting at  $29^{\circ}56'58.16''\text{N}$  latitude  $81^{\circ}18'11.96''\text{W}$  longitude, showing: (a) the exposed wall base, and (b) a funnel-shaped depression following basal soil escape (Hudyma et al., 2017).

The undercutting of shallowly embedded walls is evident in Figure 12a, which shows exposure of the base of a sheet pile wing wall that was scoured to a depth that provided a pathway for retained soil to escape from under the wall. This created a funnel-shaped depression behind the seawall at this location (Figure 12b). Figure 13a shows erosion into the dune and around a wing wall. The face and part of the wing wall were made of embedded vinyl sheet piling. However, the part of the wing wall extending into the dune was of timber pile and wooden lagging. Erosion past the sheet piling into the more open structure of the wooden lagging resulted in break-up of the wall, erosion of the retained soil, and exposure of shallow foundations previously supporting the deck (not shown). Lastly, Figure 13b illustrates the consequences of an incomplete seawall. The wing wall was a temporary timber pile and wooden lagging installed to accommodate a possible future extension of the sheet pile wall face to the neighboring property. The timber seawall was compromised by the storm. The four residences protected by the wall experienced damage, with the most damage adjacent to the temporary wing wall.

The structure with face and wing walls constructed similarly with vinyl sheet pile in Figure 12 experienced some undermining damage; however, the impenetrable material of the wall (vinyl) provided excellent resistance to wave action that was likely intensified by entrained sand and debris from adjacent damaged structures. The walls that the GEER team found to be minimally damaged during Hurricane Irma had sufficient vertical embedment into the beach sands or lateral embedment back into the dune to maintain their structural integrity, even if basal or side exposure of the wing wall resulted in some erosion. The reconnaissance identified two concerns for vinyl sheet pile walls. Walls are installed with weep holes to allow water to drain from the retained sand behind the wall at the beach elevation. Following Hurricane Irma, the weep holes were approximately 0.5 m to 1 m (1.6 ft to 3.3 ft) above the new beach elevation. In many walls with soil still retained, the vinyl sheets bowed out of plumb below the weep holes. This is likely because of both the loss of basal support on the outside face of the wall and pore pressure in the confined soil from trapped water behind the wall. While the vinyl sheet piling is ductile and corrosion resistant, inspection found areas with previous cracks and repairs, possibly due to impact from wave-borne debris.

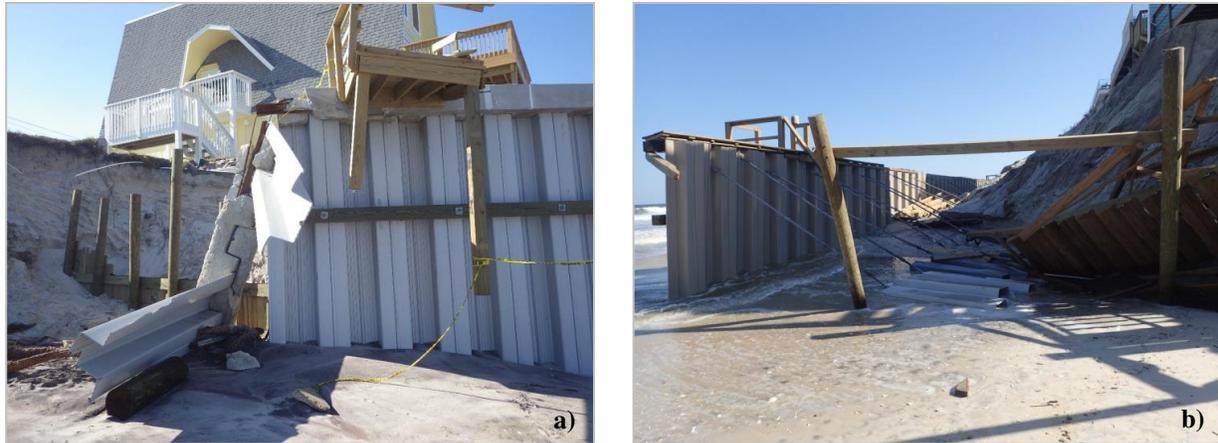
*Figure 13: Failure of two residential sheet pile retaining walls from side erosion following Hurricane Irma, showing: (a) a partial sheet pile wing wall that was extended into the dune using timber piles and wooden lagging at 29°56'55.10"N latitude and 81°18'13.49"W longitude, and (b) the backside of the wall and anchors from the side where the wing wall was not yet installed at 29°56'46.05"N latitude and 81°18'7.5"W longitude (Hudyma et al., 2017).*

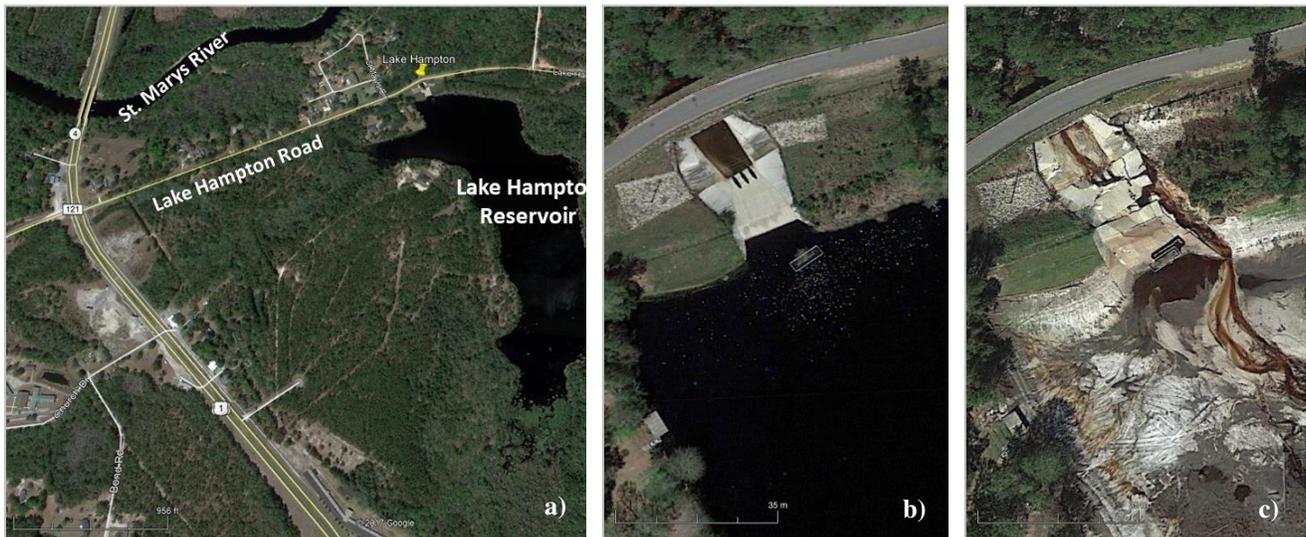
where a concrete structure with four 2.1 m (6.9 ft) diameter concrete pipes passed water from the spillway pool into the downstream tributary (Hudyma et al., 2017). Figure 14 shows aerial images of the dam prior to and after the dam's failure.

Figure 14. (a) Lake Hampton Dam reconnaissance site location with aerial photos of the dam (b) before (March 2017), and (c) after (October 2017) the failure (Google Earth 2018).

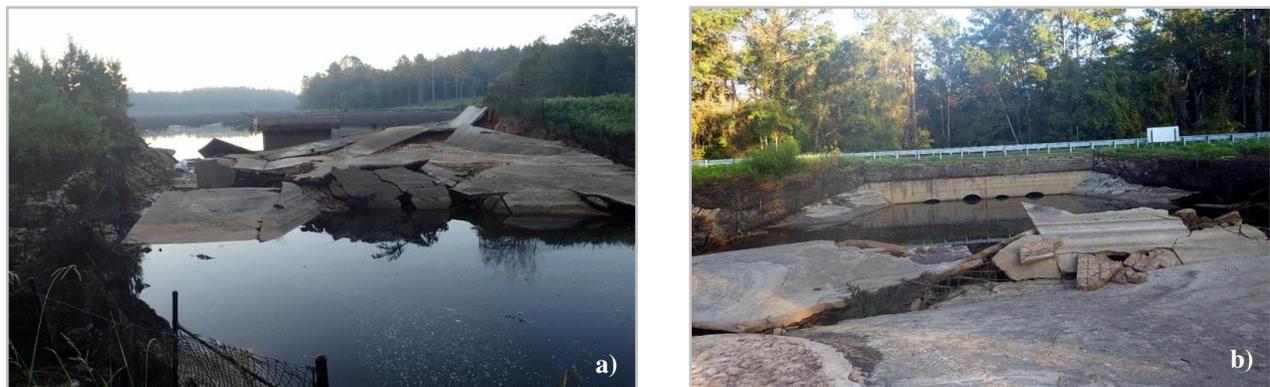
Figure 15 illustrates the remains of the failed dam and surrounding infrastructure. The inlet structure remained intact and in position; the embankment and soils supporting the spillway, however, were washed away and the concrete cover was left cracked and in disarray. Figure 16 shows the significantly eroded eastern embankment and the remaining organic debris as well as the newly formed drainage path for Pigeon Creek. The post-failure erosion channel was located on the east side of the dam, while limited soil erosion was observed along the western embankment. Figure 16 shows two colors of soil in the east embankment, and we speculate the gray soil to the right may have been modified with cement or lime to minimize seepage.

Figure 15: Failed Lake Hampton reservoir dam at 30°46'40.1"N latitude and 81°58'13.0"W longitude: (a) looking south from, and (b) looking north toward Lake Hampton Road.

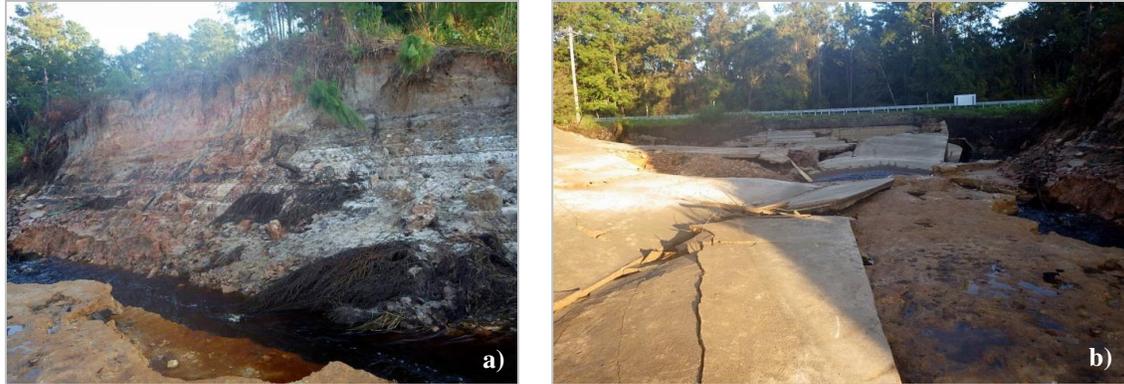
Figure 16: Erosion of the eastern natural embankment and dam soils showing: (a) eastern embankment and post failure outlet stream, and (b) eastern dam and embankment erosion south of Lake Hampton Road at 30°46'33.89"N latitude and 81°58'15.47"W longitude.

A combination of rainfall and overland flow filling Lake Hampton upstream of the dam was likely the major cause of the dam's failure. The GEER team found significant erosion along the eastern bank of the dam (Figure 16a), which likely led to undermining of the concrete spillway and complete erosion of the soil below it. The GEER team found evidence of plant debris high up on the intact embankment at the west side, indicating a high reservoir water level. It is uncertain why the eastern embankment was preferentially eroded. However, photographic evidence shows muddier sediment to the east along the spillway and downstream floodplain, and Figure 14c shows the new breach channel across the east embankment post-failure.

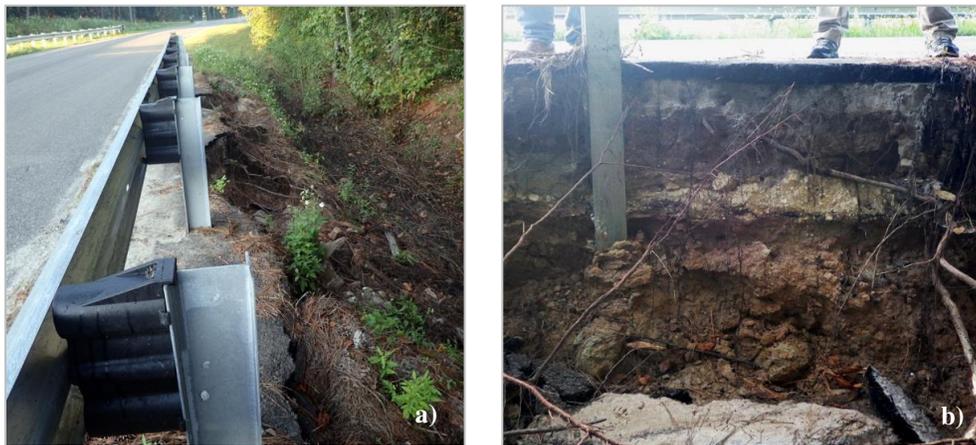
Lake Hampton Road was also subject to damage, and Figure 17 illustrates the erosion that occurred downstream of the dam and road. Erosion of both pavement and road base resulted in guardrail posts becoming exposed. Figure 15b shows the road crossing from the south, where soil and infrastructure remained relatively intact. Figures 17 and 18 comparatively show the road crossing from downstream with significant erosion of embankment soils at either side of the concrete pipe culvert. The downstream floodplain (Figure 18) had low vegetation removed and/or covered with sediment; large brush was denuded to a certain elevation, and trees were destabilized and uprooted. Surface soil remaining on the downstream embankments and the denuded floodplain was dark brown and muddy; Figure 18b, however, shows areas of lighter brown soil that may indicate dried in-place soils or in-place soil mixed with eroded dam embankment soil.

Figure 17: Erosion damage of the northern section of Lake Hampton Road at the Pigeon River crossing north of the dam near 30°46'45.19"N latitude and 81°58'24.6"W longitude.

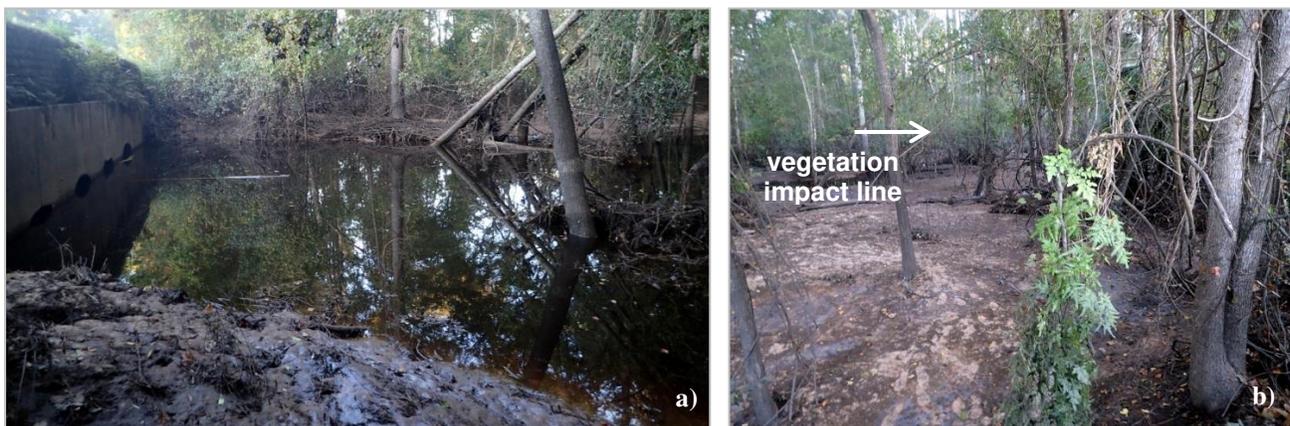
Figure 18: Downstream view of the road crossing at Pigeon Creek near 30°46'45.19"N latitude and 81°58'24.6"W longitude after the failure, illustrating: (a) the dam outlet under Hampton Road with four small diameter openings in a concrete culvert, stacked concrete sack wall stabilizing the roadway, and evidence of high water levels; and, (b) evidence of high water levels, sediment buildup, and debris within the floodplain.

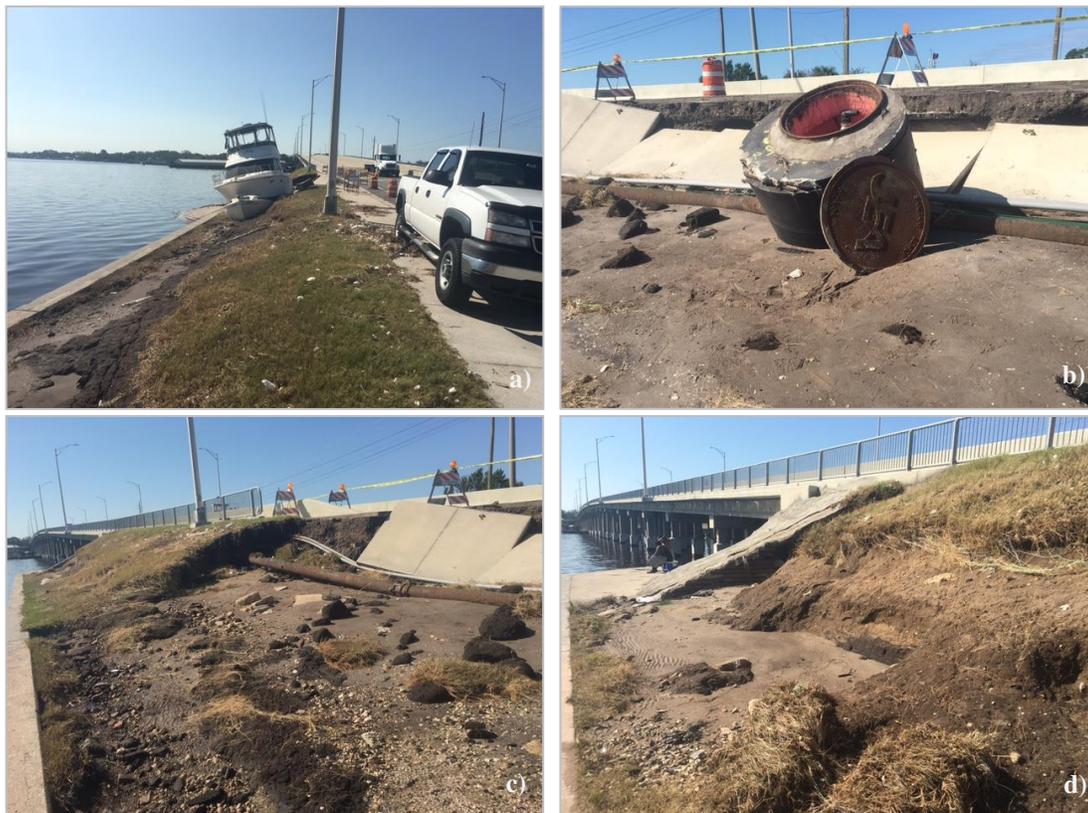
Figure 21. Erosion along the northeast embankment of the US 17 bridge over the Trout River at  $30^{\circ}23'45.44''\text{N}$  latitude and  $81^{\circ}38'53.95''\text{W}$  longitude shown from the north southward, including: (a) vessel washed ashore exacerbating scour, (b) an exposed sewer pipe and access structure, (c) exposed sewer pipe and electrical conduit and failed sidewalk, and (d) the terminus of scour at the stacked concrete sack wall where embankment cover was present (Hudyma et al., 2017).

The storm surge generated by Hurricane Irma ranged from 1.2 m to 1.6 m (3.9 ft to 5.2 ft) (Cangialosi et al., 2018) in height and extended into the Trout River, elevating water levels, overtopping the embankment support wall at the river level, and subjecting the northern embankments to erosion. Significant erosion occurred along the northeast bridge embankment on September 10, 2017, extending from the concrete cover of the embankment to approximately 140 m (459 ft) north into the grass- and brush-protected area embankment. The northernmost section of the embankment was protected by woody brush and small trees, and experienced minimal scour. The grass-protected, taller section of the embankment was scoured significantly into the slope (Figure 21b, c, d) to the extent that the edge of the road was undermined, concrete sidewalk panels were dislodged, and underground utilities were exposed and unsupported. The embankment section nearest the transition between the grass and concrete cover experienced the most scour, where the concrete cover was undermined to the stacked concrete sack wall and toward the bridge abutment (Figure 21d, Figure 22a). Localized scour also occurred along the northwest embankment at, and just beyond, the transition between the grass and concrete cover (Figure 22b), likely caused by an eddy current that developed after the high winds and surge accelerated the water through the constriction in the river. During the hurricane, several vessels broke free from their moorings and washed up on the embankment (Figure 21a), which created additional erosion as turbulent water flowed around these obstacles.

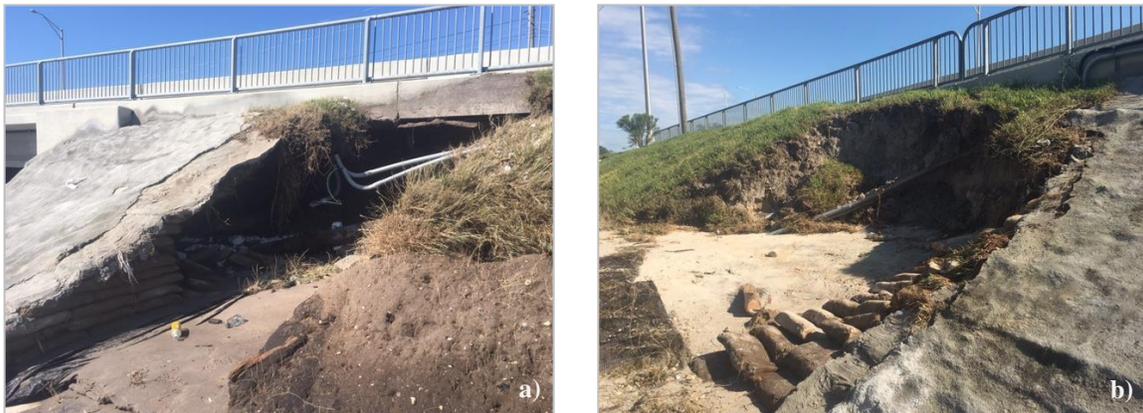
The GEER team visited the site two weeks after the scour damage occurred and repairs were partially completed. Construction crews had partially rebuilt the embankment to the design elevation and placed excavatable flowable fill into vertical trenches near the roadside to stabilize soil below the road and around underground utilities. Figure 23 shows a flowable fill trench adjacent to the northeast abutment (approximately 5 m long, 1 m wide, 6 m deep, or 16.4 ft by 3.3 ft by 19.7 ft) and adjacent to the northeast section of road (approximately 21 m long, 1 m wide, 2 m deep, or 69 ft by 3.3 ft by 6.6 ft).

Figure 22. Scour damage along the (a) northeastern and (b) northwestern bridge embankment of the US 17 bridge over the Trout River at 30°23'44.43"N latitude and 81°38'54.13"W longitude (Hudyma et al., 2017).

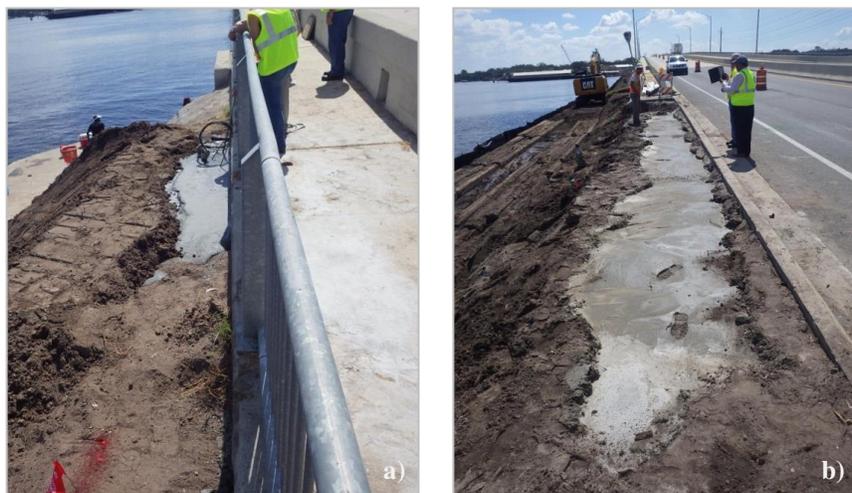
Figure 23: Repaired northeastern bridge embankment for US 17 bridge over the Trout River at 30°23'45.44"N latitude and 81°38'53.95"W longitude that includes the rebuilt soil and excavatable flowable fill trench embankment (a) adjacent to the concrete covered, stacked concrete sack wall; and (b) roadway edge (Hudyma et al., 2017).
