Hurricane Irma: Consequences of Intense Rainfall and Storm Surge from a Tropical Storm in North and Central Florida

ABSTRACT: Hurricane Irma affected the Florida peninsula from September 9-11, 2017, with high winds, rainfall, and storm surge. Although the storm made landfall on the west coast of Florida, impacts of the rainfall and storm surge affected central and northeast Florida. A GEER team mobilized on September 23, 2017, spent three days documenting sinkhole damage in central Florida, coastal scour and erosion along the northeast coast of Florida, and infrastructure damage in northeast Florida. Numerous sites with geotechnical damage were documented but this case history focuses specifically on sinkhole damage in The Villages, erosion and scour at Vilano Beach, failure of a concrete cover earth dam at Hampton Lake, and bridge embankment damage on US-17 over the Trout River. The most notable challenges to reconnaissance were the widespread and varied nature of the damages from Hurricane Irma and the rapid repair of damaged infrastructure that required the team to work closely with local, state, and federal officials to obtain documentation of the damage prior to repair.

Refe

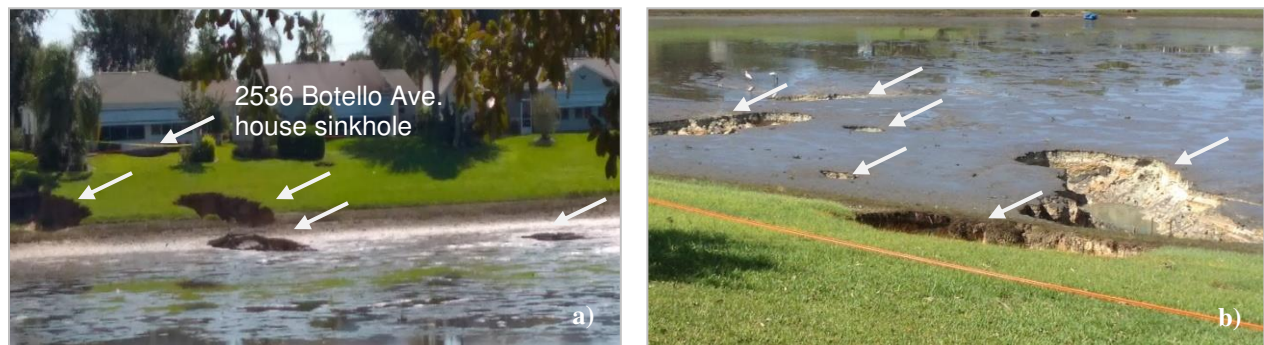
Residents graciously provided the GEER team with an account of the sinkhole events and photographs taken prior to the GEER team's arrival. On September 11, the water level in the pond was above the inlet pipes. On September 12, the water level decreased to approximately the midpoint of the inlet pipes. By the morning of September 13, the pond was empty. Digital photographs from residents show five sinkholes in the retention pond basin and two sinkholes on the bank behind the house at 2536 Botello Avenue (Figure 5). During the site visit 14 days following Hurricane Irma on September 25, repair of

the sinkholes within the basin and along the bank was being completed. Repair was performed using a Caterpillar D4 bulldozer to end dump granular fill near the holes, infill them, and then compact the fill with the machine's weight. The dimensions of the sinkholes themselves could not be estimated from either the pre-repair photos or the repairs.

Figure 5. Sinkholes on the bank of and within the retention pond between Alhambra Way and Botello Avenue at 28°57'11.92"N latitude and 81°59'31.49"W longitude (Images courtesy of Sheila Huffman Dailey, Dan Snyder, and Barbara Beveridge; from Hudyma et al., 2017).

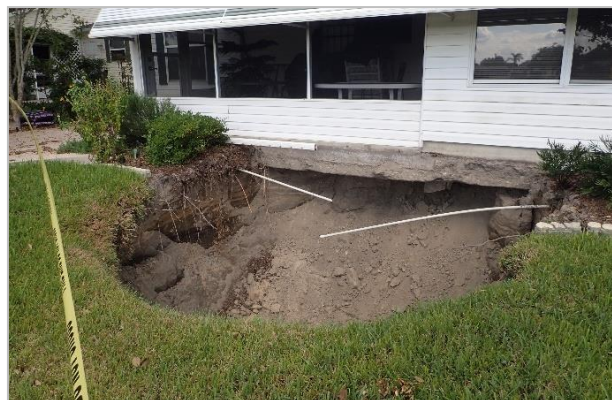
Sinkholes near the residential structures were easier to quantify during the site visit. The sinkhole that formed beneath the edge of the slab-on-grade foundation at 2536 Botello Avenue (Figure 6) was roughly elliptical in shape, approximately 4.0 m by 4.5 m (13 by 15 ft), with a depth of 2.5 m (8 ft), and exposed a small diameter, shallowly buried irrigation pipe that was unsupported over the hole. A repaired sinkhole with unknown dimensions was found at the edge of the road at 2532 Botello Avenue (Figure 7). There, the asphalt pavement showed no indication of distress, and it is unknown if the sinkhole extended under the road. The GEER team visited two other locations in The Villages where sinkholes formed, affecting retention ponds and a golf course irrigation infrastructure, and causing two houses to be classified as unsafe for occupancy by the local building official. The team heard anecdotal reports of dozens of other sinkholes that formed in The Villages, but were unable to visit them. Ruiter (2018) reports more than 400 sinkholes formed in north and central Florida as a result of Hurricane Irma.

Figure 6. Sinkhole undercutting a foundation at 2536 Botello Road at 28°57'11.67"N latitude and 81°59'30.05"W longitude (Hudyma et al., 2017).

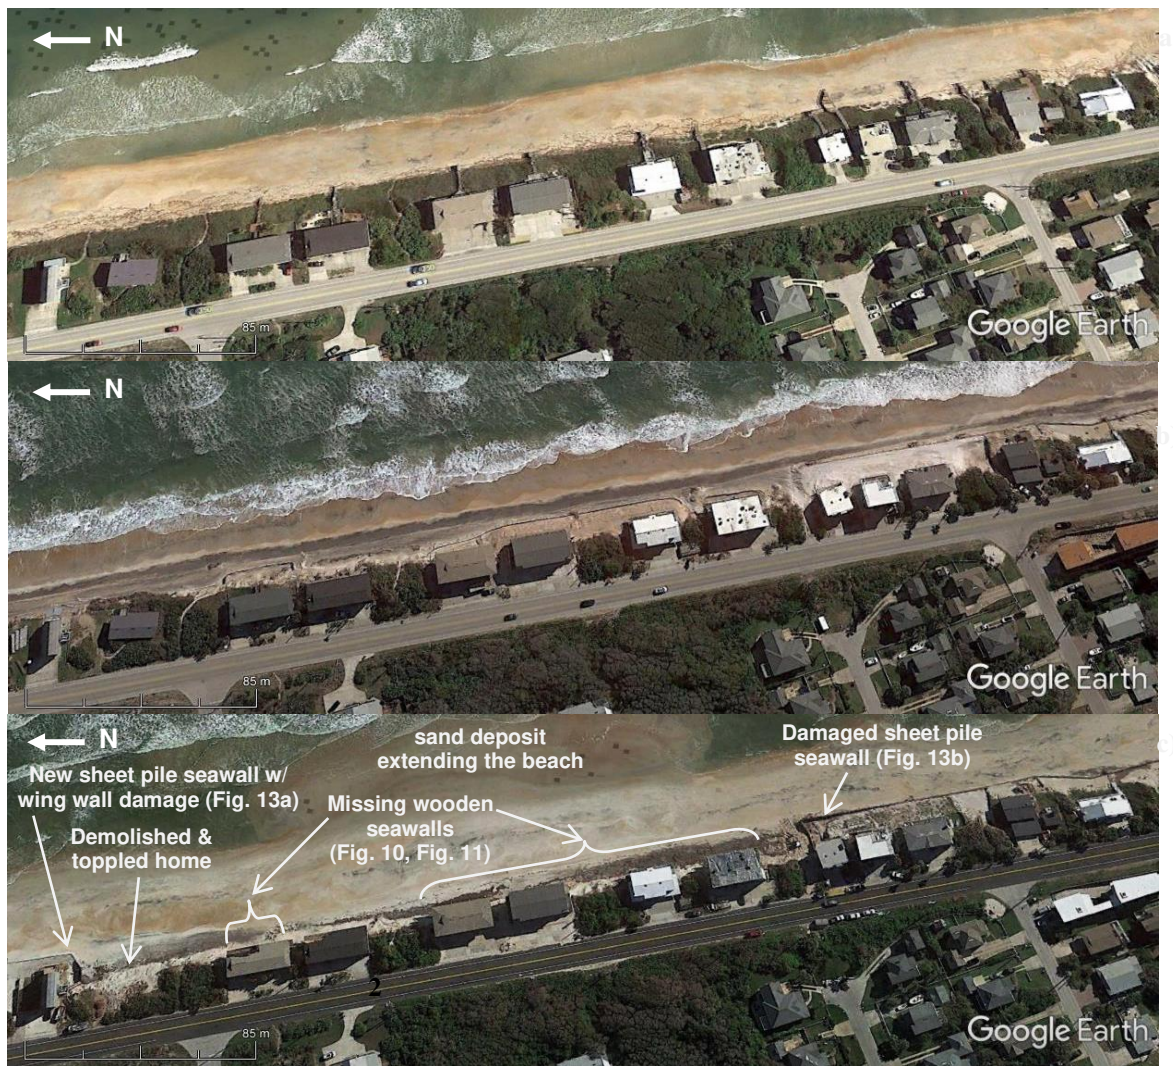
Vilano Beach has been experiencing consistent dune erosion during major storm events since 1994. Figure 9 illustrates how significantly and quickly the seemingly stable dune system changed because of extreme storms. The majority of erosion occurred after 2015 from both Hurricane Matthew (October 16, 2016) and Hurricane Irma (September 11, 2017). Figure 9c is annotated to show Hurricane Irma damage identified by the GEER team. To prevent erosion, seawalls of varying types were installed to protect residences from destructive wave action. The walls ranged from simply constructed walls to more complex walls with anchors. Many of the more complex systems were vinyl sheet pile walls anchored by either helical or dead man anchors connected to either pressure-treated wooden wales 100 mm (4 in) square in cross-section or cylindrical wooden piles secured at the front of the sheet piles. Several residences with more complex seawalls still experienced some damage and scour. The unprotected areas adjacent to seawalls were at greater risk of erosion and scour as the wave energy was directed around the seawalls and focused on the unprotected beach, dunes, and structures. Several residential structures with limited or no seawalls had their timber pile foundations exposed. In one extreme case, a residence supported by shallow foundations was completely undermined and toppled onto the beach.

Figure 9: Changes to the Vilano Beach coastline from 4020 to 3880 Coastal Highway, St. Augustine, Florida, at $29^{\circ}56'49.30''\text{N}$ latitude and $81^{\circ}18'9.37''\text{W}$ longitude dated: (a) November 2015, with few seawalls present; (b) March 2017, with seawalls installed following 2016 Hurricane Matthew, and; (c) October 2018, following damage from 2017 Hurricane Irma (Google Earth, 2018).

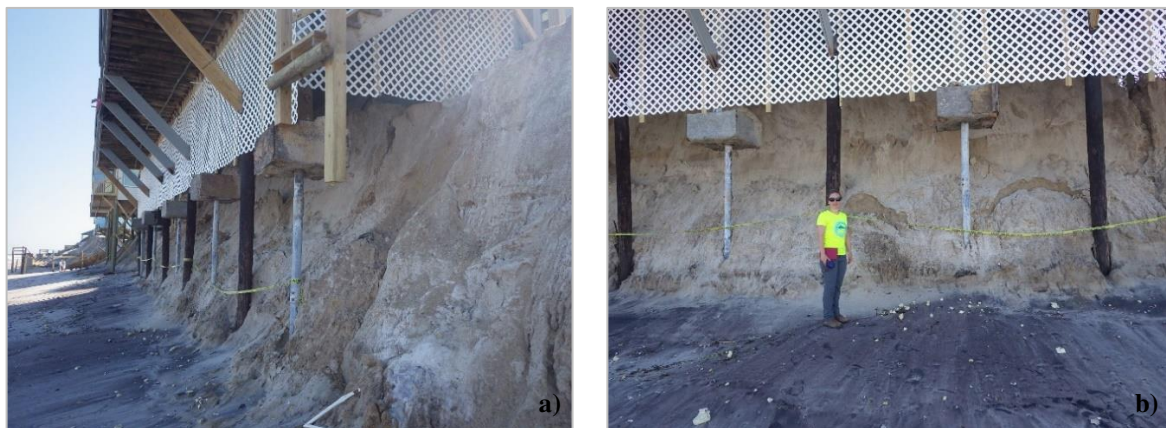
Figure 10 provides an example of damage to a residence that had been constructed on the dunes and protected by a wooden seawall of unknown design installed a distance away from the structure on the beach. The residence and its balcony are supported by alternating deeply embedded pressure-treated timber piles and pressure-treated lumber columns supported by concrete footings, presumably at the previous ground level, and micropiles. This structure experienced substantial erosion, where foundation elements became exposed over more than 10 m (~30 ft) height and both the footprint of the balcony area and structure itself were undercut. The seawall was itself destroyed (see Figure 9c). Minor slope failures were evident on the remaining dune face (Figure 10b). Drying and loss of capillary suction in the sand during the heat of the day made the exposed slopes more prone to sloughing and put the structures at greater risk of being undermined.

Figure 10: Erosion undercutting both the timber pile supports and micropile supported concrete footings for a beach house with continued slope failures in drying sand at $29^{\circ}56'47.00''\text{N}$ latitude and $81^{\circ}18'8.10''\text{W}$ longitude after Hurricane Irma.

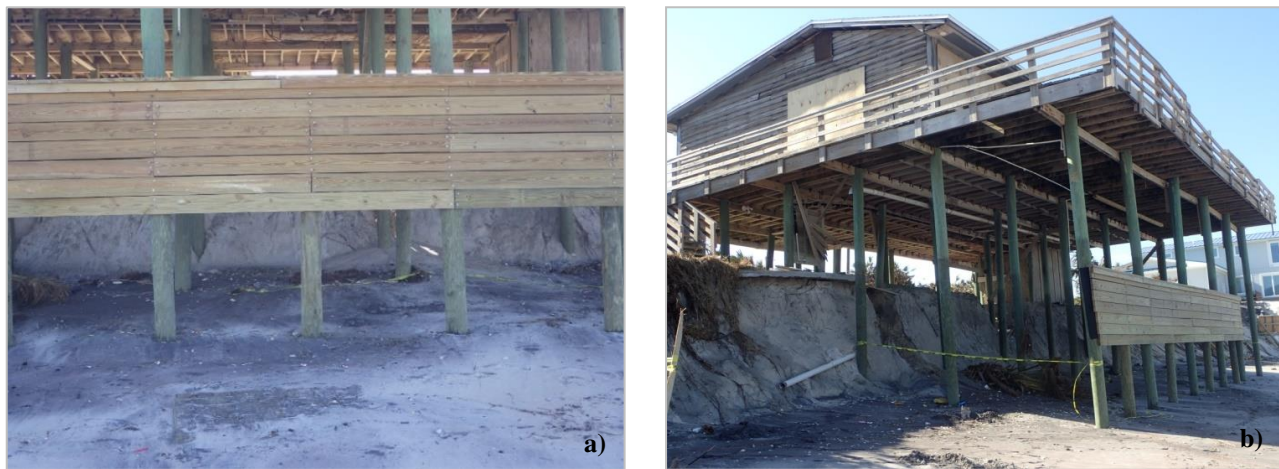
Figure 11 shows a wooden seawall left partially intact after Hurricane Irma. The seawall was constructed from pressure-treated lumber approximately 50 mm by 150 mm (2 in. by 6 in.) in cross-section nailed to pressure-treated timber piles supporting upper levels of the residence. The lumber was either not embedded or minimally embedded into the soil. The wall itself remained intact and undamaged, likely because it was attached to the piles. While the wall may have been initially effective at preventing erosion, soil was eroded from beneath and around the sides of the wall, undercutting three rows of timber piles. Notice also the underside of the elevated structure. The GEER team was uncertain how developed the ground floor of this structure was; however, there was evidence that walls and utilities were eliminated by wind and wave activity.

Figure 11. (a) Shallowly embedded timber seawall at approximately 29°56'49.30"N latitude and 81°18'9.37"W longitude, showing significant erosion (about 2 m or 6.6 ft) below a residential structure; and (b) subsequent beach erosion and removal of the first story walls by wind and water.

Timber pile and wooden lagging did not fare well in the extreme conditions brought on by Hurricane Irma (Figures 11 and 13). Lagging for these barriers may not have extended deep enough into the beach and retained soil was subject to basal erosion, leaving wooden walls unsupported and subject to even greater wave loading. Additionally, the impact of waves carrying entrained debris and sand likely amplified the rate of damage for these timber walls. Nearly all the wooden face

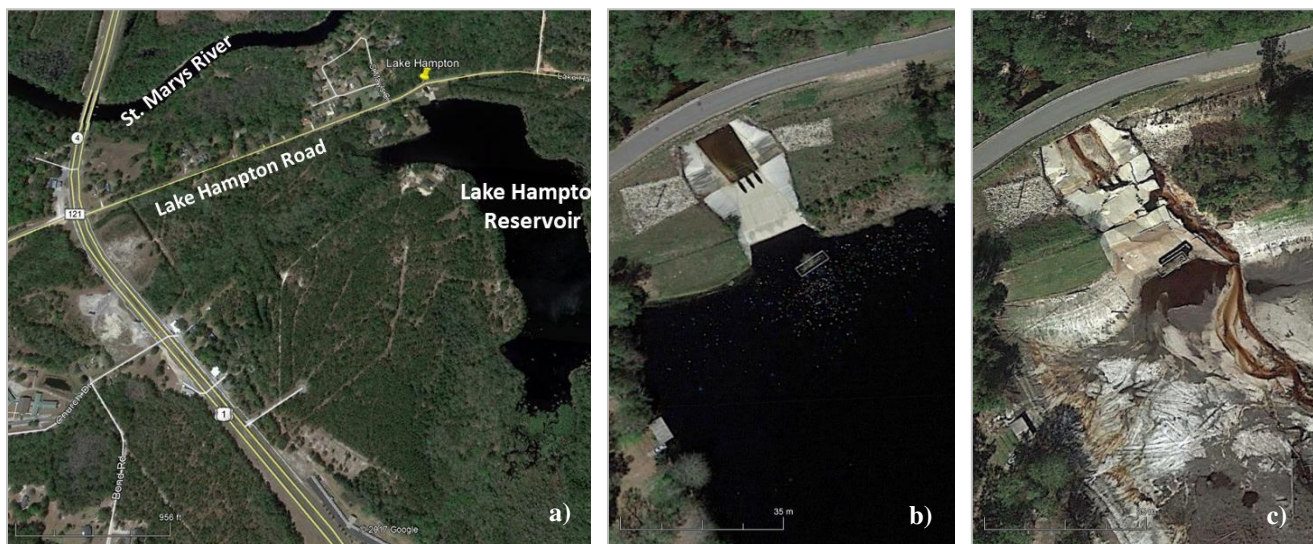
where a concrete structure with four 2.1 m (6.9 ft) diameter concrete pipes passed water from the spillway pool into the downstream tributary (Hudyma et al., 2017). Figure 14 shows aerial images of the dam prior to and after the dam's failure.

Figure 14. (a) Lake Hampton Dam reconnaissance site location with aerial photos of the dam (b) before (March 2017), and (c) after (October 2017) the failure (Google Earth 2018).

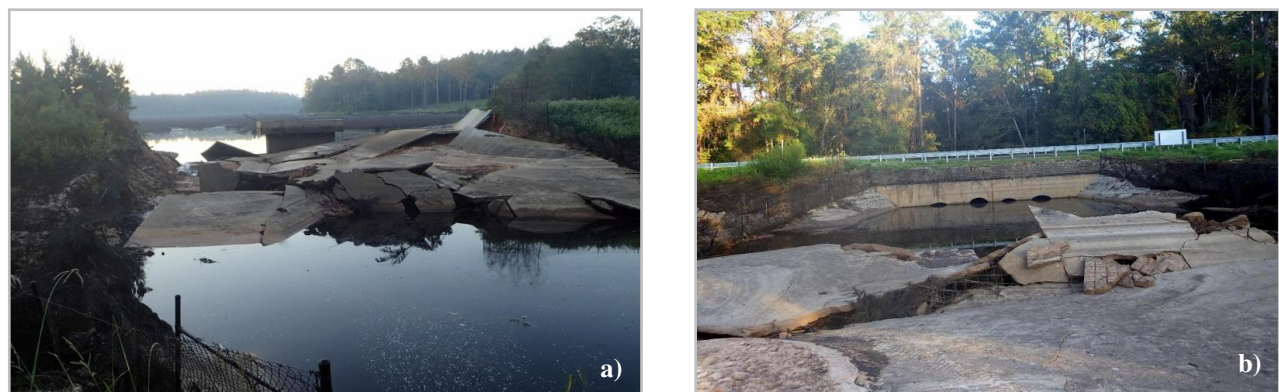
Figure 15 illustrates the remains of the failed dam and surrounding infrastructure. The inlet structure remained intact and in position; the embankment and soils supporting the spillway, however, were washed away and the concrete cover was left cracked and in disarray. Figure 16 shows the significantly eroded eastern embankment and the remaining organic debris as well as the newly formed drainage path for Pigeon Creek. The post-failure erosion channel was located on the east side of the dam, while limited soil erosion was observed along the western embankment. Figure 16 shows two colors of soil in the east embankment, and we speculate the gray soil to the right may have been modified with cement or lime to minimize seepage.

Figure 15: Failed Lake Hampton reservoir dam at 30°46'40.1"N latitude and 81°58'13.0"W longitude: (a) looking south from, and (b) looking north toward Lake Hampton Road.

A combination of rainfall and overland flow filling Lake Hampton upstream of the dam was likely the major cause of the dam's failure. The GEER team found significant erosion along the eastern bank of the dam (Figure 16a), which likely led to undermining of the concrete spillway and complete erosion of the soil below it. The GEER team found evidence of plant debris high up on the intact embankment at the west side, indicating a high reservoir water level. It is uncertain why the eastern embankment was preferentially eroded. However, photographic evidence shows muddier sediment to the east along the spillway and downstream floodplain, and Figure 14c shows the new breach channel across the east embankment post-failure.

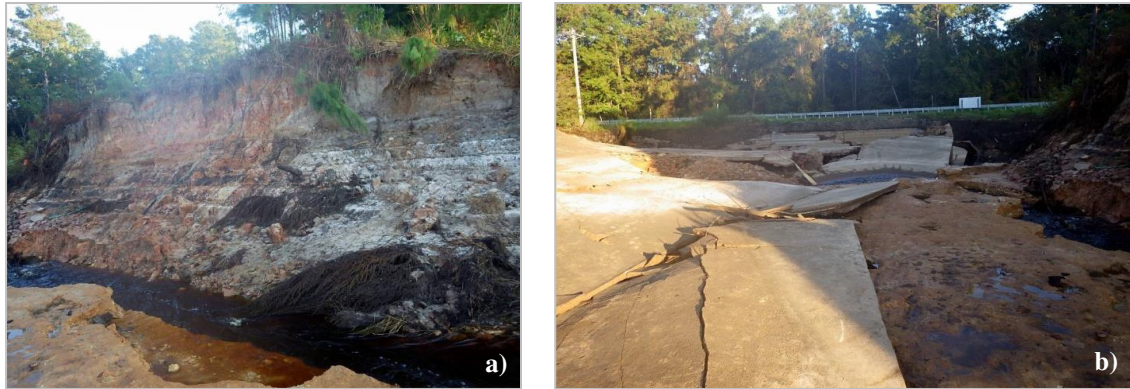
Figure 16: Erosion of the eastern natural embankment and dam soils showing: (a) eastern embankment and post failure outlet stream, and (b) eastern dam and embankment erosion south of Lake Hampton Road at 30°46'33.89"N latitude and 81°58'15.47"W longitude.

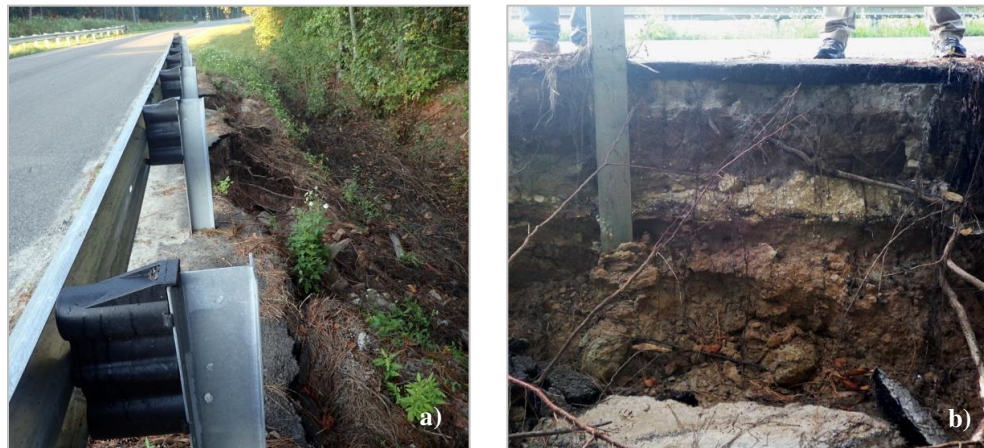
Lake Hampton Road was also subject to damage, and Figure 17 illustrates the erosion that occurred downstream of the dam and road. Erosion of both pavement and road base resulted in guardrail posts becoming exposed. Figure 15b shows the road crossing from the south, where soil and infrastructure remained relatively intact. Figures 17 and 18 comparatively show the road crossing from downstream with significant erosion of embankment soils at either side of the concrete pipe culvert. The downstream floodplain (Figure 18) had low vegetation removed and/or covered with sediment; large brush was denuded to a certain elevation, and trees were destabilized and uprooted. Surface soil remaining on the downstream embankments and the denuded floodplain was dark brown and muddy; Figure 18b, however, shows areas of lighter brown soil that may indicate dried in-place soils or in-place soil mixed with eroded dam embankment soil.

Figure 17: Erosion damage of the northern section of Lake Hampton Road at the Pigeon River crossing north of the dam near 30°46'45.19"N latitude and 81°58'24.6"W longitude.

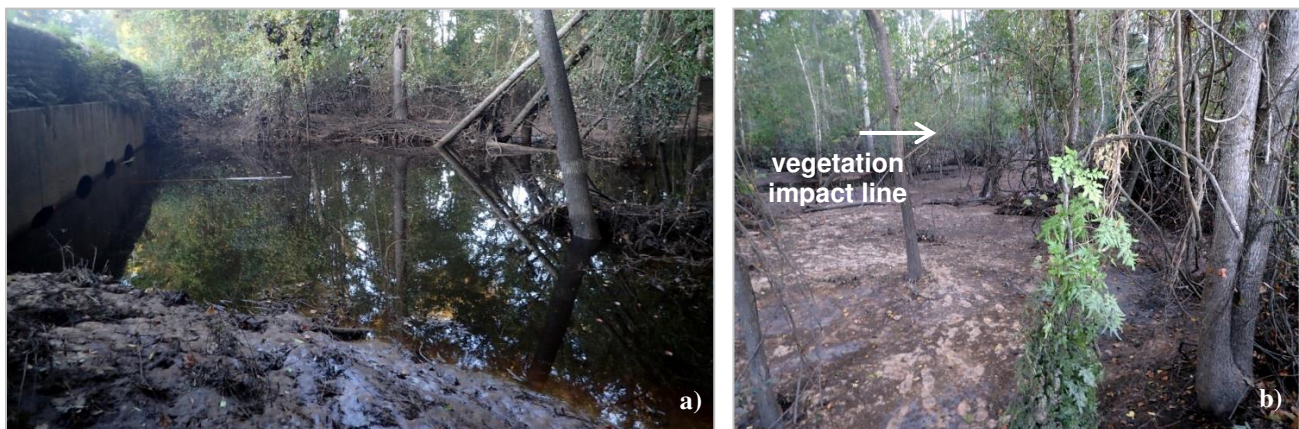
Figure 18: Downstream view of the road crossing at Pigeon Creek near 30°46'45.19"N latitude and 81°58'24.6"W longitude after the failure, illustrating: (a) the dam outlet under Hampton Road with four small diameter openings in a concrete culvert, stacked concrete sack wall stabilizing the roadway, and evidence of high water levels; and, (b) evidence of high water levels, sediment buildup, and debris within the floodplain.

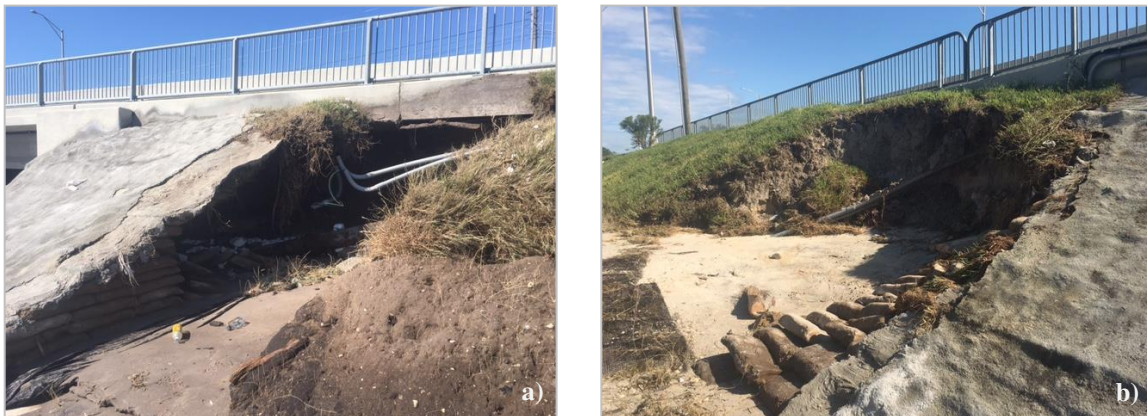
Figure 22. Scour damage along the (a) northeastern and (b) northwestern bridge embankment of the US 17 bridge over the Trout River at $30^{\circ}23'44.43''\text{N}$ latitude and $81^{\circ}38'54.13''\text{W}$ longitude (Hudyma et al., 2017).

The GEER team visited the site two weeks after the scour damage occurred and repairs were partially completed. Construction crews had partially rebuilt the embankment to the design elevation and placed excavatable flowable fill into vertical trenches near the roadside to stabilize soil below the road and around underground utilities. Figure 23 shows a flowable fill trench adjacent to the northeast abutment (approximately 5 m long, 1 m wide, 6 m deep, or 16.4 ft by 3.3 ft by 19.7 ft) and adjacent to the northeast section of road (approximately 21 m long, 1 m wide, 2 m deep, or 69 ft by 3.3 ft by 6.6 ft).

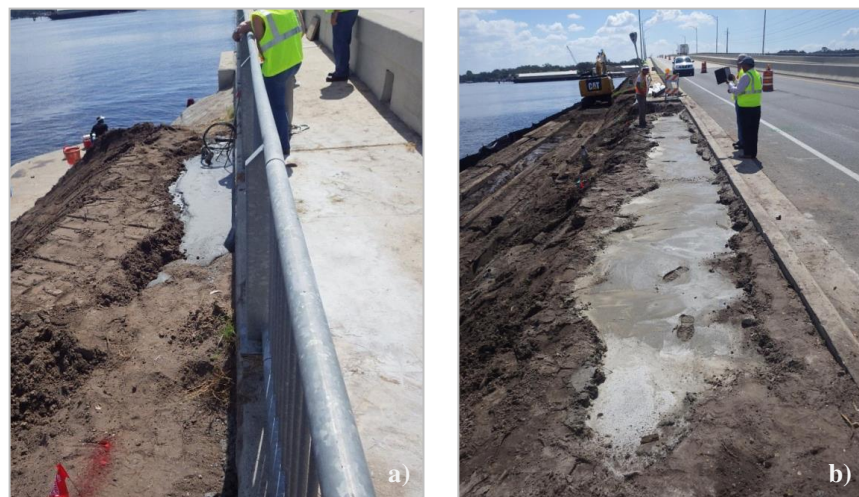
Figure 23: Repaired northeastern bridge embankment for US 17 bridge over the Trout River at $30^{\circ}23'45.44''\text{N}$ latitude and $81^{\circ}38'53.95''\text{W}$ longitude that includes the rebuilt soil and excavatable flowable fill trench embankment (a) adjacent to the concrete covered, stacked concrete sack wall; and (b) roadway edge (Hudyma et al., 2017).
