Hurricane Irma: Consequences of Intense Rainfall and Storm Surge from a Tropical Storm in North and Central Florida

Reference: Landon M. E., Hudyma N. W., and Sharma R. S. (2020). Hurricane Irma: Consequences of Intense Rainfall and Storm Surge from a Tropical Storm in North and Central Florida. *International Journal of Geoengineering Case Histories*, Volume 5, Issue 4, pp. 26-46, doi: 10.4417/IJGCH-05-04-02

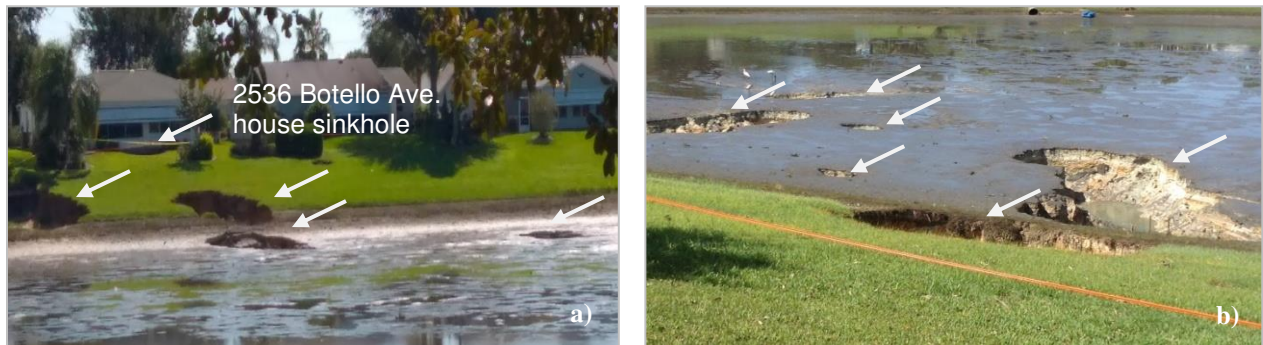
Residents graciously provided the GEER team with an account of the sinkhole events and photographs taken prior to the GEER team's arrival. On September 11, the water level in the pond was above the inlet pipes. On September 12, the water level decreased to approximately the midpoint of the inlet pipes. By the morning of September 13, the pond was empty. Digital photographs from residents show five sinkholes in the retention pond basin and two sinkholes on the bank behind the house at 2536 Botello Avenue (Figure 5). During the site visit 14 days following Hurricane Irma on September 25, repair of

the sinkholes within the basin and along the bank was being completed. Repair was performed using a Caterpillar D4 bulldozer to end dump granular fill near the holes, infill them, and then compact the fill with the machine's weight. The dimensions of the sinkholes themselves could not be estimated from either the pre-repair photos or the repairs.

Figure 5. Sinkholes on the bank of and within the retention pond between Alhambra Way and Botello Avenue at $28^{\circ}57'11.92''N$ latitude and $81^{\circ}59'31.49''W$ longitude (Images courtesy of Sheila Huffman Dailey, Dan Snyder, and Barbara Beveridge; from Hudyma et al., 2017).

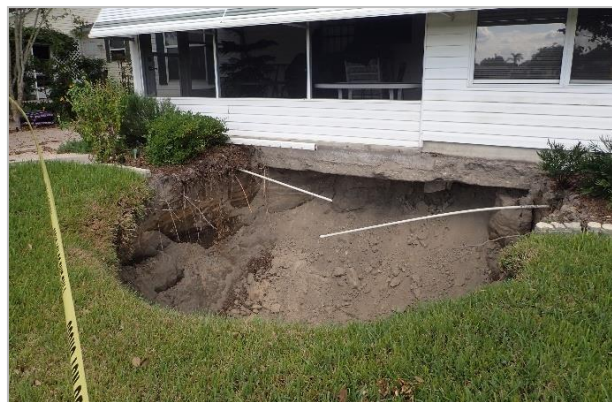
Sinkholes near the residential structures were easier to quantify during the site visit. The sinkhole that formed beneath the edge of the slab-on-grade foundation at 2536 Botello Avenue (Figure 6) was roughly elliptical in shape, approximately 4.0 m by 4.5 m (13 by 15 ft), with a depth of 2.5 m (8 ft), and exposed a small diameter, shallowly buried irrigation pipe that was unsupported over the hole. A repaired sinkhole with unknown dimensions was found at the edge of the road at 2532 Botello Avenue (Figure 7). There, the asphalt pavement showed no indication of distress, and it is unknown if the sinkhole extended under the road. The GEER team visited two other locations in The Villages where sinkholes formed, affecting retention ponds and a golf course irrigation infrastructure, and causing two houses to be classified as unsafe for occupancy by the local building official. The team heard anecdotal reports of dozens of other sinkholes that formed in The Villages, but were unable to visit them. Ruiter (2018) reports more than 400 sinkholes formed in north and central Florida as a result of Hurricane Irma.

Figure 6. Sinkhole undercutting a foundation at 2536 Botello Road at $28^{\circ}57'11.67''N$ latitude and $81^{\circ}59'30.05''W$ longitude (Hudyma et al., 2017).

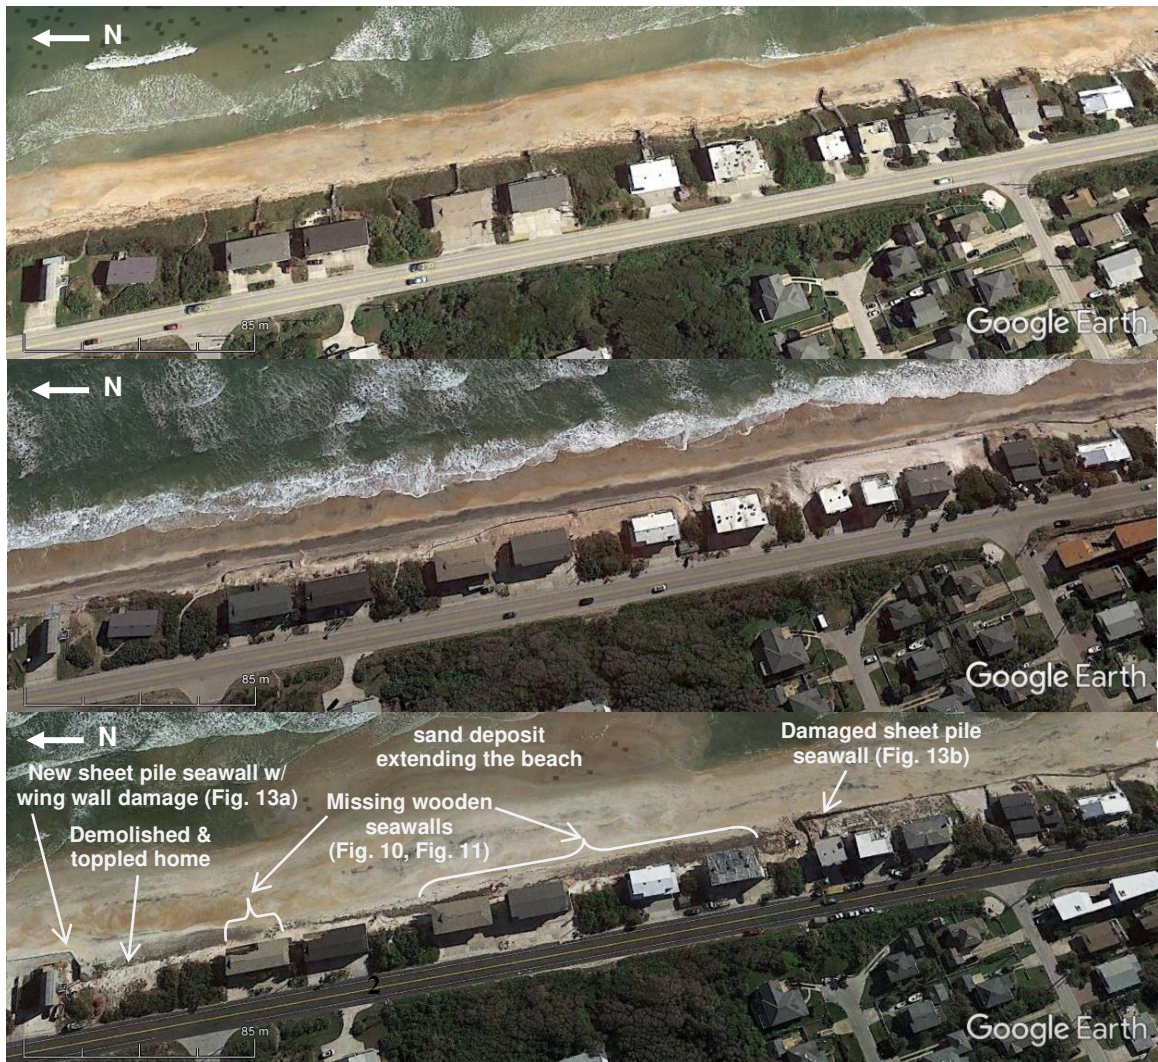
Vilano Beach has been experiencing consistent dune erosion during major storm events since 1994. Figure 9 illustrates how significantly and quickly the seemingly stable dune system changed because of extreme storms. The majority of erosion occurred after 2015 from both Hurricane Matthew (October 16, 2016) and Hurricane Irma (September 11, 2017). Figure 9c is annotated to show Hurricane Irma damage identified by the GEER team. To prevent erosion, seawalls of varying types were installed to protect residences from destructive wave action. The walls ranged from simply constructed walls to more complex walls with anchors. Many of the more complex systems were vinyl sheet pile walls anchored by either helical or dead man anchors connected to either pressure-treated wooden wales 100 mm (4 in) square in cross-section or cylindrical wooden piles secured at the front of the sheet piles. Several residences with more complex seawalls still experienced some damage and scour. The unprotected areas adjacent to seawalls were at greater risk of erosion and scour as the wave energy was directed around the seawalls and focused on the unprotected beach, dunes, and structures. Several residential structures with limited or no seawalls had their timber pile foundations exposed. In one extreme case, a residence supported by shallow foundations was completely undermined and toppled onto the beach.

Figure 9: Changes to the Vilano Beach coastline from 4020 to 3880 Coastal Highway, St. Augustine, Florida, at 29°56'49.30"N latitude and 81°18'9.37"W longitude dated: (a) November 2015, with few seawalls present; (b) March 2017, with seawalls installed following 2016 Hurricane Matthew, and; (c) October 2018, following damage from 2017 Hurricane Irma (Google Earth, 2018).

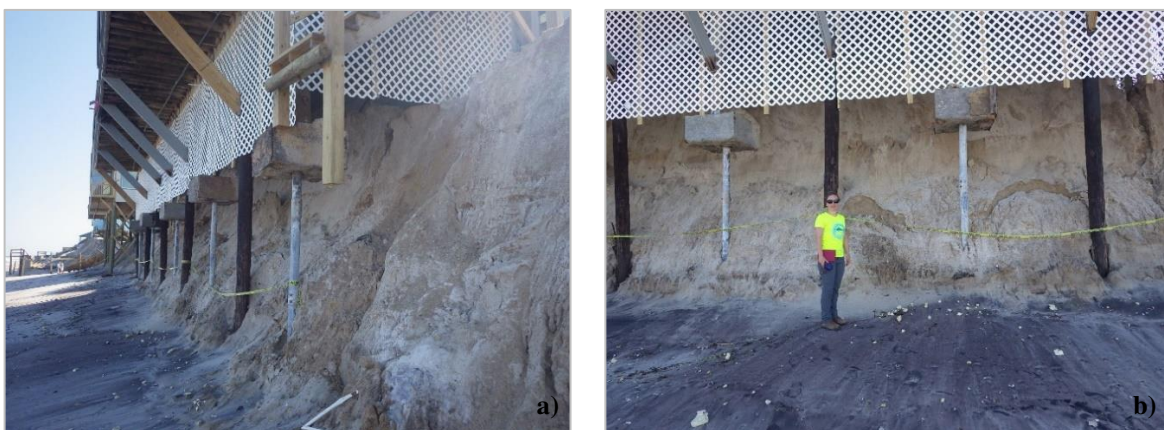
Figure 10 provides an example of damage to a residence that had been constructed on the dunes and protected by a wooden seawall of unknown design installed a distance away from the structure on the beach. The residence and its balcony are supported by alternating deeply embedded pressure-treated timber piles and pressure-treated lumber columns supported by concrete footings, presumably at the previous ground level, and micropiles. This structure experienced substantial erosion, where foundation elements became exposed over more than 10 m (~30 ft) height and both the footprint of the balcony area and structure itself were undercut. The seawall was itself destroyed (see Figure 9c). Minor slope failures were evident on the remaining dune face (Figure 10b). Drying and loss of capillary suction in the sand during the heat of the day made the exposed slopes more prone to sloughing and put the structures at greater risk of being undermined.

Figure 10: Erosion undercutting both the timber pile supports and micropile supported concrete footings for a beach house with continued slope failures in drying sand at 29°56'47.00"N latitude and 81°18'8.10"W longitude after Hurricane Irma.

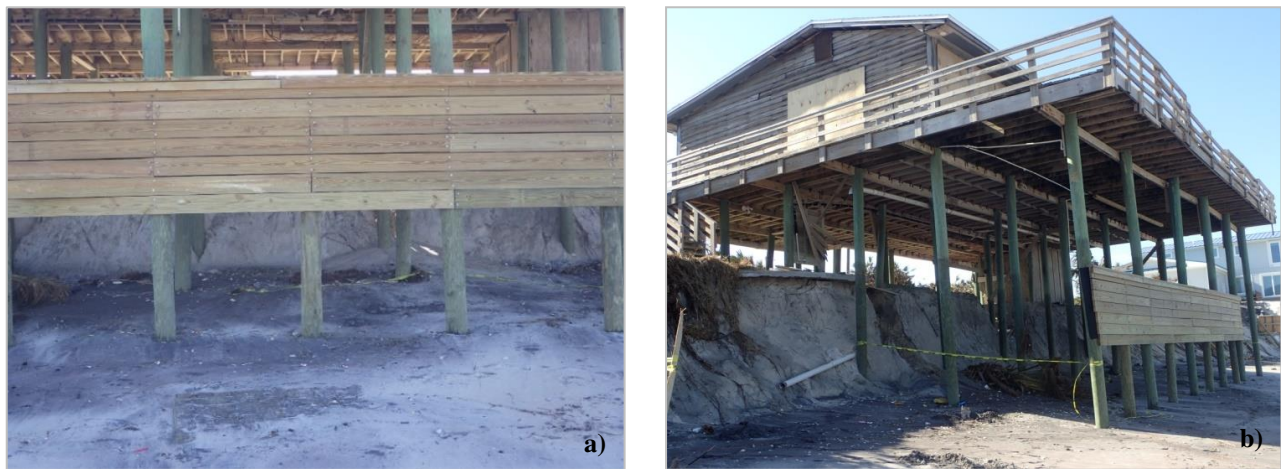
Figure 11 shows a wooden seawall left partially intact after Hurricane Irma. The seawall was constructed from pressure-treated lumber approximately 50 mm by 150 mm (2 in. by 6 in.) in cross-section nailed to pressure-treated timber piles supporting upper levels of the residence. The lumber was either not embedded or minimally embedded into the soil. The wall itself remained intact and undamaged, likely because it was attached to the piles. While the wall may have been initially effective at preventing erosion, soil was eroded from beneath and around the sides of the wall, undercutting three rows of timber piles. Notice also the underside of the elevated structure. The GEER team was uncertain how developed the ground floor of this structure was; however, there was evidence that walls and utilities were eliminated by wind and wave activity.

Figure 11. (a) Shallowly embedded timber seawall at approximately 29°56'49.30"N latitude and 81°18'9.37"W longitude, showing significant erosion (about 2 m or 6.6 ft) below a residential structure; and (b) subsequent beach erosion and removal of the first story walls by wind and water.

Timber pile and wooden lagging did not fare well in the extreme conditions brought on by Hurricane Irma (Figures 11 and 13). Lagging for these barriers may not have extended deep enough into the beach and retained soil was subject to basal erosion, leaving wooden walls unsupported and subject to even greater wave loading. Additionally, the impact of waves carrying entrained debris and sand likely amplified the rate of damage for these timber walls. Nearly all the wooden face

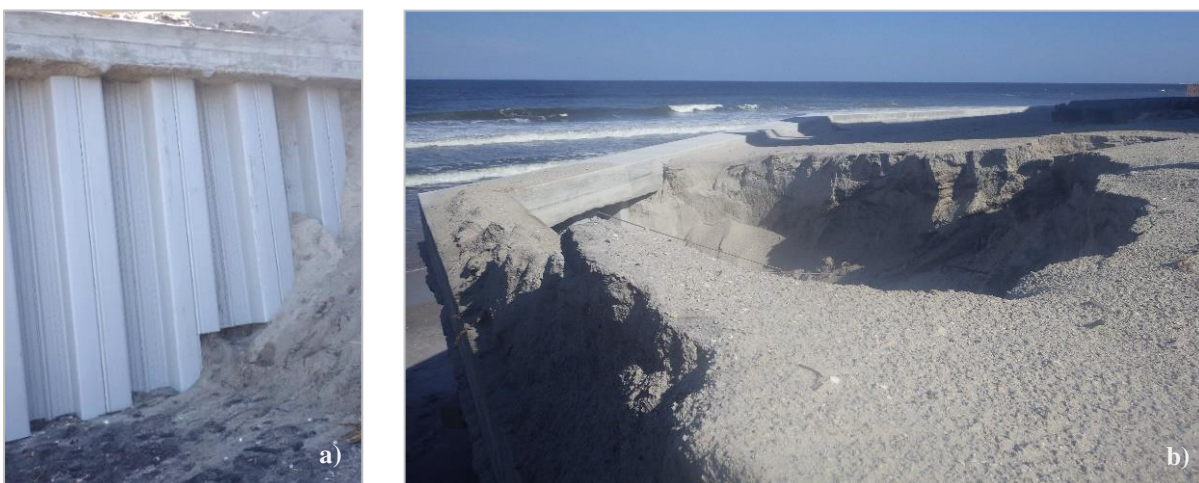
Figure 12: Sheet pile retaining wall failure from undercutting at 29°56'58.16"N latitude 81°18'11.96"W longitude, showing: (a) the exposed wall base, and (b) a funnel-shaped depression following basal soil escape (Hudyma et al., 2017).

The undercutting of shallowly embedded walls is evident in Figure 12a, which shows exposure of the base of a sheet pile wing wall that was scoured to a depth that provided a pathway for retained soil to escape from under the wall. This created a funnel-shaped depression behind the seawall at this location (Figure 12b). Figure 13a shows erosion into the dune and around a wing wall. The face and part of the wing wall were made of embedded vinyl sheet piling. However, the part of the wing wall extending into the dune was of timber pile and wooden lagging. Erosion past the sheet piling into the more open structure of the wooden lagging resulted in break-up of the wall, erosion of the retained soil, and exposure of shallow foundations previously supporting the deck (not shown). Lastly, Figure 13b illustrates the consequences of an incomplete seawall. The wing wall was a temporary timber pile and wooden lagging installed to accommodate a possible future extension of the sheet pile wall face to the neighboring property. The timber seawall was compromised by the storm. The four residences protected by the wall experienced damage, with the most damage adjacent to the temporary wing wall.

The structure with face and wing walls constructed similarly with vinyl sheet pile in Figure 12 experienced some undermining damage; however, the impenetrable material of the wall (vinyl) provided excellent resistance to wave action that was likely intensified by entrained sand and debris from adjacent damaged structures. The walls that the GEER team found to be minimally damaged during Hurricane Irma had sufficient vertical embedment into the beach sands or lateral embedment back into the dune to maintain their structural integrity, even if basal or side exposure of the wing wall resulted in some erosion. The reconnaissance identified two concerns for vinyl sheet pile walls. Walls are installed with weep holes to allow water to drain from the retained sand behind the wall at the beach elevation. Following Hurricane Irma, the weep holes were approximately 0.5 m to 1 m (1.6 ft to 3.3 ft) above the new beach elevation. In many walls with soil still retained, the vinyl sheets bowed out of plumb below the weep holes. This is likely because of both the loss of basal support on the outside face of the wall and pore pressure in the confined soil from trapped water behind the wall. While the vinyl sheet piling is ductile and corrosion resistant, inspection found areas with previous cracks and repairs, possibly due to impact from wave-borne debris.

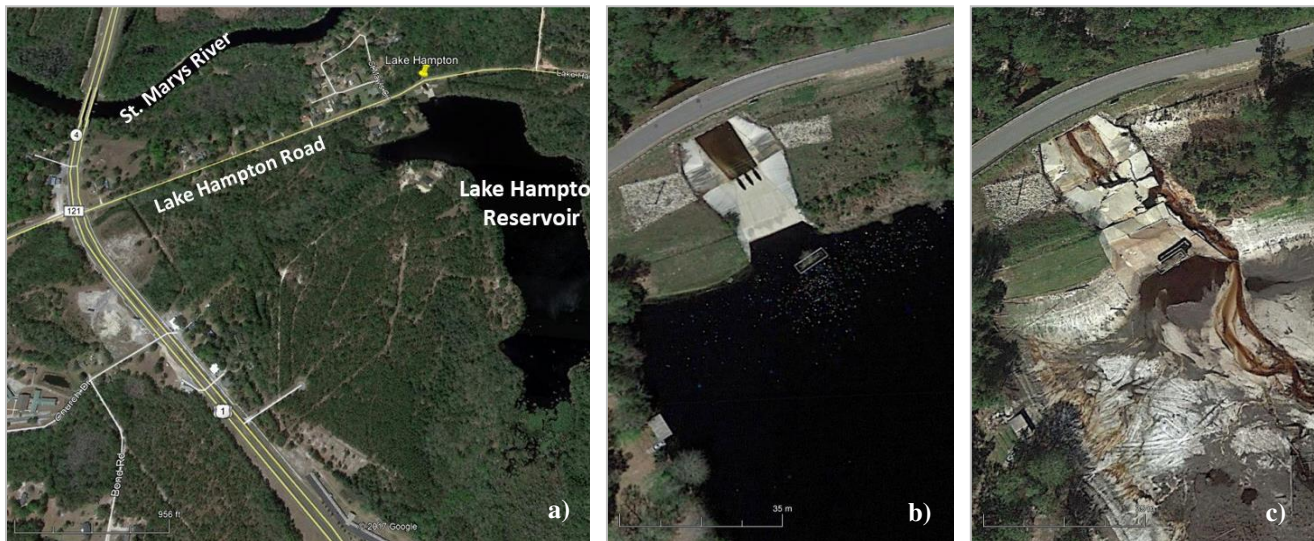
where a concrete structure with four 2.1 m (6.9 ft) diameter concrete pipes passed water from the spillway pool into the downstream tributary (Hudyma et al., 2017). Figure 14 shows aerial images of the dam prior to and after the dam's failure.

Figure 14. (a) Lake Hampton Dam reconnaissance site location with aerial photos of the dam (b) before (March 2017), and (c) after (October 2017) the failure (Google Earth 2018).

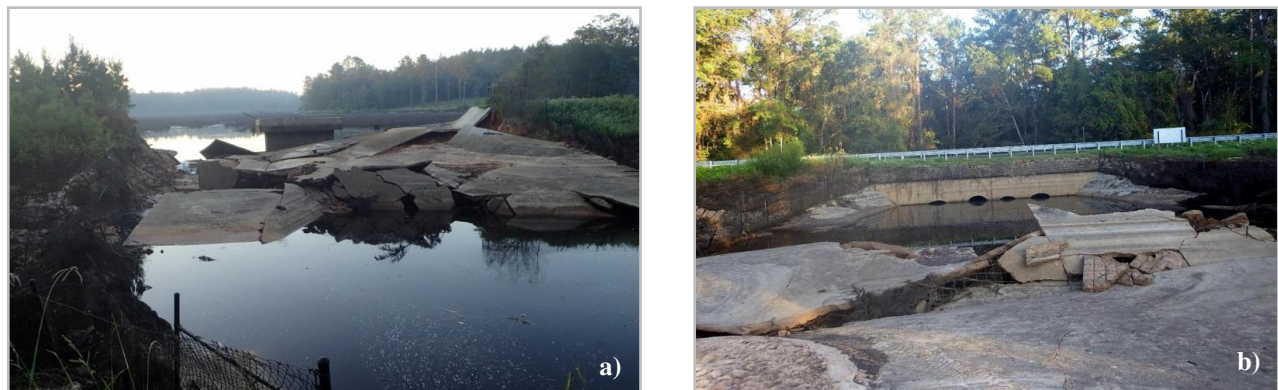
Figure 15 illustrates the remains of the failed dam and surrounding infrastructure. The inlet structure remained intact and in position; the embankment and soils supporting the spillway, however, were washed away and the concrete cover was left cracked and in disarray. Figure 16 shows the significantly eroded eastern embankment and the remaining organic debris as well as the newly formed drainage path for Pigeon Creek. The post-failure erosion channel was located on the east side of the dam, while limited soil erosion was observed along the western embankment. Figure 16 shows two colors of soil in the east embankment, and we speculate the gray soil to the right may have been modified with cement or lime to minimize seepage.

Figure 15: Failed Lake Hampton reservoir dam at 30°46'40.1"N latitude and 81°58'13.0"W longitude: (a) looking south from, and (b) looking north toward Lake Hampton Road.

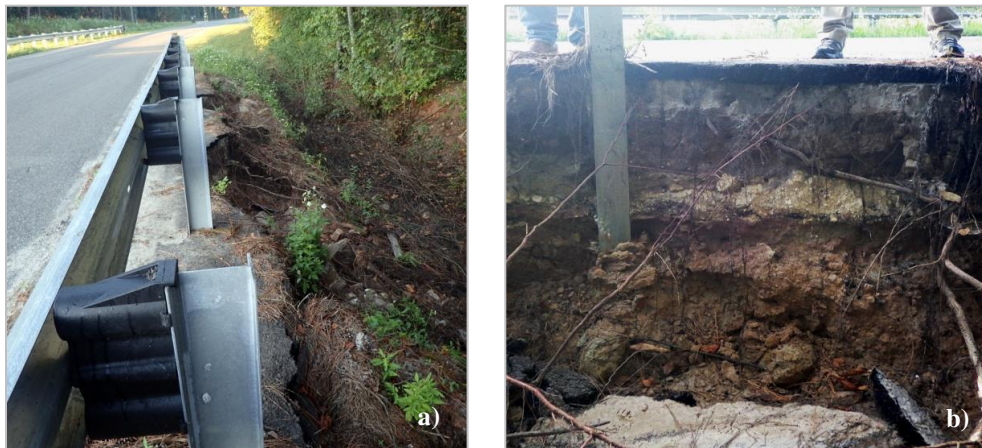
Lake Hampton Road was also subject to damage, and Figure 17 illustrates the erosion that occurred downstream of the dam and road. Erosion of both pavement and road base resulted in guardrail posts becoming exposed. Figure 15b shows the road crossing from the south, where soil and infrastructure remained relatively intact. Figures 17 and 18 comparatively show the road crossing from downstream with significant erosion of embankment soils at either side of the concrete pipe culvert. The downstream floodplain (Figure 18) had low vegetation removed and/or covered with sediment; large brush was denuded to a certain elevation, and trees were destabilized and uprooted. Surface soil remaining on the downstream embankments and the denuded floodplain was dark brown and muddy; Figure 18b, however, shows areas of lighter brown soil that may indicate dried in-place soils or in-place soil mixed with eroded dam embankment soil.

Figure 17: Erosion damage of the northern section of Lake Hampton Road at the Pigeon River crossing north of the dam near 30°46'45.19"N latitude and 81°58'24.6"W longitude.

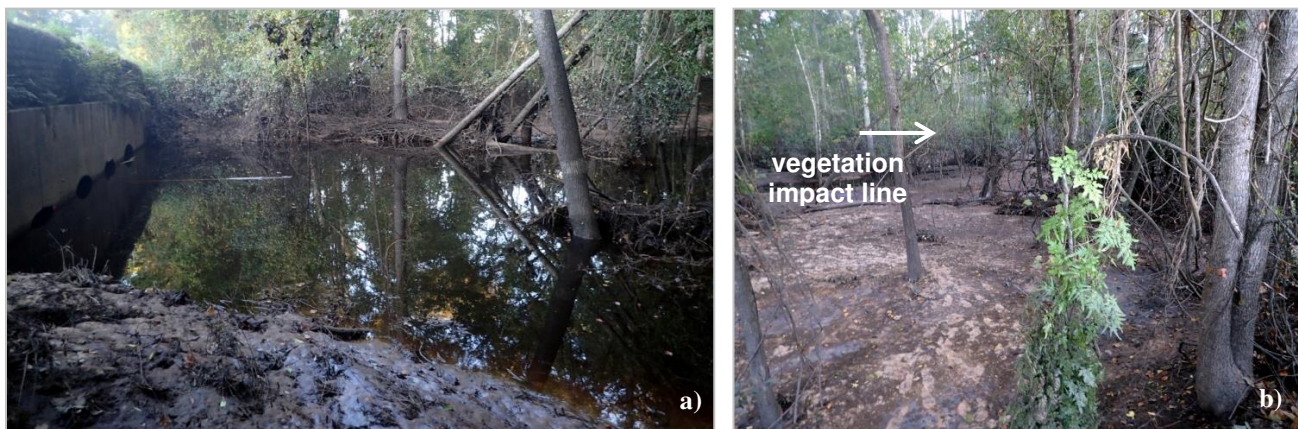
Figure 18: Downstream view of the road crossing at Pigeon Creek near 30°46'45.19"N latitude and 81°58'24.6"W longitude after the failure, illustrating: (a) the dam outlet under Hampton Road with four small diameter openings in a concrete culvert, stacked concrete sack wall stabilizing the roadway, and evidence of high water levels; and, (b) evidence of high water levels, sediment buildup, and debris within the floodplain.

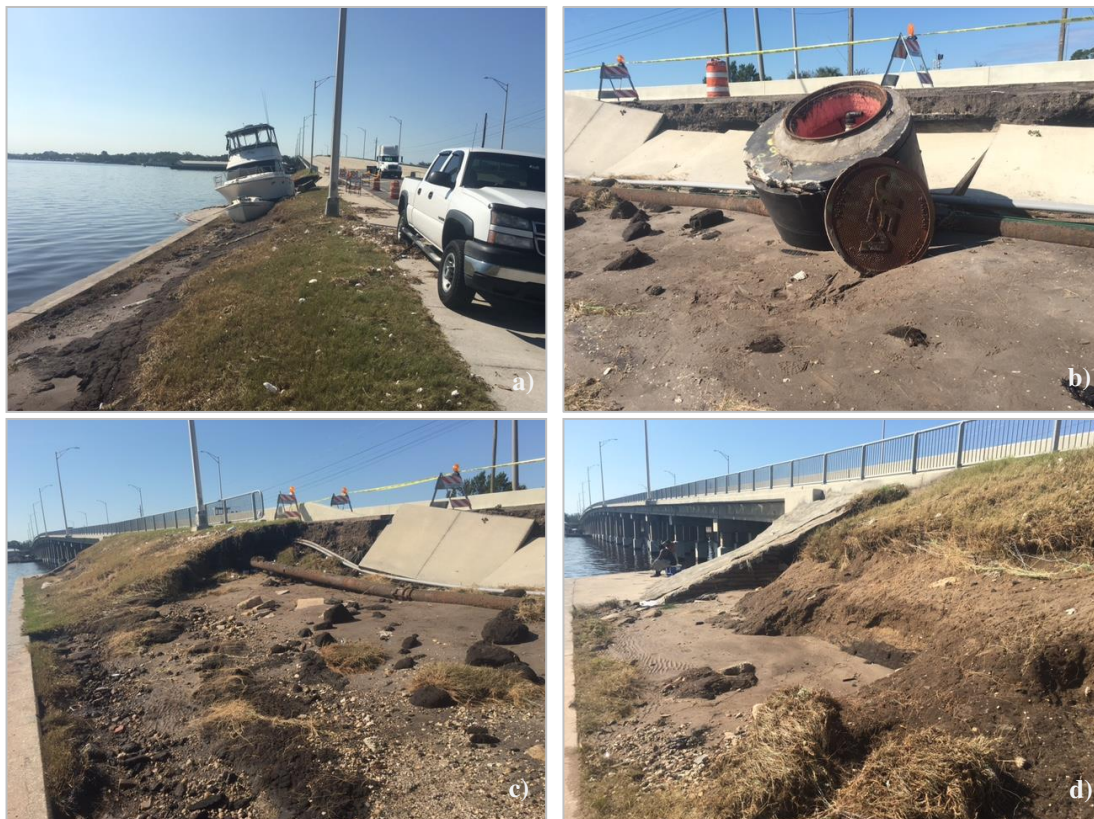
Figure 21. Erosion along the northeast embankment of the US 17 bridge over the Trout River at $30^{\circ}23'45.44''N$ latitude and $81^{\circ}38'53.95''W$ longitude shown from the north southward, including: (a) vessel washed ashore exacerbating scour, (b) an exposed sewer pipe and access structure, (c) exposed sewer pipe and electrical conduit and failed sidewalk, and (d) the terminus of scour at the stacked concrete sack wall where embankment cover was present (Hudyma et al., 2017).

The storm surge generated by Hurricane Irma ranged from 1.2 m to 1.6 m (3.9 ft to 5.2 ft) (Cangialosi et al., 2018) in height and extended into the Trout River, elevating water levels, overtopping the embankment support wall at the river level, and subjecting the northern embankments to erosion. Significant erosion occurred along the northeast bridge embankment on September 10, 2017, extending from the concrete cover of the embankment to approximately 140 m (459 ft) north into the grass- and brush-protected area embankment. The northernmost section of the embankment was protected by woody brush and small trees, and experienced minimal scour. The grass-protected, taller section of the embankment was scoured significantly into the slope (Figure 21b, c, d) to the extent that the edge of the road was undermined, concrete sidewalk panels were dislodged, and underground utilities were exposed and unsupported. The embankment section nearest the transition between the grass and concrete cover experienced the most scour, where the concrete cover was undermined to the stacked concrete sack wall and toward the bridge abutment (Figure 21d, Figure 22a). Localized scour also occurred along the northwest embankment at, and just beyond, the transition between the grass and concrete cover (Figure 22b), likely caused by an eddy current that developed after the high winds and surge accelerated the water through the constriction in the river. During the hurricane, several vessels broke free from their moorings and washed up on the embankment (Figure 21a), which created additional erosion as turbulent water flowed around these obstacles.

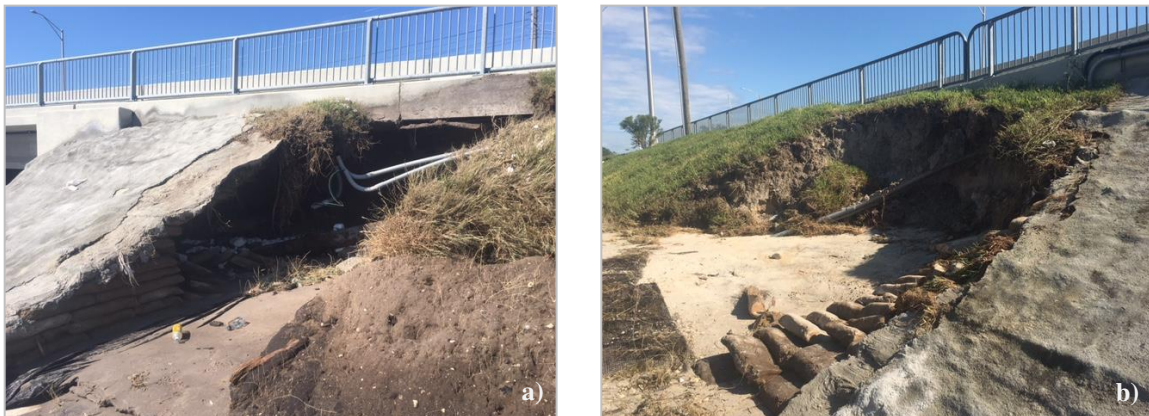
Figure 22. Scour damage along the (a) northeastern and (b) northwestern bridge embankment of the US 17 bridge over the Trout River at 30°23'44.43"N latitude and 81°38'54.13"W longitude (Hudyma et al., 2017).

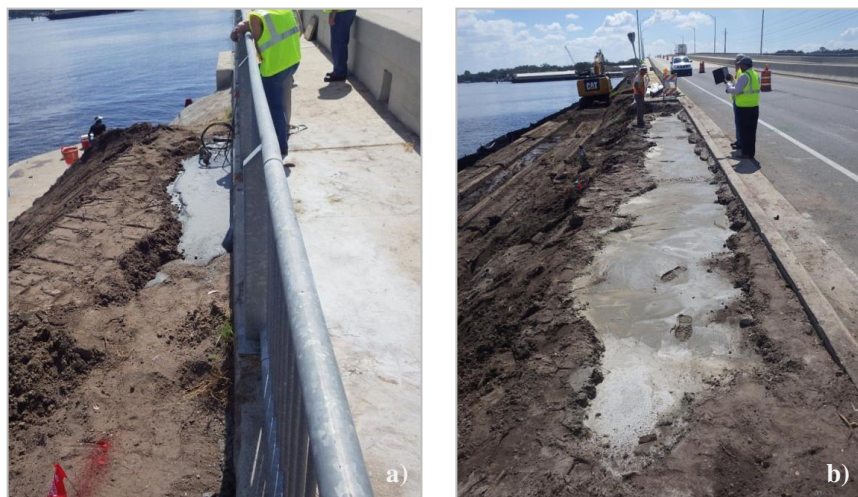
Figure 23: Repaired northeastern bridge embankment for US 17 bridge over the Trout River at 30°23'45.44"N latitude and 81°38'53.95"W longitude that includes the rebuilt soil and excavatable flowable fill trench embankment (a) adjacent to the concrete covered, stacked concrete sack wall; and (b) roadway edge (Hudyma et al., 2017).

The GEER team visited the site two weeks after the scour damage occurred and repairs were partially completed. Construction crews had partially rebuilt the embankment to the design elevation and placed excavatable flowable fill into vertical trenches near the roadside to stabilize soil below the road and around underground utilities. Figure 23 shows a flowable fill trench adjacent to the northeast abutment (approximately 5 m long, 1 m wide, 6 m deep, or 16.4 ft by 3.3 ft by 19.7 ft) and adjacent to the northeast section of road (approximately 21 m long, 1 m wide, 2 m deep, or 69 ft by 3.3 ft by 6.6 ft).
